CIE 5318 Fieldwork Hydraulic Engineering

- Final Report -

This report is written for the course CIE5318 “Fieldwork Hydraulic Engineering”. This is an elective course in the curriculum of the master Hydraulic Engineering at the Faculty of Civil Engineering and Geosciences. The content of this report is the elaboration of the October 2011 fieldwork in Bulgaria.

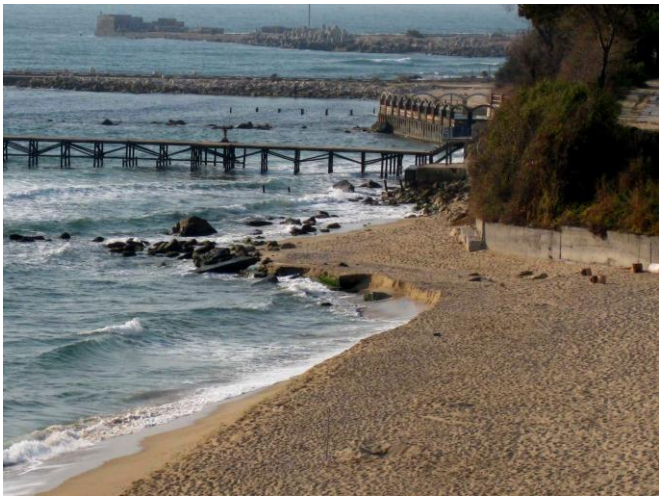
FIGURE 2-2 - CLEARLY VISIBLE ESCARPMENT LINE DUE TO WAVE ACTION IN THE NIGHT OF 7 TO 8 OCT.

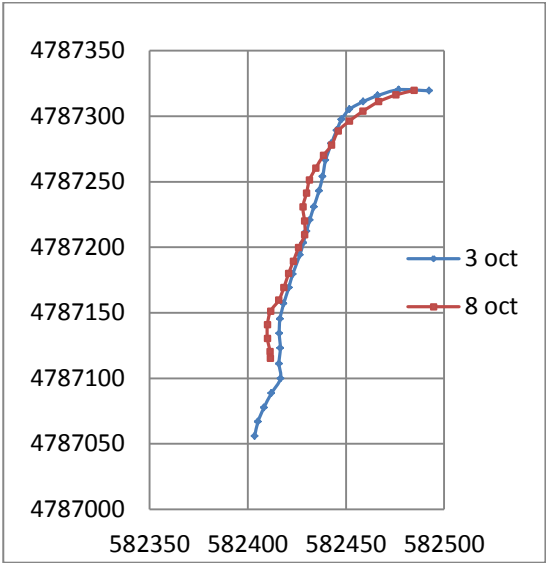
FIGURE 2-3 - GPS TRACKS OF 3 AND 8 OCTOBER 2011.

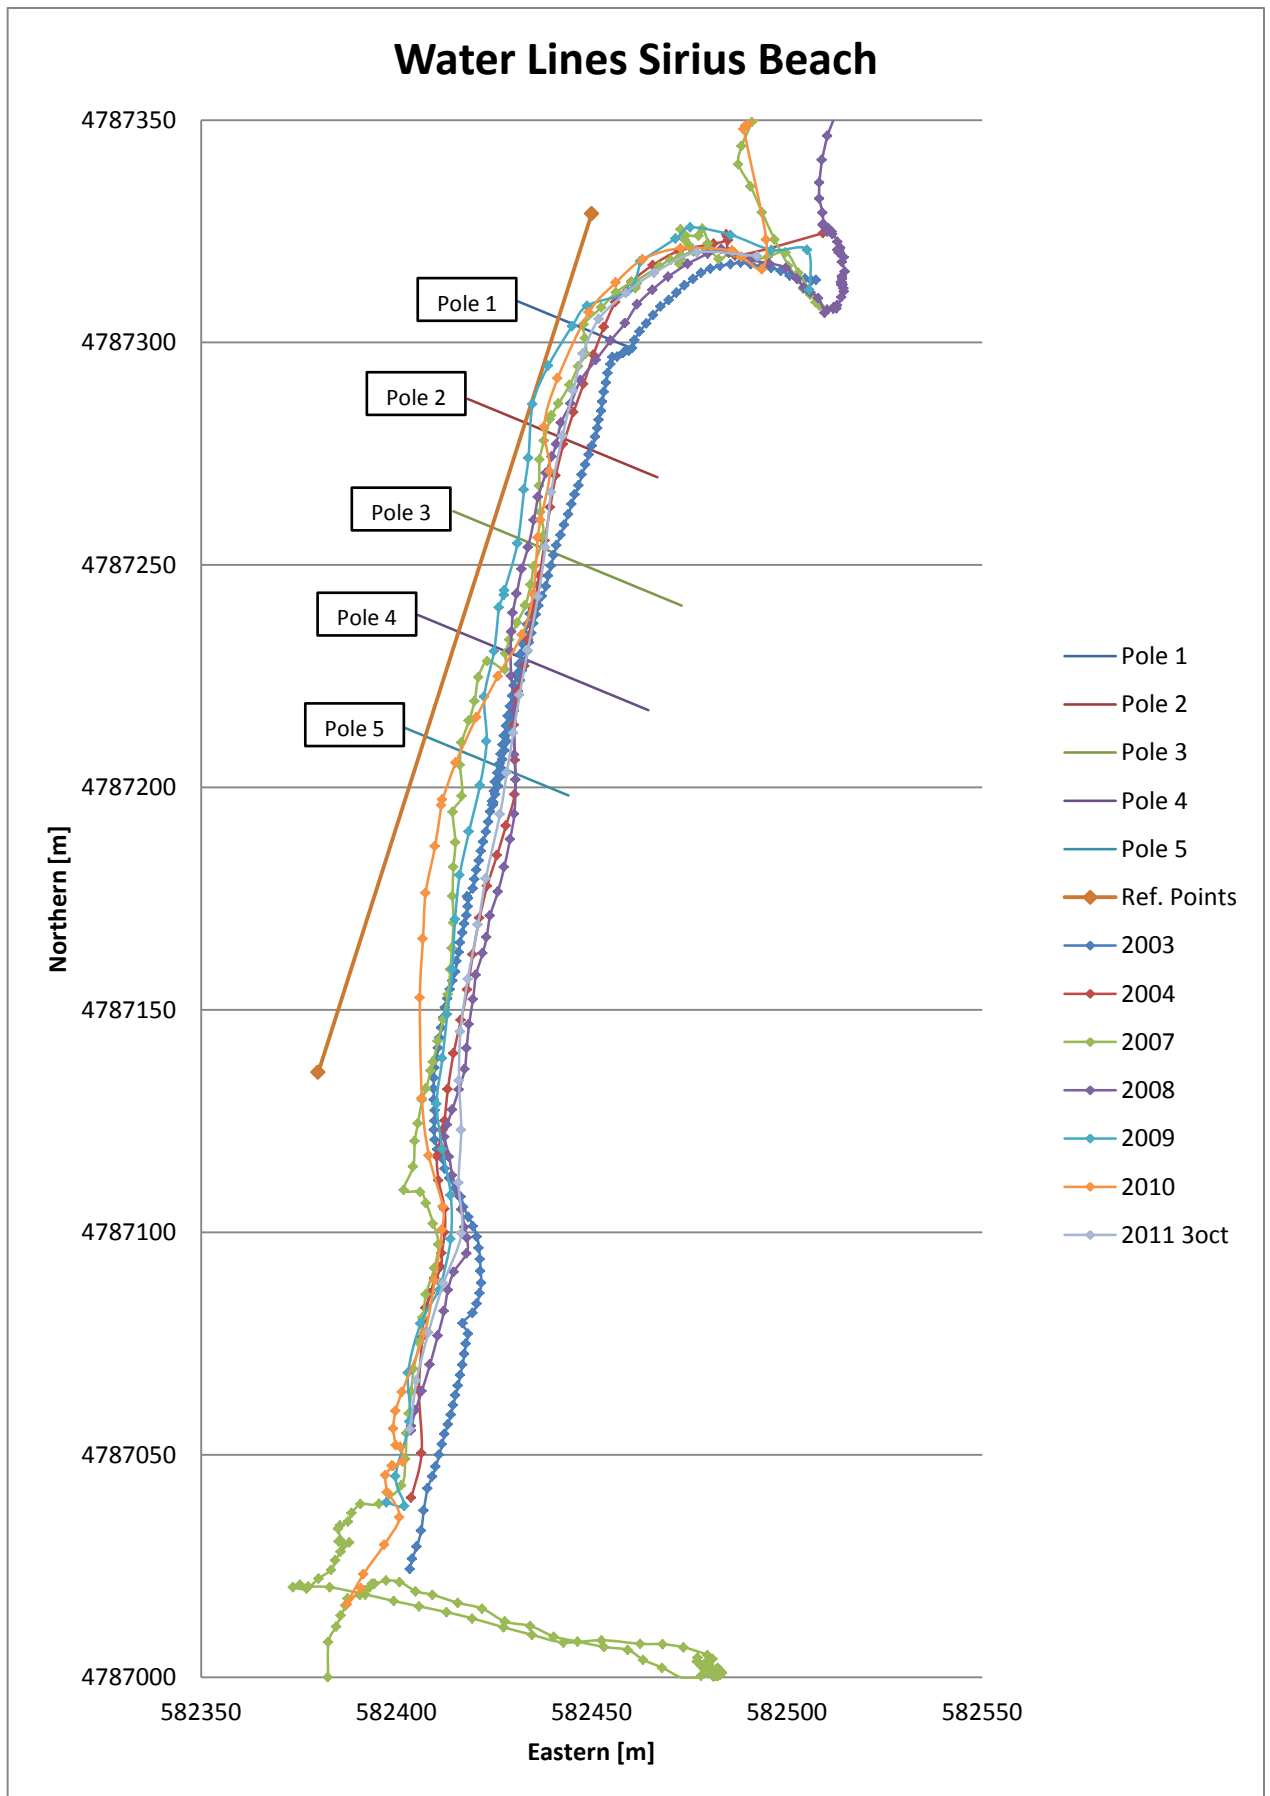
One type of beach measurements is measuring the waterline with a handheld GPS receiver. The waterline is defined as the still water line excluding individual waves. GPS devices have a log option which automatically saves the location every couple of meters. Depending on the amount of available satellites the accuracy is in the order of 5 meters. Also it should be noted that every individual through the years will choose a different path as the Waterline; even in data from the same years a difference between different tracks can be seen. The data is good for a global image whether or not beach waterlines are retreating or not but should not be used for very detailed purposes. GPS data of the waterline position has been collected since 2003 and is compared in Figure 2-4.

FIGURE 2-4 - WATER LINES SIRIUS BEACH (2003 - 2011).

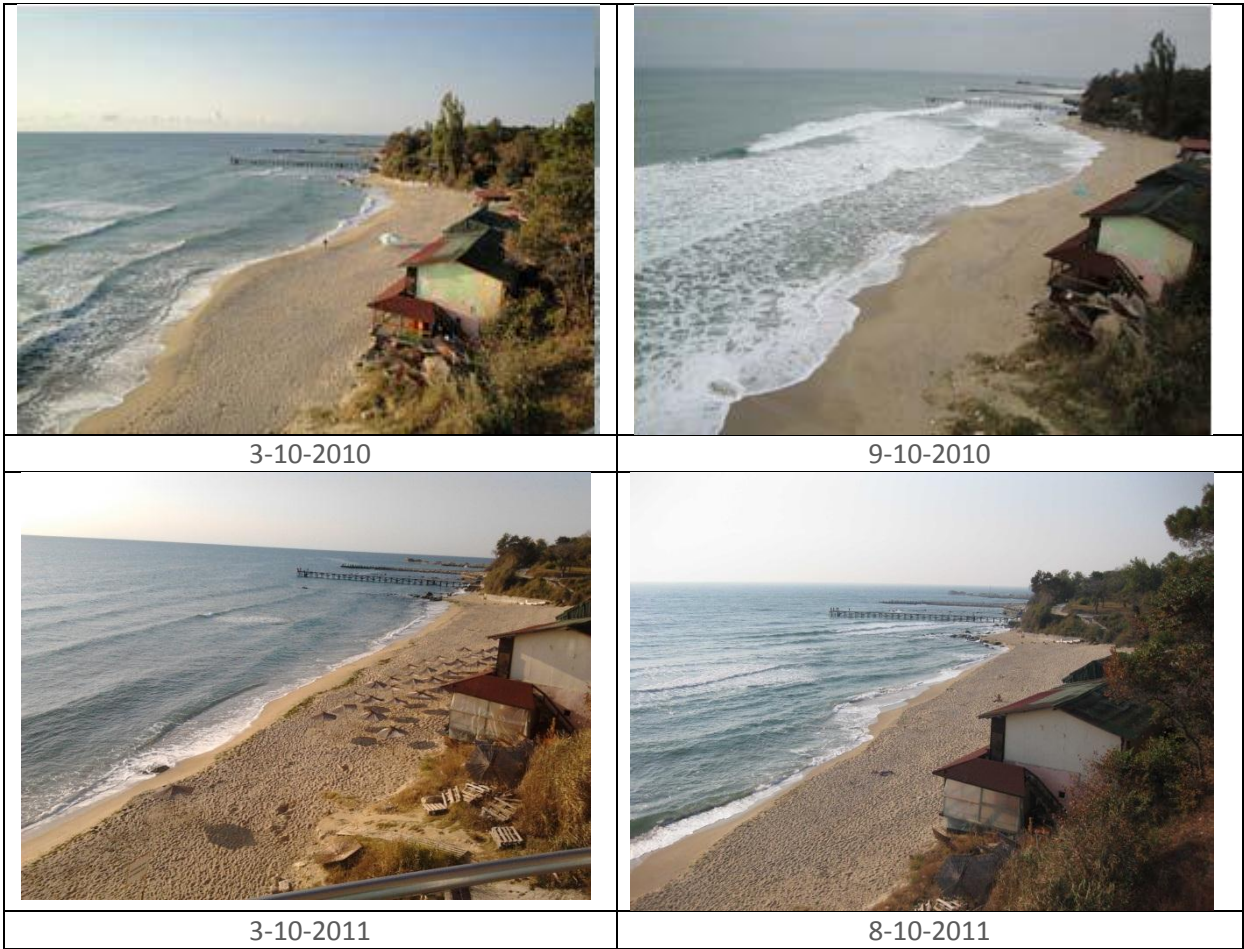
Previous year photographs were taken on arrival and departure from the balcony of the Sirius Hotel. This year almost identical photos were taken. The pictures of last year also show that a lot can happen in a short time span.

FIGURE 2-5 - PICTURES OF SIRIUS BEACH AT ARRIVAL AND DEPARTURE (2010 & 2011).

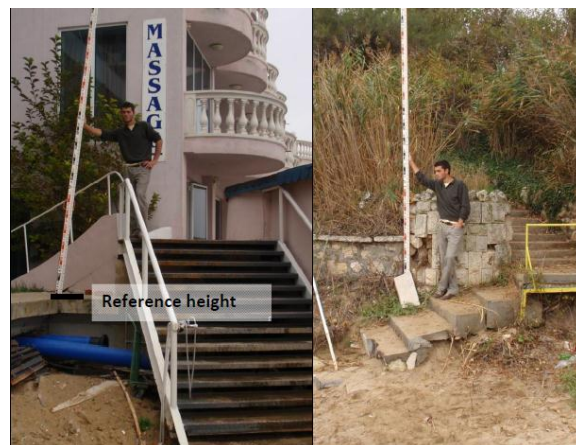
FIGURE 2-6 - REFERENCE POINT 1 (LHS) AND REFERENCE POINT 2 (RHS).

Reference point 2 was positioned at the Southern end of the beach, also at a staircase. The UTM coordinates for this point are 35T, 582380 m East, 4787136 m North.

These points are the exact same points that were used in previous years, to simplify conversion.

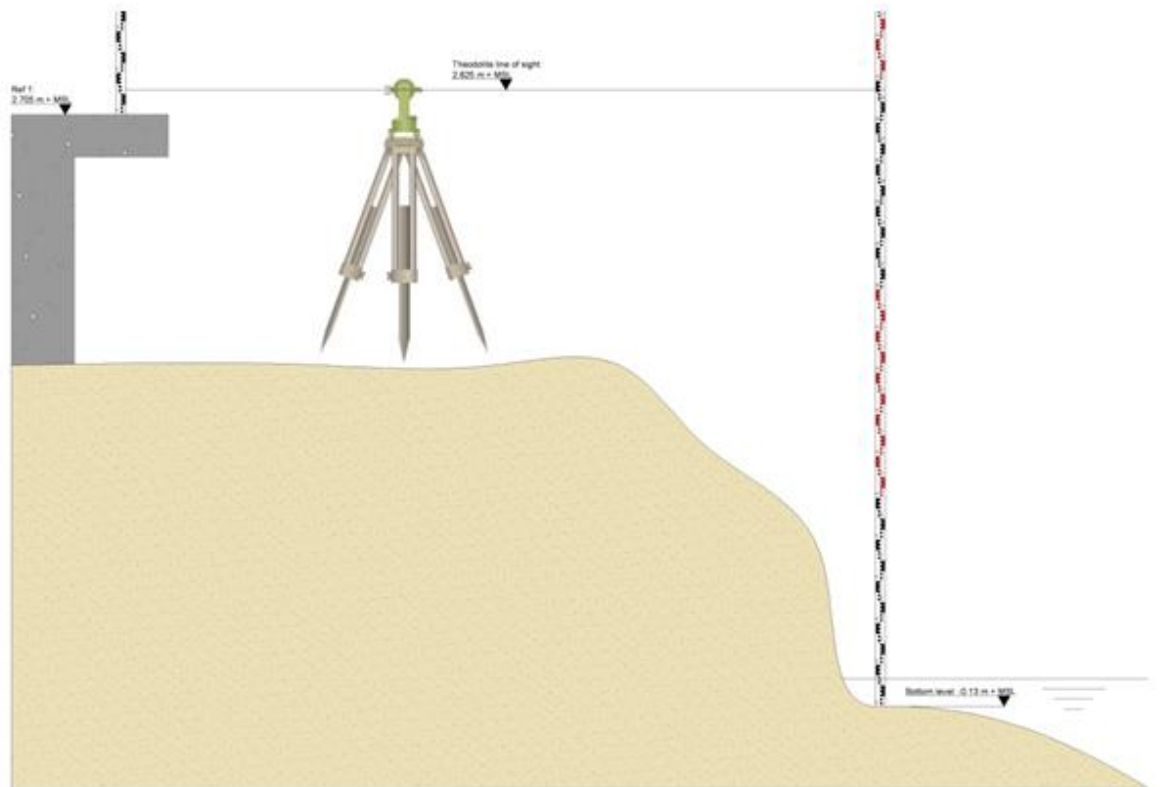
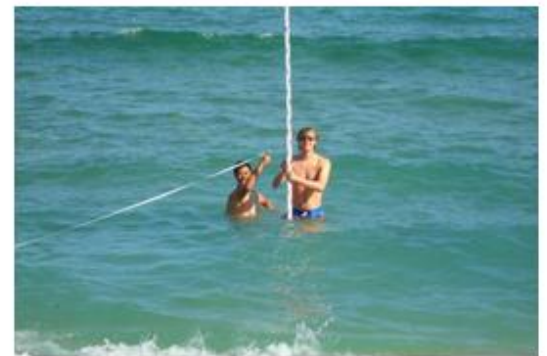
In the ideal case, only one theodolite is used to measure all 5 cross-shore profiles. Every theodolite requires of course its own coupling to the reference point; the height of the line of sight of that theodolite should be determined based on a levelling rod at the reference point. Unfortunately, at further distances the measuring pole cannot be seen clearly anymore. In this case, it was decided to use 3 theodolites, so every levelling rod could be read accurately. Figure 2-8 shows the procedure of measuring a vertical position with a theodolite.

FIGURE 2-8 - PROCEDURE OF MEASURING A VERTICAL POSITION WITH A THEODOLITE

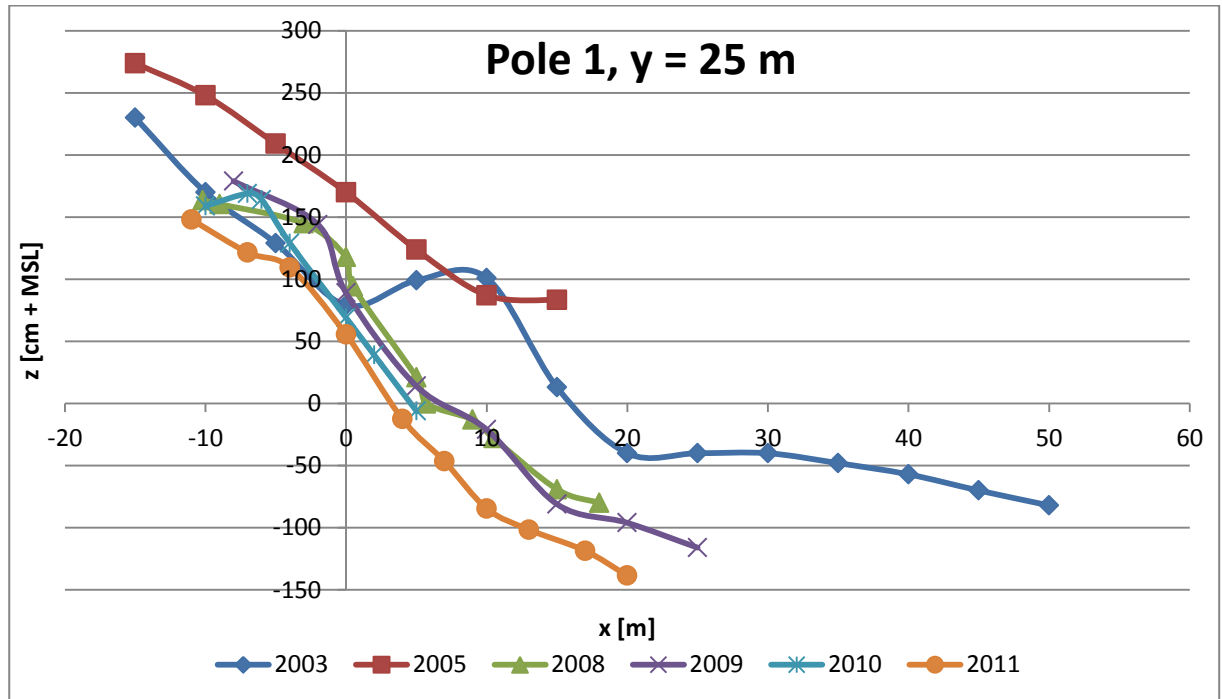
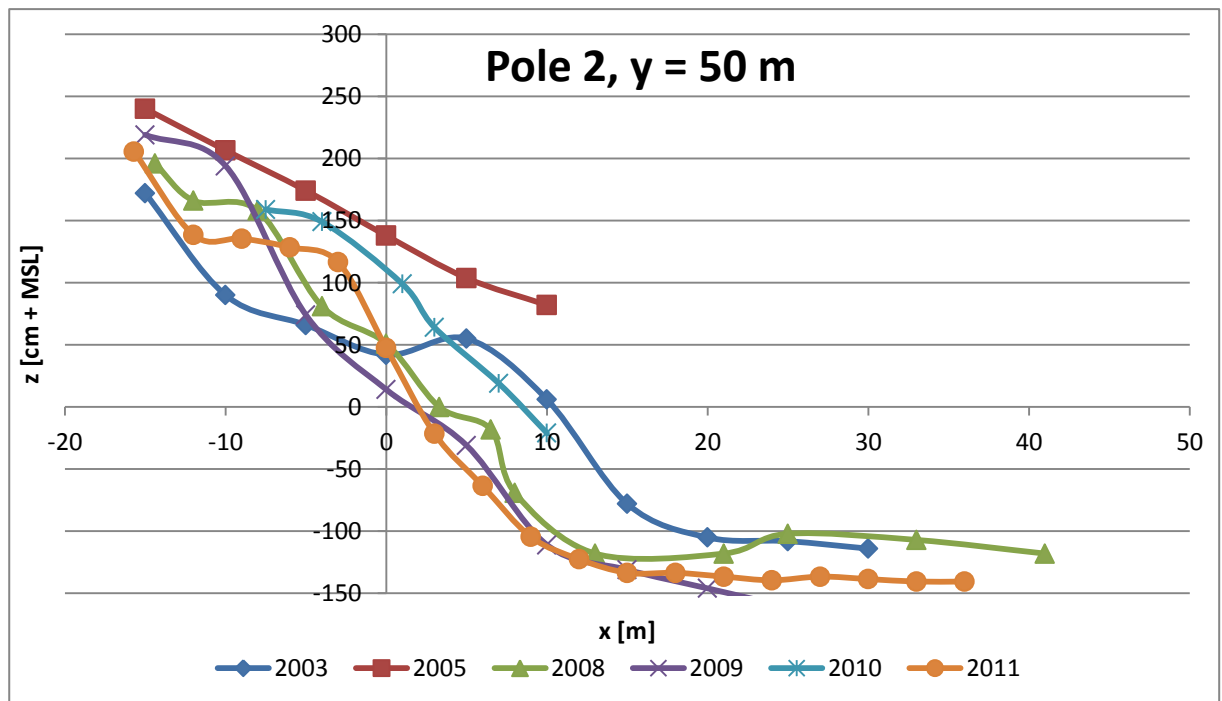
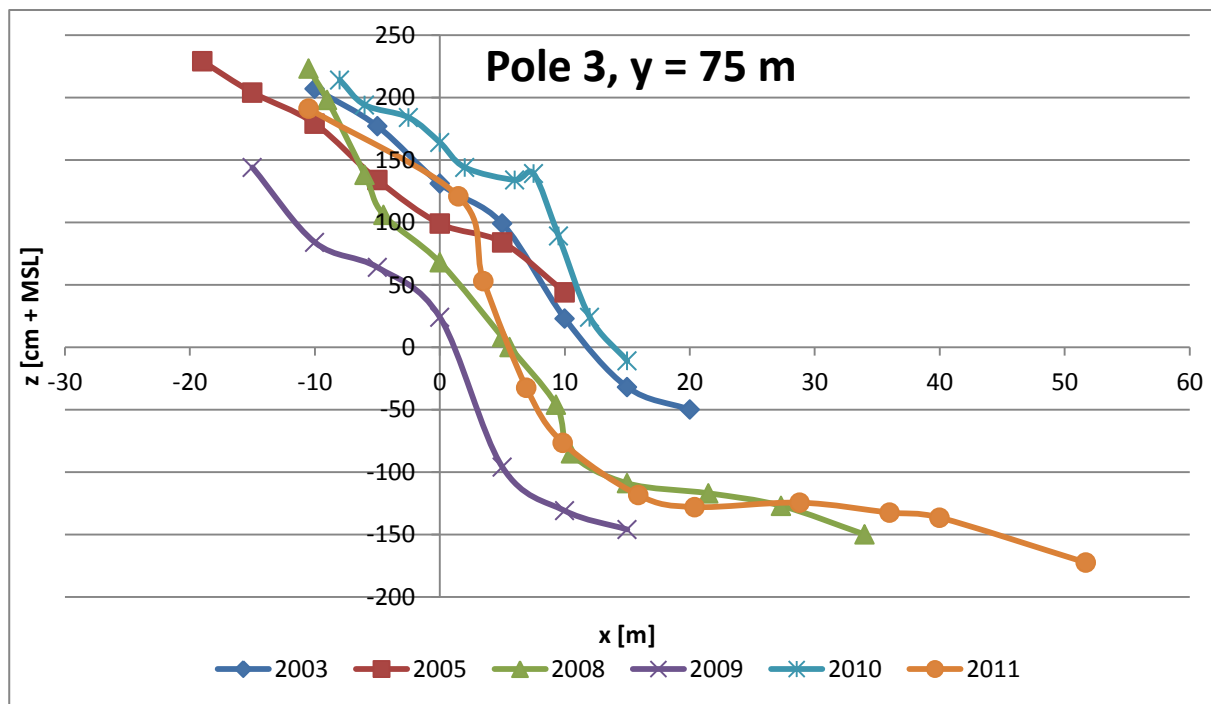
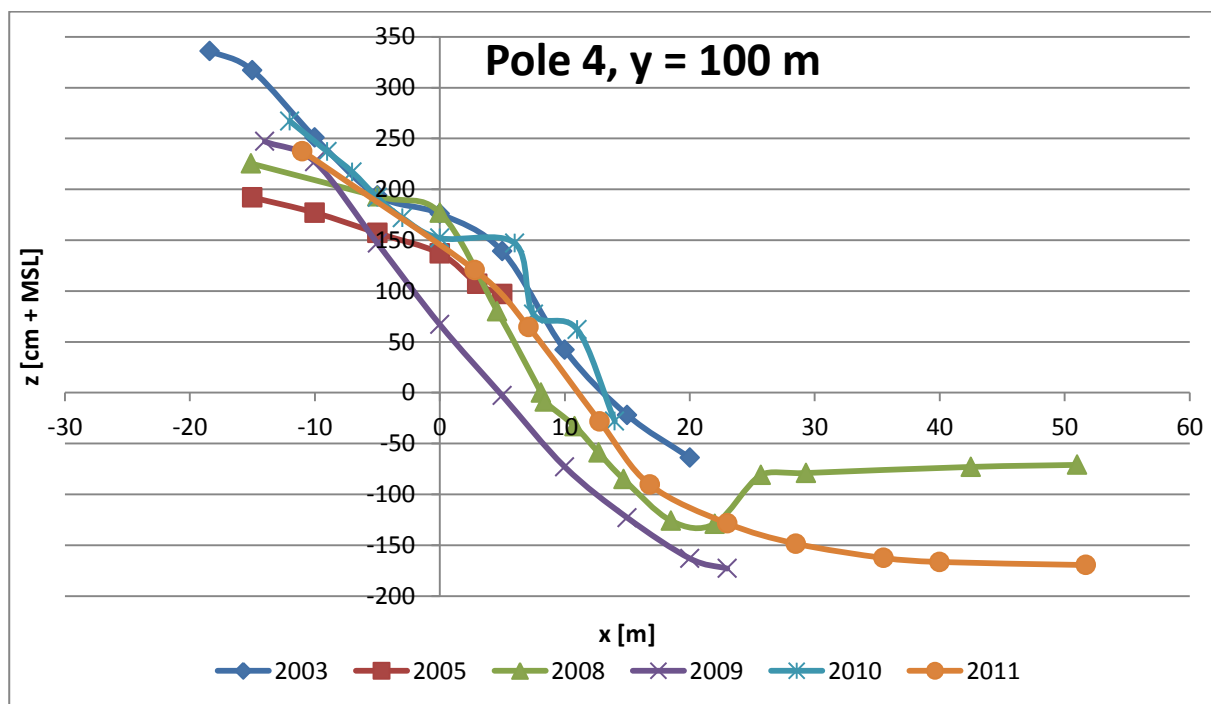
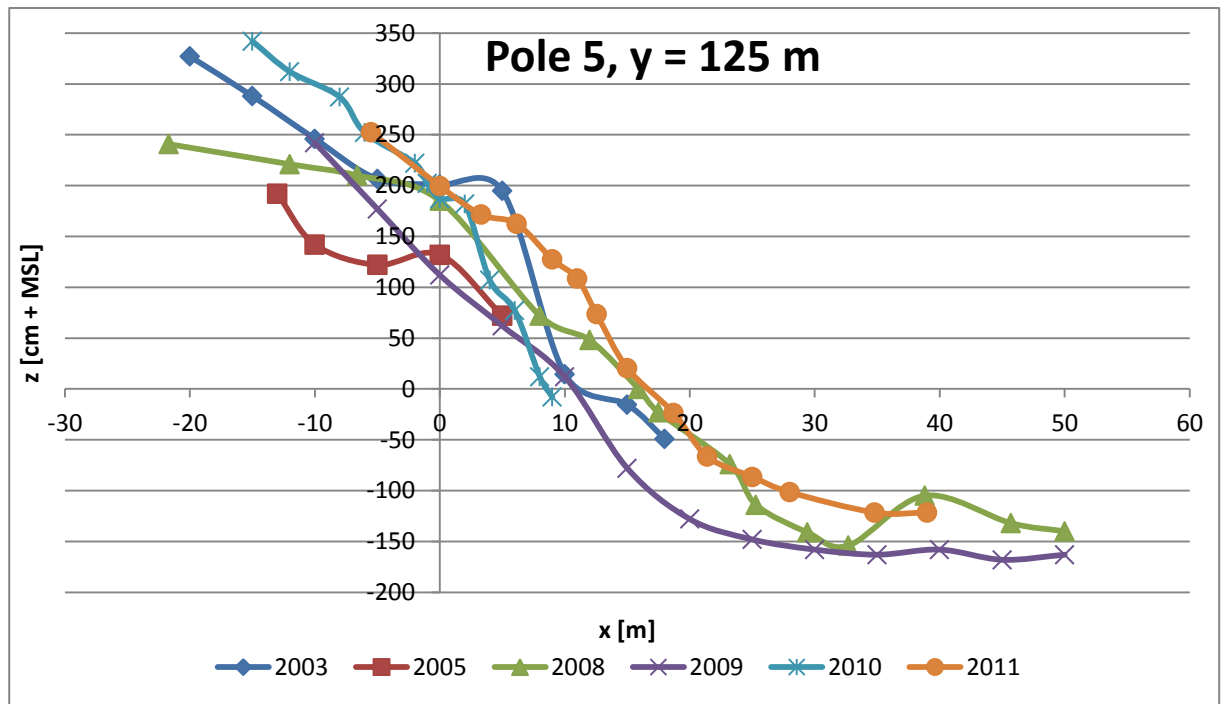
FIGURE 2-9 - CROSS SHORE PROFILE POLE 1 (AT 25 M).

FIGURE 2-10 - CROSS SHORE PROFILE POLE 2 (AT 50 M).

FIGURE 2-11 - CROSS SHORE PROFILE POLE 3 (AT 75 M).

FIGURE 2-12 - CROSS SHORE PROFILE POLE 4 (AT 100 M).

FIGURE 2-13 - CROSS SHORE PROFILE POLE 5 (AT 125 M).

The cross-shore profiles do not provide an unambiguous picture of a long term trend. The first positions - closest to the Hotel Sirius – show a retreat of the coast in the past few years. Then at pole 4 it appears that the coastline is more or less stable in time. Pole 5 shows an accretion of the coast over time. When considering all cross-shore profiles, it can be noted that the rate of accretion/erosion is much smaller than the initial rate (at 2003).

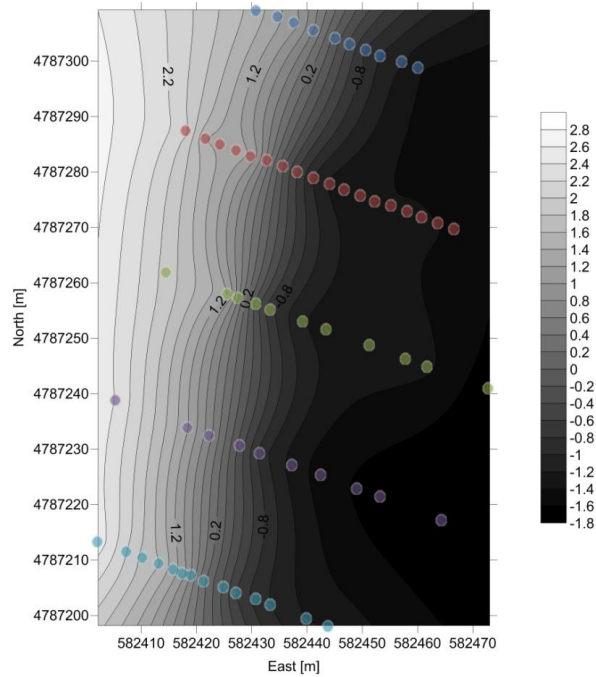
FIGURE 2-14 - DEPTH CONTOUR MAP OF SIRIUS BEACH.

Figure 2-14 displays a depth contour map of Sirius Beach, which was produced with the data of the cross-sectional measurements. The coloured dots are the measurement locations. From this image it may be noted that the foreshore at pole 2 and 3 is somewhat flatter than at pole 4 and 5. Figure 2-15 provides a bird's eye perspective of the beach.

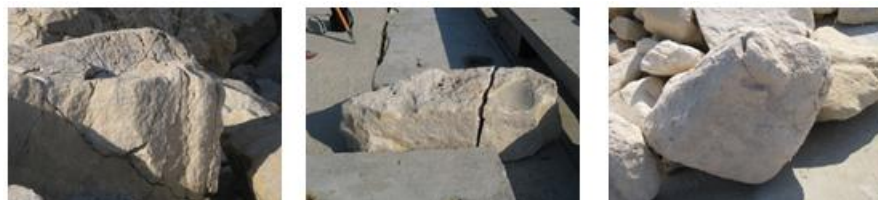
The quality of the stones is not that good as can be seen in Figure 3-3. The stones break easily, and have a lot of cracks.

Several stones where lying on top of the groin. Those stones are placed there during storms. When comparing photos of previous years with each other, it is clear that the stones are moving. For example the stones that where laying on the south side of the top of the groin (2011) where not there in 2009. From the photos can be concluded that the stones are moving and that the stones are to light.

FIGURE 3-3 - PHOTOS OF STONES ON TOP OF THE GROIN

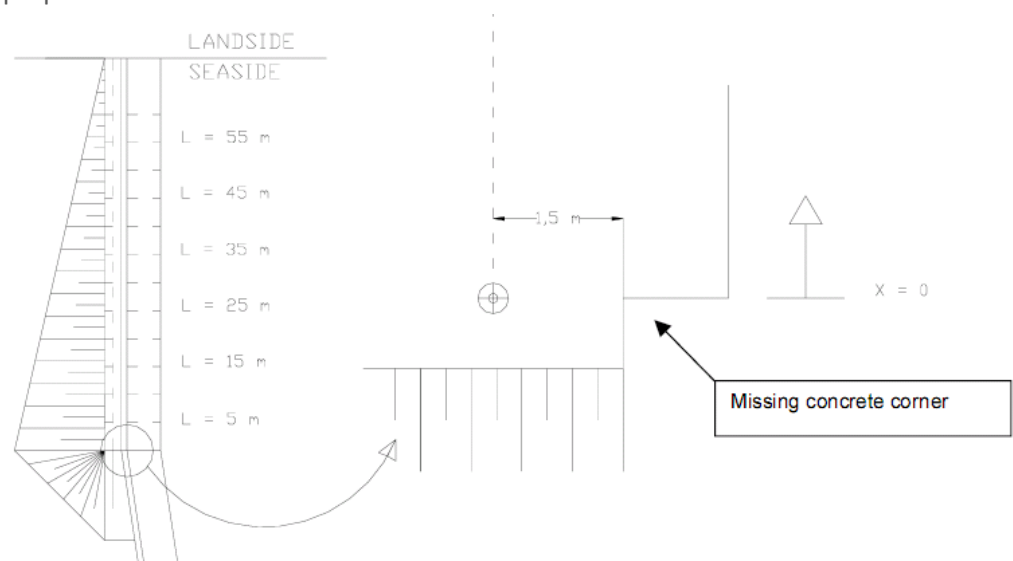
In 2002 the groin near St. Konstantine is measured for the first time. In this year they marked a base point at the groin, just before the bent in the groin (see Figure 3-4 and Figure 3-5). This base point is considered stable and not to vary over the years. From the base point in the direction of the beach, a straight line over the crest of the groin, the base line is created with reference points every 5 meters (in Figure 3-4 only the base point, and from the 5m point on a point every 10 meters are shown). Cross-sections will be measured perpendicular to the base line.

FIGURE 3-4 - OVERVIEW OF THE BREAKWATER, INCLUDING LOCATIONS OF THE CROSS-SECTIONS OF PREVIOUS YEARS

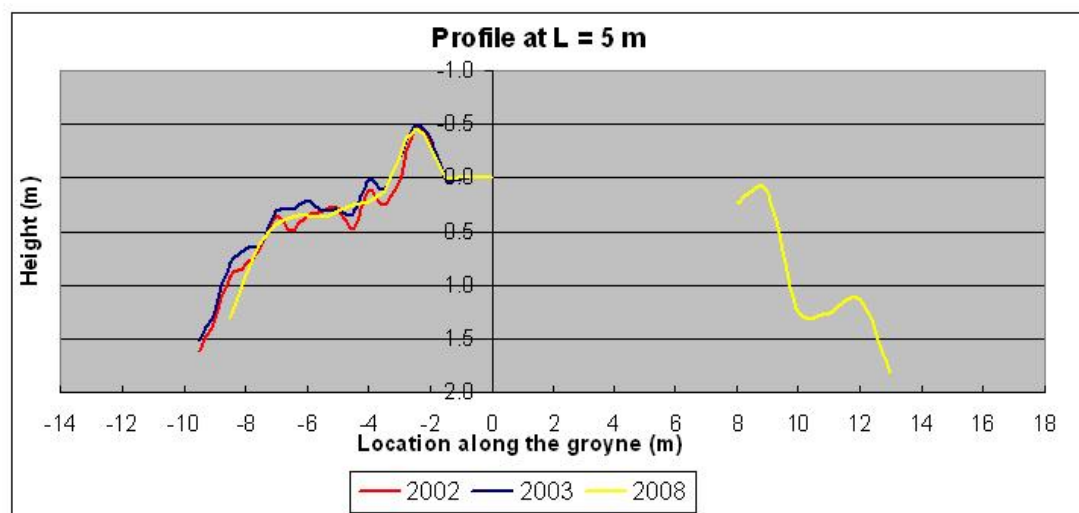
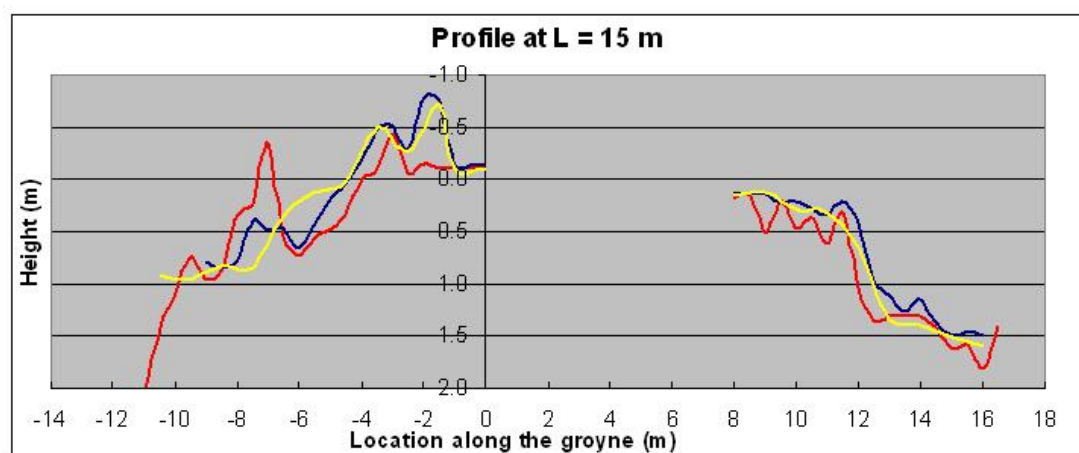
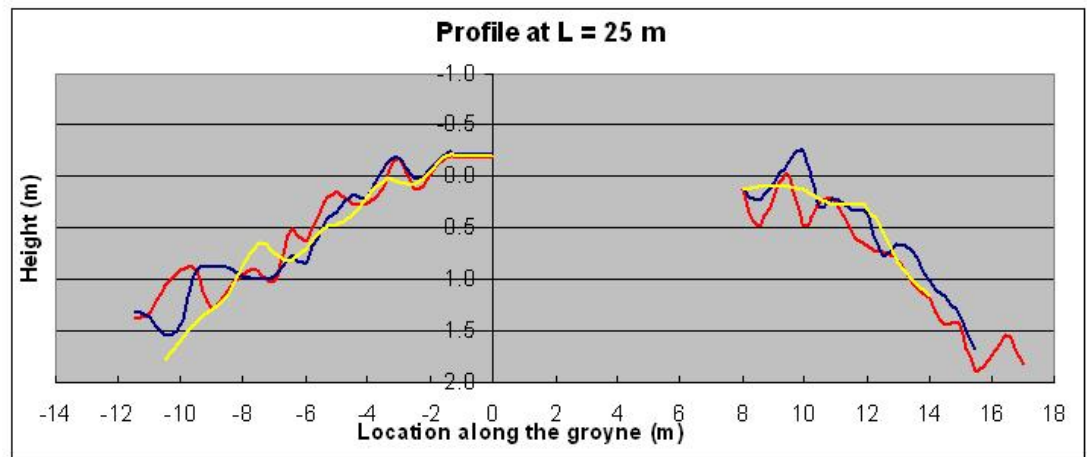
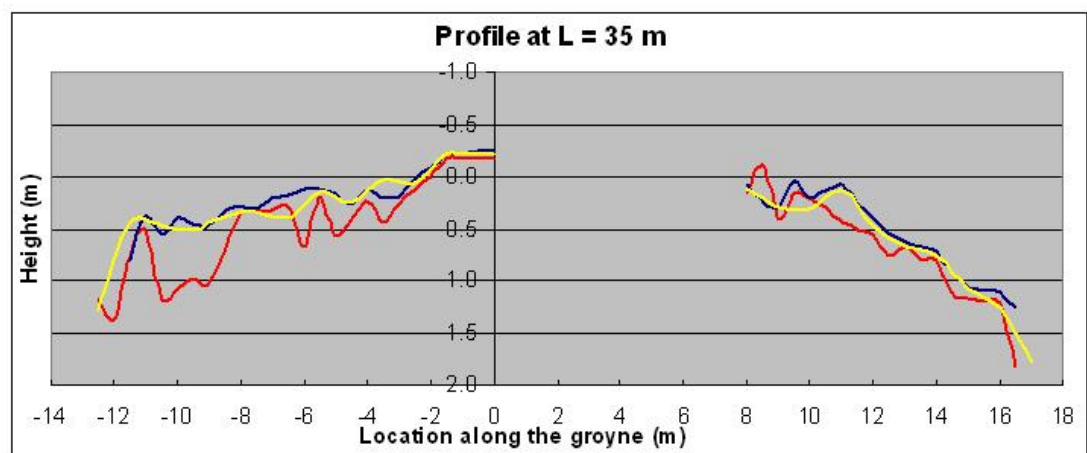
The north side of cross-section $L = 5\text{m}$ is measured for the first time in 2008. For the cross-sections $L = 15\text{m}$, $L = 25\text{m}$ and $L = 35\text{m}$, both, the north and south side of the groin is measured in all the years. From the cross-sections $L = 45\text{m}$ and $L = 55\text{m}$ no reliable data is available. Because of a lack of reliable data those last to cross-sections are not added to this report.

FIGURE 3-6 - CROSS-SECTION AT L = 5M (REPORT 2008)

FIGURE 3-7 - CROSS-SECTION AT L = 15M (REPORT 2008)

FIGURE 3-8 - CROSS-SECTION AT L = 25M (REPORT 2008)

FIGURE 3-9 - CROSS-SECTION AT L = 35M (REPORT 2008)

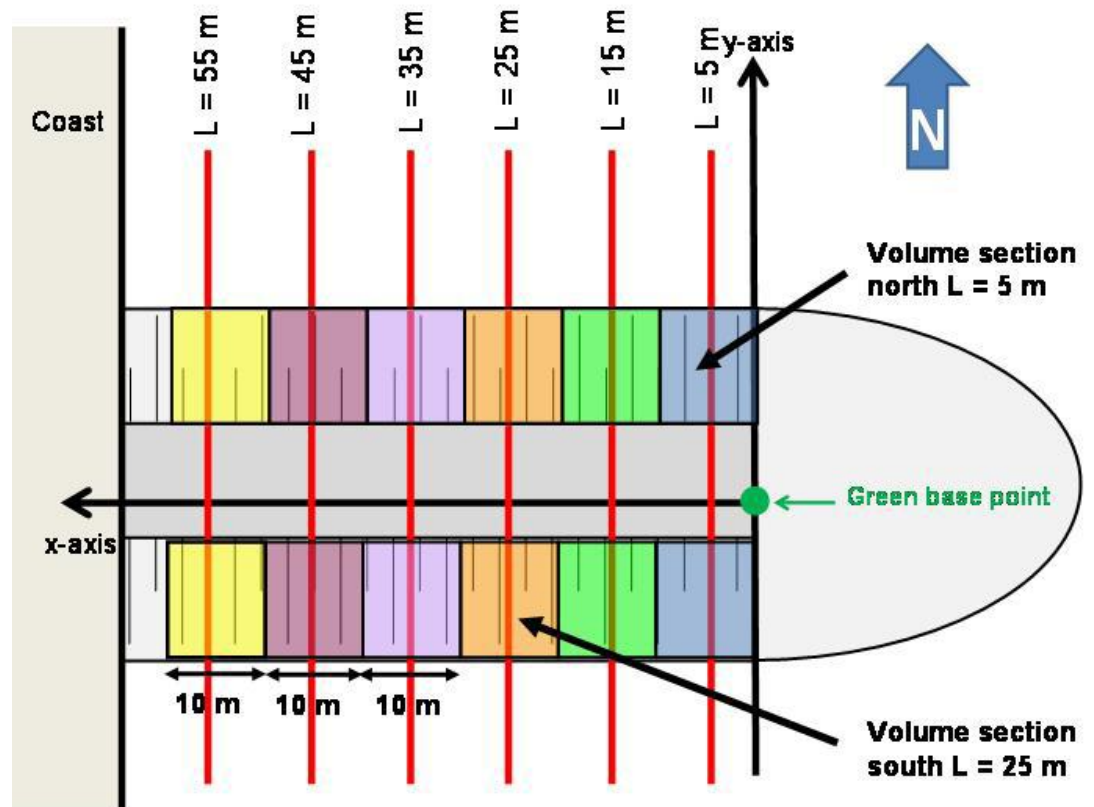
Within this paragraph the change of volume over the years will be elaborated. The north and south side of the groin will be looked at separately. This is done because of the difference in load. Besides a difference between the north and south side, the groin is split up in sections of 10 meter (see Figure 3-10).

FIGURE 3-10 - SECTIONS OF VOLUME CALCULATION (REPORT 2008)

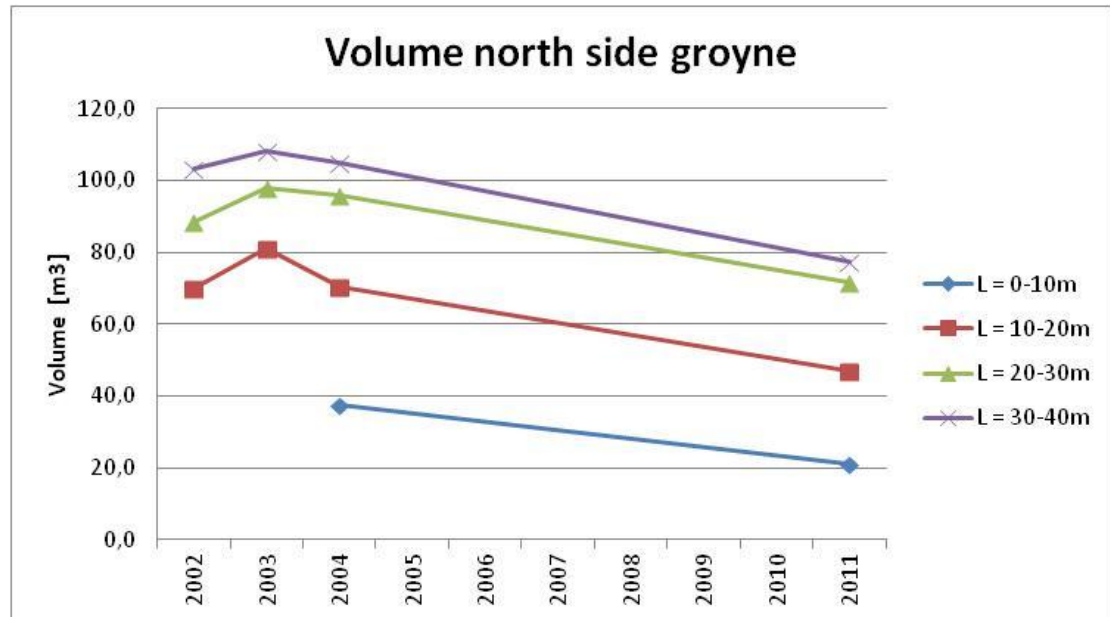
Because of the lack of data from the last cross-sections only the sections $L=0-10\text{m}$ till $L=30-40\text{m}$ are taken into account in the comparison of the volume.

FIGURE 3-11 - VOLUME NORTH SIDE GROIN PER SECTION

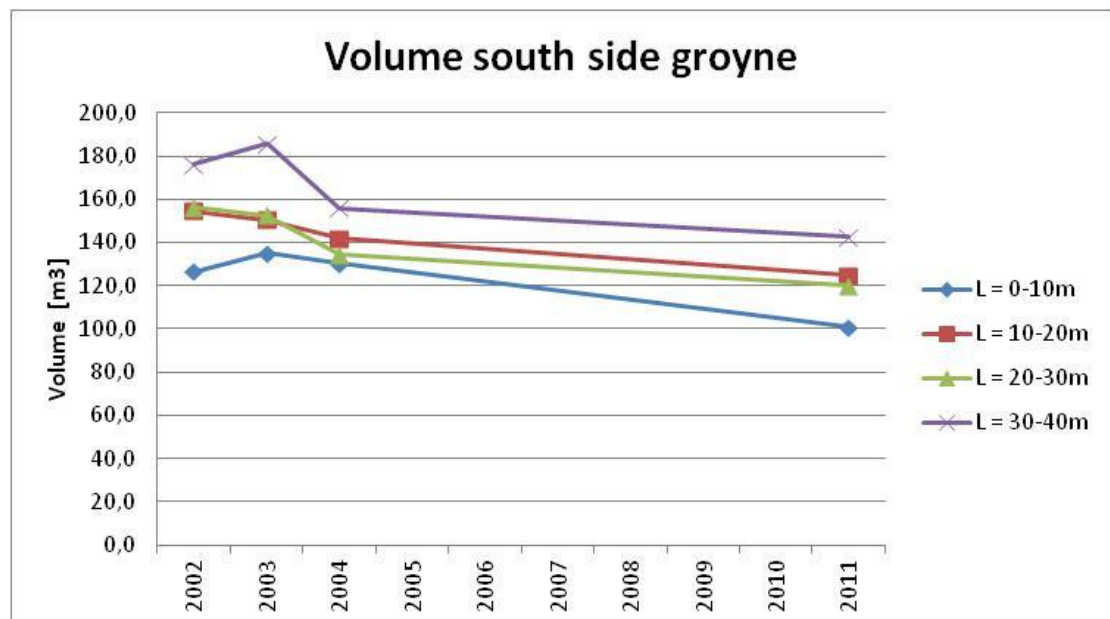
Figure 3-12 gives the change in volume for the south side of the groin. On average a decrease of volume can be measured over the years.

FIGURE 3-12 - VOLUME SOUTH SIDE GROIN PER SECTION

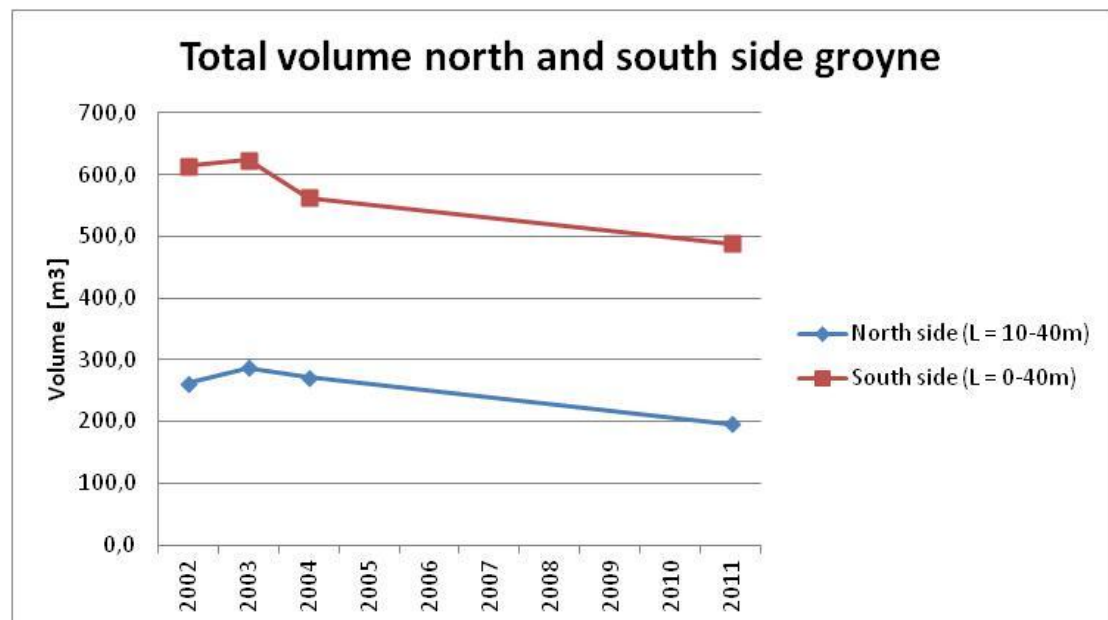
- An increase of volume can be explained by movement of stones of the tip of the groin (where no cross-sections are measured) in the direction of the shore. The tip of the breakwater was heavily damaged, which makes it assumable that stones have been moved in the direction of the shore. After the first year the small stones where moved from the tip in the direction of the shore. The next year the heavy storms moved those stones further in the direction of the shore or moves them into to the sea, what results in an decrease of the volume;

- The stones applied on the groin are too small, this results in moving of the stones during the storms. This is clearly visible in Figure 3-3 where stones are moved from the slope to the top of the groin. Besides movement of stones, the stones are also rocking during storms, which finally results in breaking of stones. So the stones become smaller, which will results in even more damage during storms.

FIGURE 3-13 - TOTAL VOLUME NORTH AND SOUTH SIDE OF THE GROIN

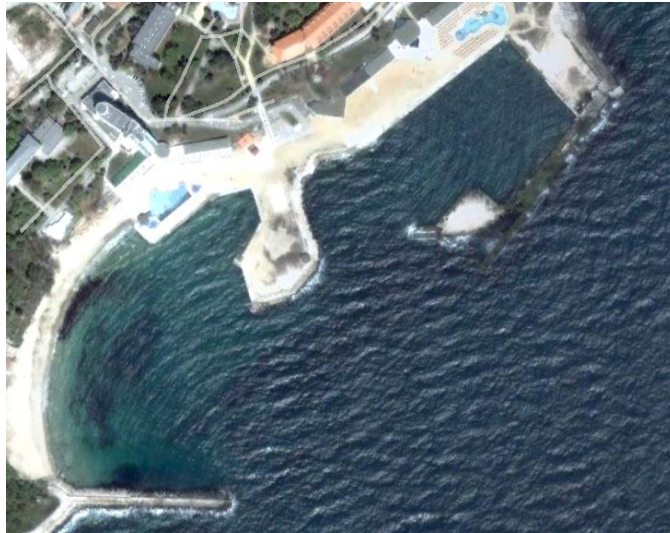
Looking at the breakwater situated to the far south (see Figure 3-14 and Figure 3-15) it is clearly visible that the wave energy behind this breakwater is much less. But during storm conditions the waves are coming from a different direction. So the southern breakwater is only effective during summer.

FIGURE 3-15 - THE WAVE PATTERNS IN THE HARBOR AND AT THE SMALL BEACH

Because the harbor is used only in summer an alternative could be a floating breakwater. The floating breakwater can be used to protect the boats during summer. And when the harbor isn't used anymore (during winter), the breakwater can be towed to another place. Because the breakwater is only used in summertime, the design can also be less massive.

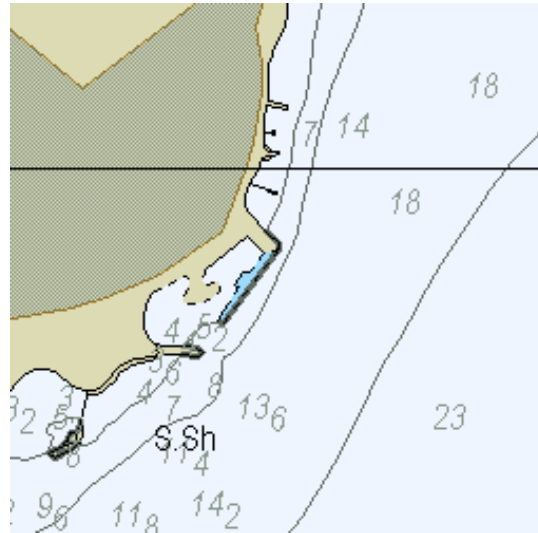
In the Black Sea there is hardly any tide, the difference is at most 9 centimetres. Because of a lack of wave data, the maximum wave is taken as half of the depth. The depth is approximately 5m (taken from Figure 3-17). This results in waves of approximately 2.5 meter high in storm conditions (higher waves will break before they reach the breakwater).

FIGURE 3-17 - DEPTHS IN FRONT OF THE BREAKWATER OF THE HARBOR

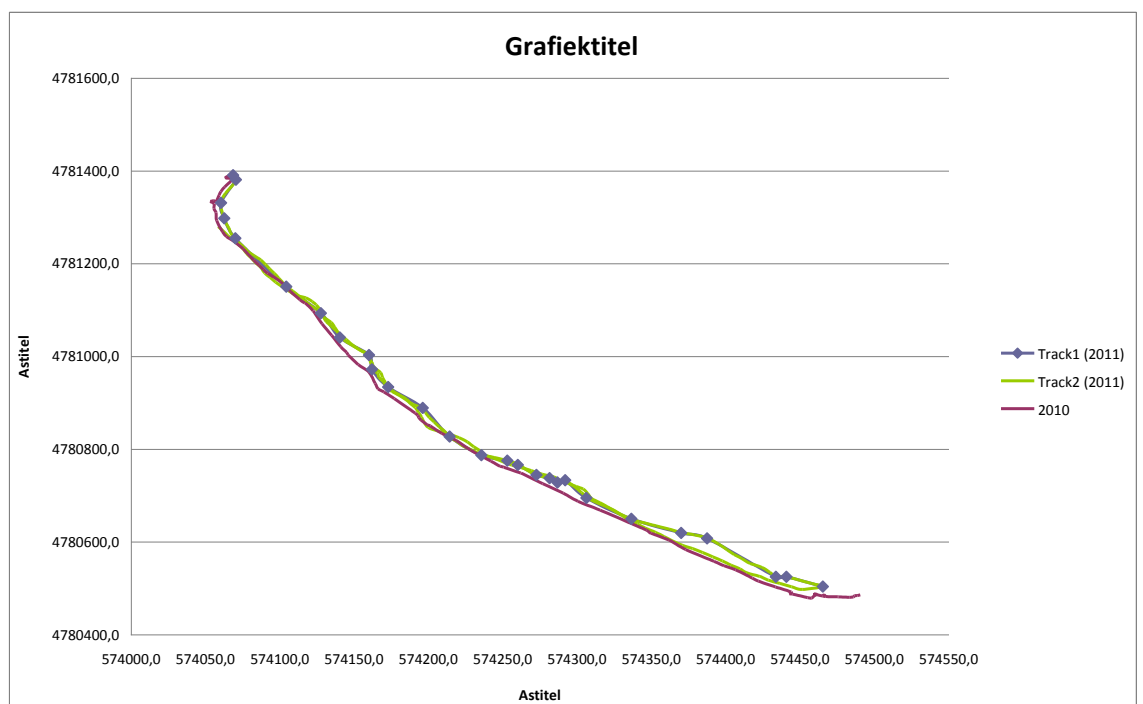
The water line has been measured this year for the second time. The results can be compared with the results from the last year. In Figure 4-2 - Waterline measurements is the graph of the waterline had been depicted. The GPS coordinates are plotted into this graph. The underlying graph is showing a different waterline, which means that the waterline has shifted easterly, which would indicate accretion of the beach. But not hard conclusions could be made because of the two lines from two different years are very close to each other. The measurements could show the development of the waterline.

FIGURE 4-2 - WATERLINE MEASUREMENTS

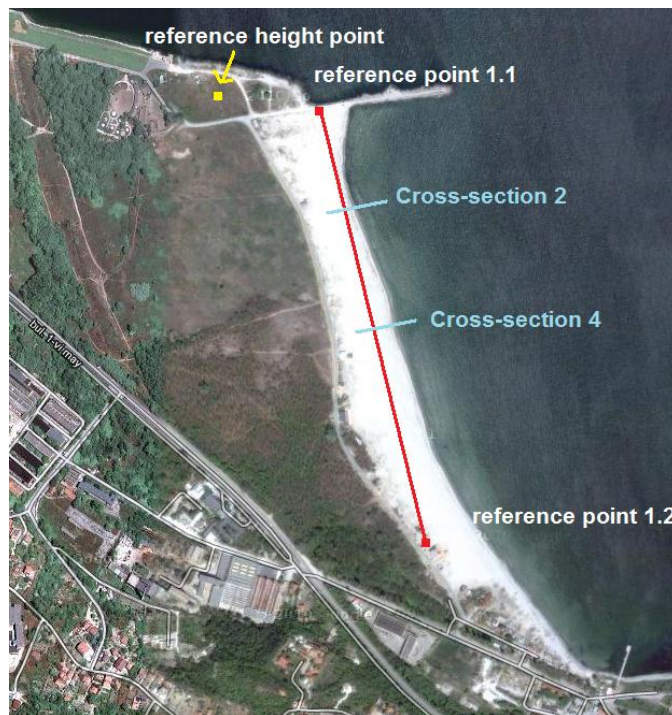
FIGURE 4-3 - OVERVIEW OF CROSS-SECTION MEASUREMENT POINTS

An overview of the base line, reference points and measured cross-section are viewed in Figure 4-3.

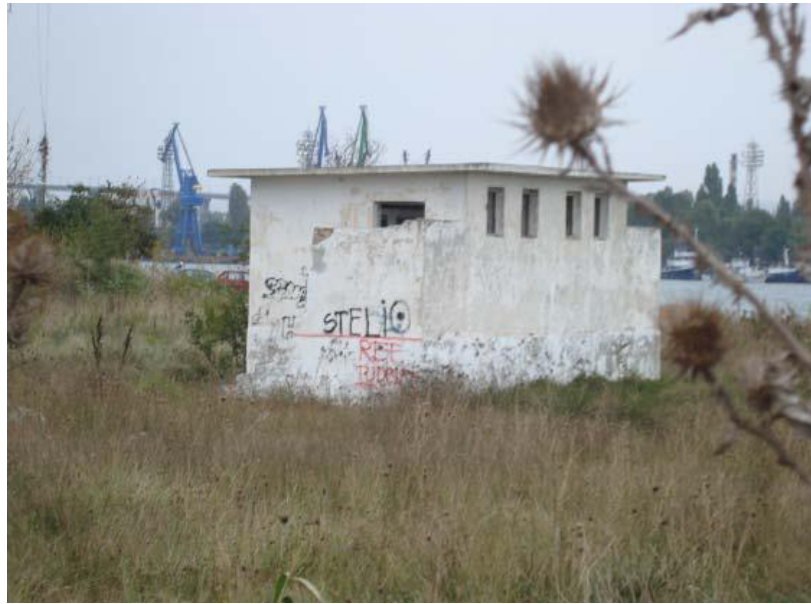
FIGURE 4-4 - OVERALL REFERENCE HEIGHT POINT ASPARUHOVO

To be able to compare the results of this measurement and the one of previous year, the same reference height and reference points had to be used. To avoid confusion the reference points in this report have the same name as in the report of 2010. During the measurements of 2010 the reference points have been marked. The reference height was located on a small building, see Figure 4-4. It is assumed that the building hasn't displaced. All the beach profiles are measured relative to the red line on the building, which is taken as the zero level.

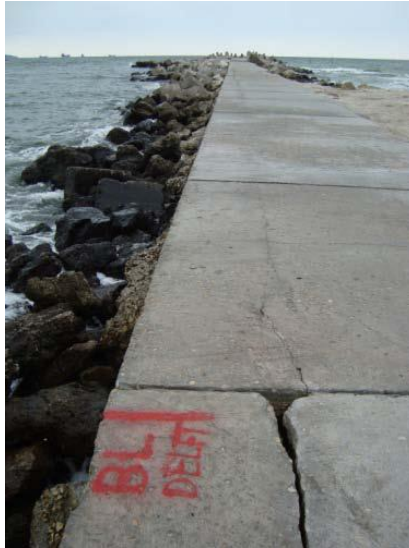
FIGURE 4-5 - REFERENCE POINT 1.1

- Reference point 1.1: Near breakwater, marked with 'BL Delft'. Coordinates: T 574027 E / 4781393 N, see Figure 4-5
- Reference point 1.2: Yellow dressing box on the beach, marked with '2010 CT5318'. Coordinates: T 574167 E / 4780749N, see Figure 4-6

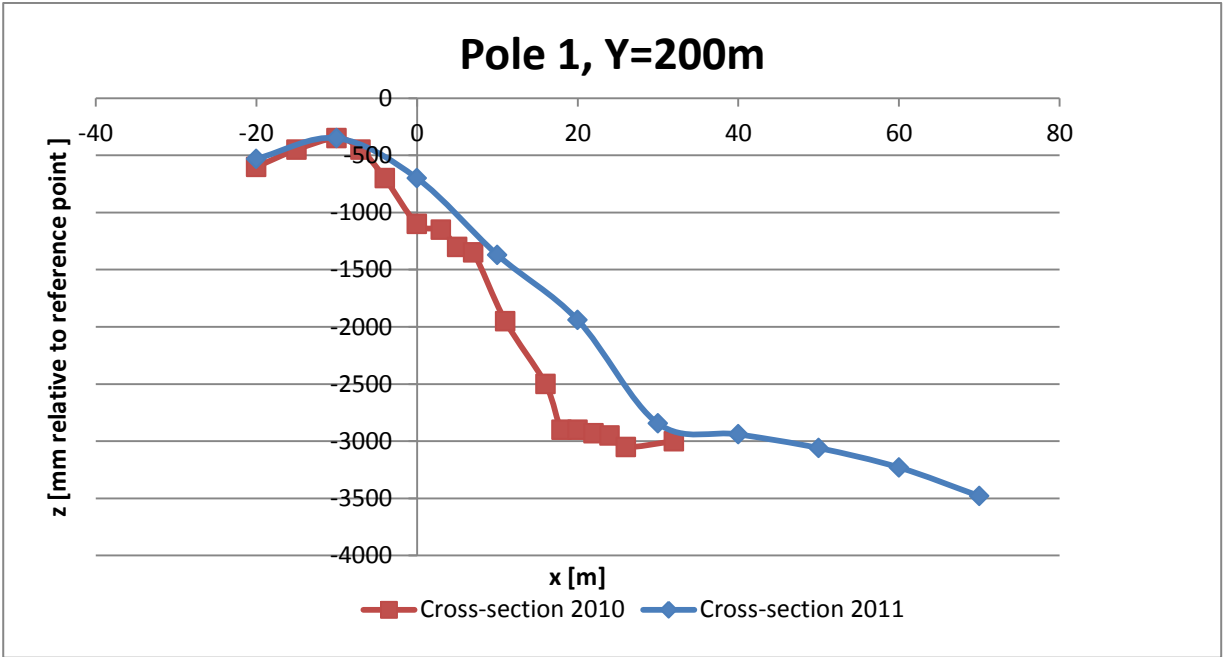
FIGURE 4-7 - CROSS-SECTION AT Y=200M IN 2010 AND 2011

The cross-section at y=200m is quite similar for 2010 and 2011 between x=-20m and x=-5m. This supports the idea that the baseline is set at the same location as previous year. Seawards from x=-5m a significant accretion can be observed. At some points the beach profile has moved about 10m seawards. According to Table Table 4-1 this observed accreting cannot (only) be the cause of measurement errors.
