CIE 5318 Fieldwork Hydraulic Engineering

- Final Report -

This report is written for the course CIE5318 “Fieldwork Hydraulic Engineering”. This is an elective course in the curriculum of the master Hydraulic Engineering at the Faculty of Civil Engineering and Geosciences. The content of this report is the elaboration of the October 2011 fieldwork in Bulgaria.

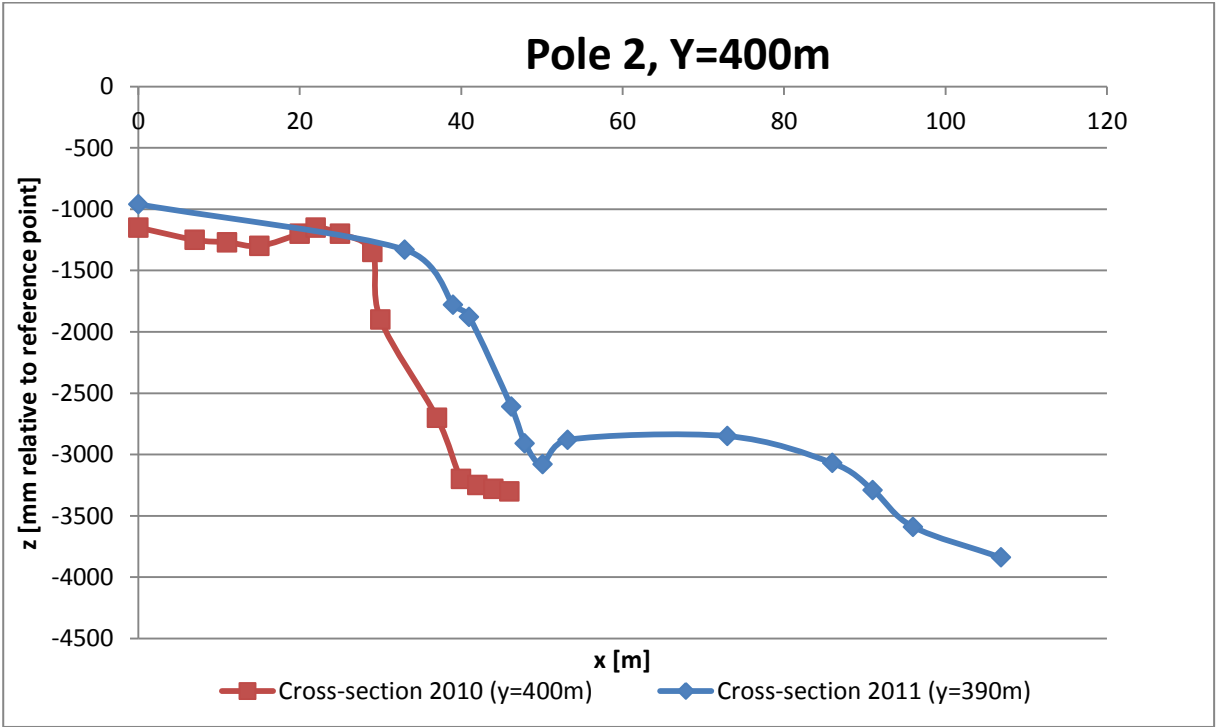
FIGURE 4-8 - CROSS-SECTION AT Y=400M IN 2010 AND 2011

The cross-section at y=400m also shows a significant accretion, which is, like the cross-section at y=200m, in the order of 10m. The sand bank in front of the beach, which is observed during the measurements of 2011, was not observed during the measurements of 2010.

Although a certain accretion seems plausible after observing the results, an accretion rate of 10m/year doesn't seem very realistic. The difference between the beach profiles of 2010 and 2011 are probably not caused by seasonal variation. Both measurements took place in October, and as shown in Table 2-1 and Table 2-2, more storm events occurred prior to the measurements in 2011. More surveys are needed to analyse the exact accretion rate of Asparuhovo Beach.

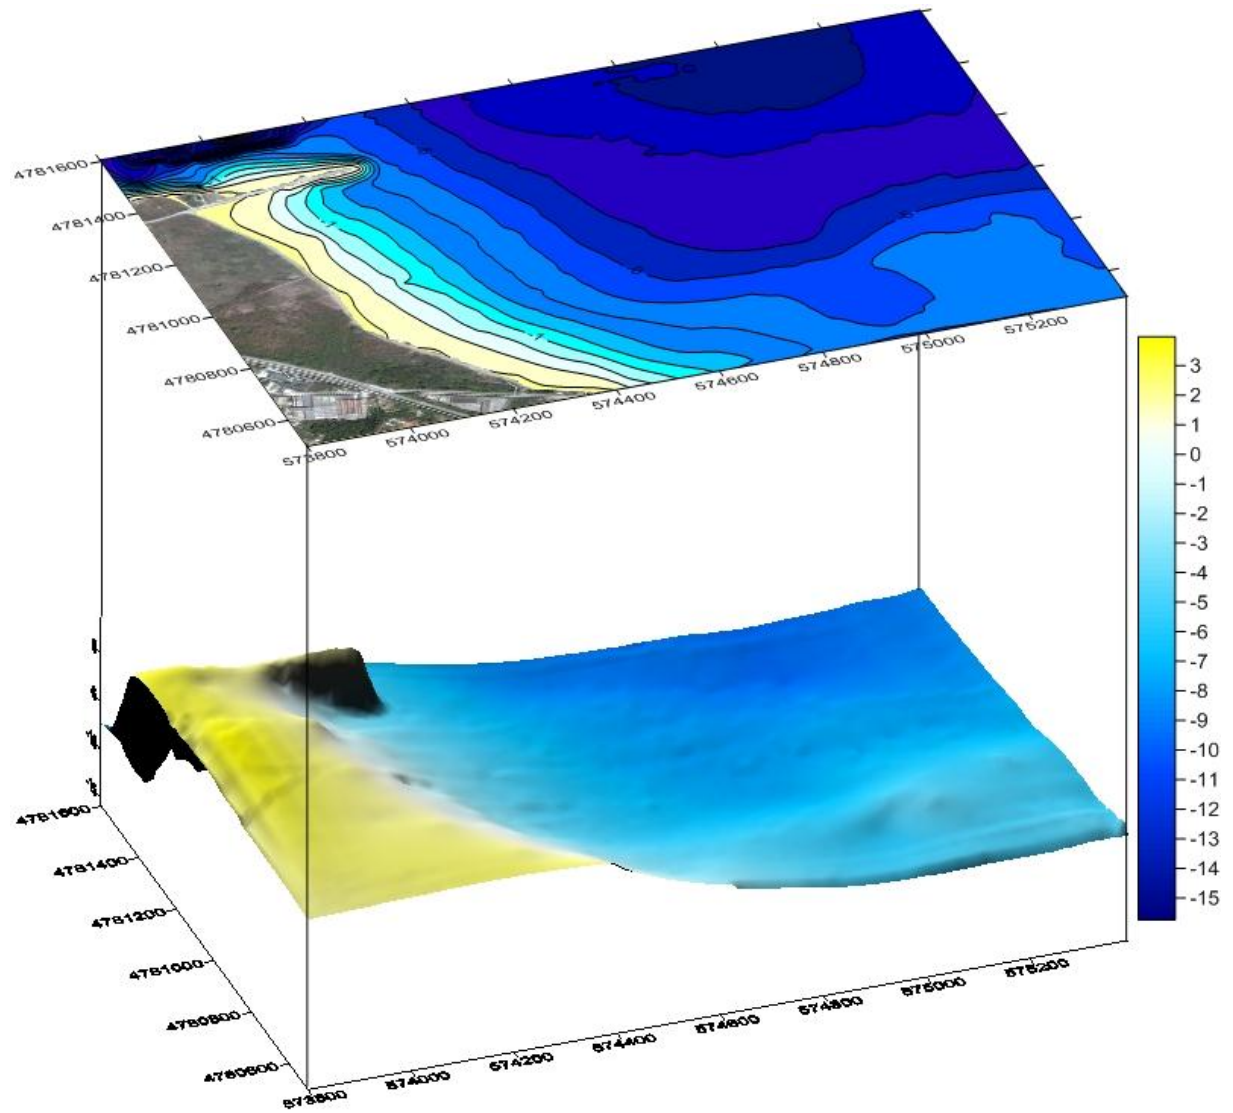
To provide data for the bathymetry of the Asparuhovo Beach measurements are made by use of an Echosounder. Thanks to the good weather it was possible to sail for the whole day and the boat has made several trips to provide the data needed for the figures of the bathymetry. The results of the bathymetry measurements are presented in Figure 4-9 - Upper figure is the depth contours and below a 3-dimensional plot of the bathymetry. The white area represents the waterline.

FIGURE 4-9 - UPPER FIGURE IS THE DEPTH CONTOURS AND BELOW A 3-DIMENSIONAL PLOT OF THE BATHYMETRY. THE WHITE AREA REPRESENTS THE WATERLINE

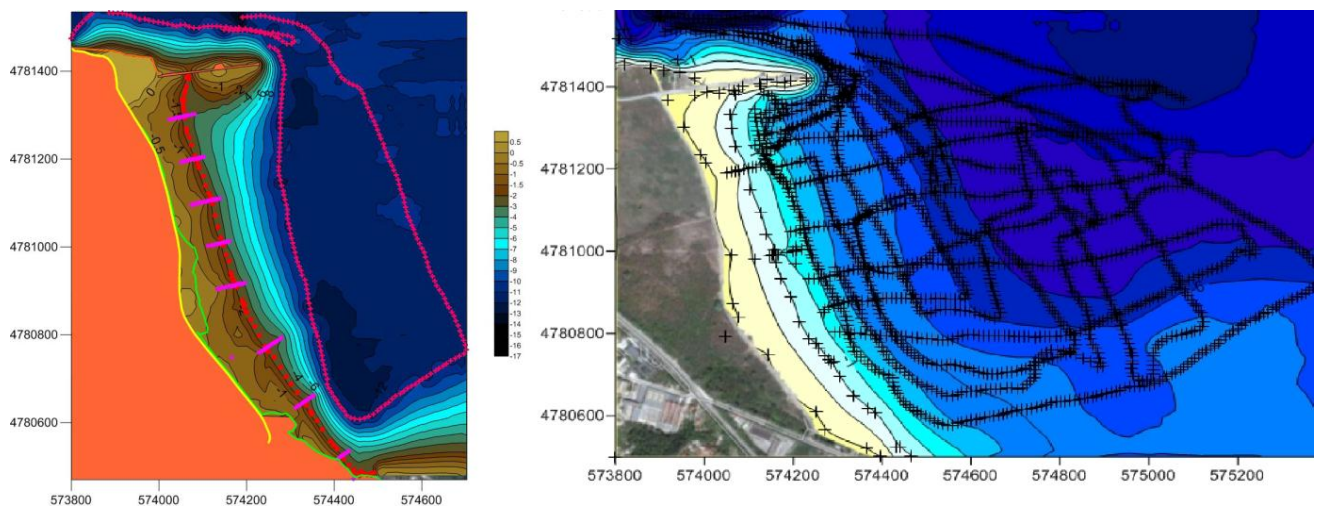
This year the weather was a lot better. So the boat with the echo sounder has made several trips to provide more data. The difference in measure points with 2010 can be seen in Figure 4-10. A note has to be made. In 2011 the reference height (zero-level) is the water level. In 2010 this is the reference point which is around 2.3 meters higher than the water level. The last difference is that in 2011 only two cross sections are measured.

FIGURE 4-10 - LEFT: THE CONTOURPLOT OF 2010. THE RED DOTTED LINE REPRESENTS THE WATERLINE AND THE RED CROSSES ARE THE MEASURED POINTS WITH THE ECHOSOUNDER. RIGHT: THE WATERLINE IS THE WHITE AREA AND THE BLACK CROSSES ARE THE MEASURED POINTS

The most notable difference is the slope of the beach. From the figures it can be seen that the slope has decreased over the last year. This can be explained by the weather conditions. Because in 2010 there were much more waves and the weather was less than it was in October of 2011. This year there were no waves worth mentioning. The result of this difference in weather conditions can lead to a different beach profile. In 2010 the beach profile probably looked like a winter of a storm profile and in 2011 the summer beach profile was clearly visible. Further off shore it is hard to draw some conclusions because in 2010 the boat didn't sail a lot and all the data is provided by interpolation between the measured points. These interpolated values are less reliable.

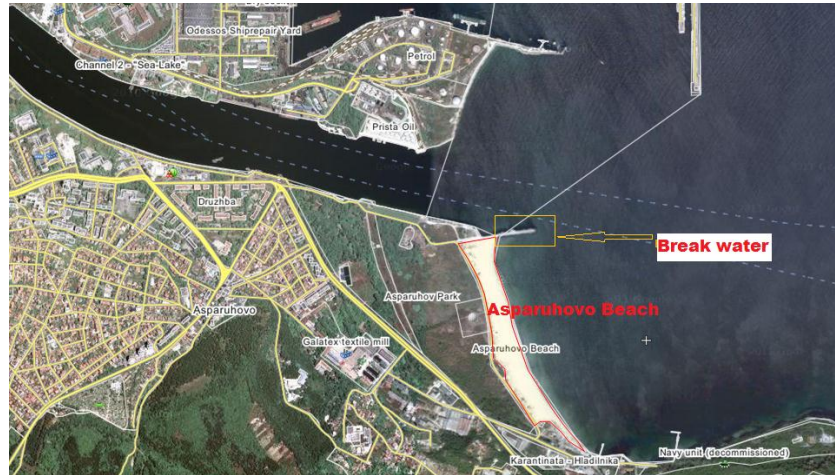
FIGURE 4-11 - BREAKWATER ASPARUHOVO

In this part of the report the breakwater of the Asparuhovo Beach is described. The breakwater is located at the northern part of the beach. The design function of the break water is to maintain the entrance of the Chanel, which connects the harbor of Varna to the black sea. The secondary function of the breakwater is to protect the Asparuhovo Beach against erosion during. In this part the breakwater will be analyzed and a conclusion will be taken about the technical and functional state of the breakwater. In Figure 4-11 the location of the breakwater is depicted.

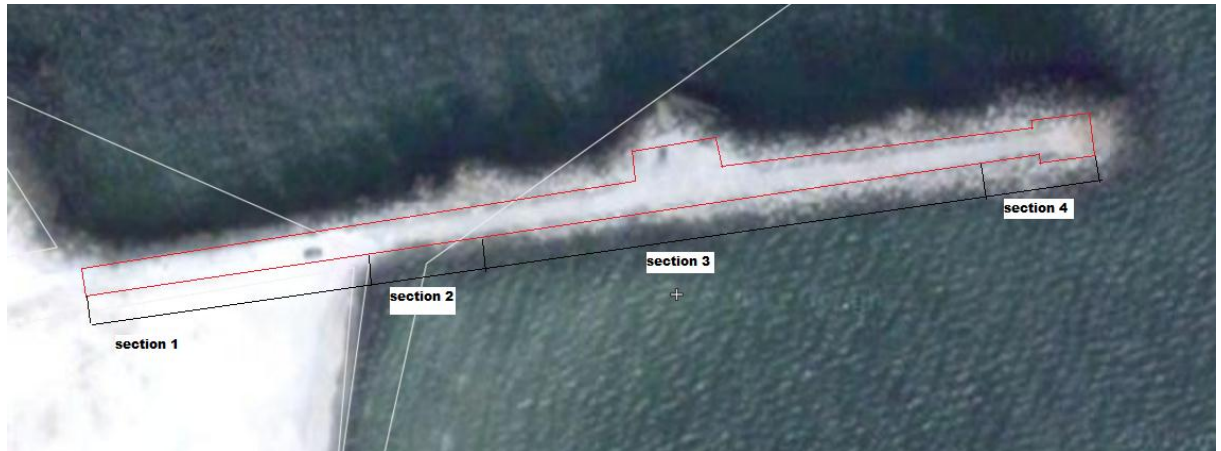
The breakwater can be divided in four different cross sections. In Figure 4-12 the breakwater with the cross sections are shown.

FIGURE 4-12 - SECTIONS

The second section is 25m long and has the same kind of stones as the first cross-section on both sides and the gaps between the stones are filled with sand, coming from normal wave action. During heavy wave action this sand may be washed away and can cause sliding of the stones, resulting in a gap under the concrete slab. On the northern side there are concrete cubes with an edge length of 0,8m and 1,0m because of the heavier wave action.

The third section is the longest one (ca. 100m) and is reinforced with concrete cubes with edge length of 1.0 m at the beginning to 1.3 m at the end of the section. Those cubes are randomly placed. In the middle of the section there is a part twice as wide as the other part, probably for the passing of trucks during construction time. On its outer part there were some concrete elements with rusty reinforcement, probably left over from some other construction site.

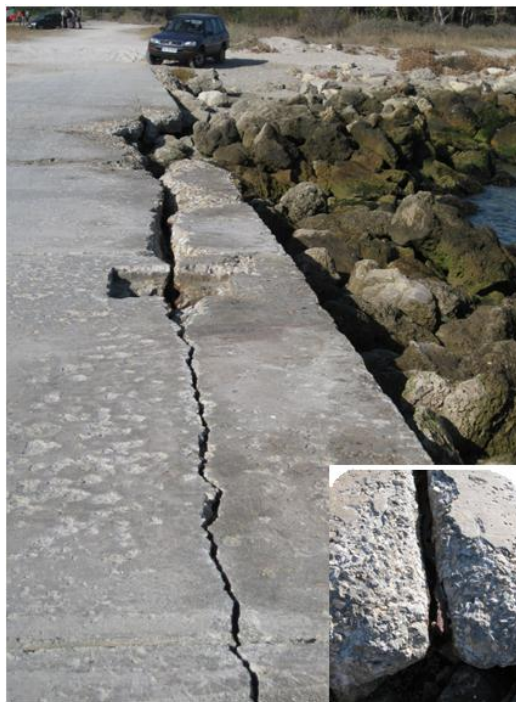
The concrete slab was broken in many places which led to the conclusion that the sub-layer wasn't really even or settlements of the sub-layer took place. The concrete slab has been casted on the stones. In the base of the breakwater the concrete slab was severely damaged and a completely corroded steel pipe was visible on one side. This pipe served for electricity cables for lamps that are missing (the rectangular openings in the slab).

This picture shows a crack that has propagated along the entire length of the breakwater. On the broken part you can see a corroded iron pipe for electricity

cables. This iron pipe is a weak spot in the concrete and that explains why the crack is in the same place on every section of the slab.

From the observation it is clear that the breakwater is not in a good condition. From the technical state it can be concluded that the maintenance is not proper. Also some construction mistakes were visible. First of all from the state of the concrete elements it is clear that the quality of concrete is very poor. Secondly from the base of the breakwater till the head of the breakwater there runs a crack. Further investigation in this crack led to the outcome that exactly at the position of the crack, there is an iron pipe placed in the concrete surface plate. This iron pipe is a weak spot in the concrete and that explains why the crack is in the same place on every section of the slab.

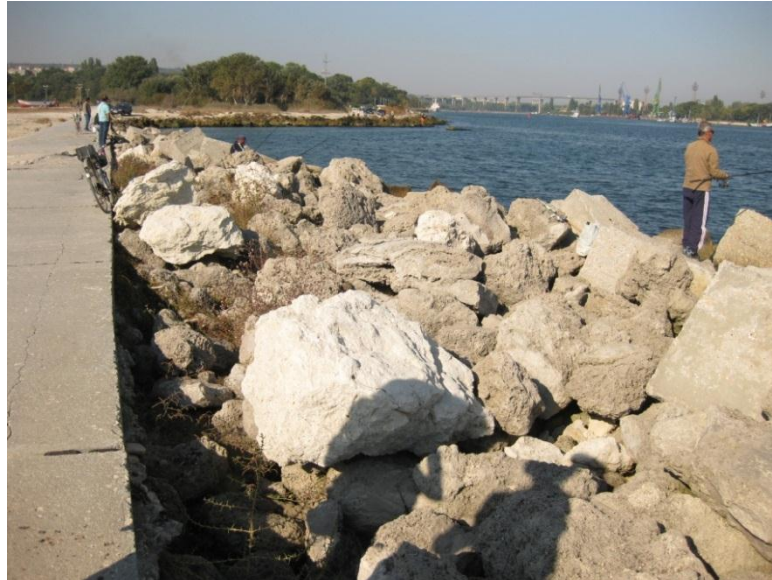
This is an overview of the main problem of the breakwater. Next to the slab there are small stones that may be washed away by the next big storm. This will cause the visible crack along the slab to open further and eventually it will break off.

We cannot be sure what is under the concrete slab but it is not stable.

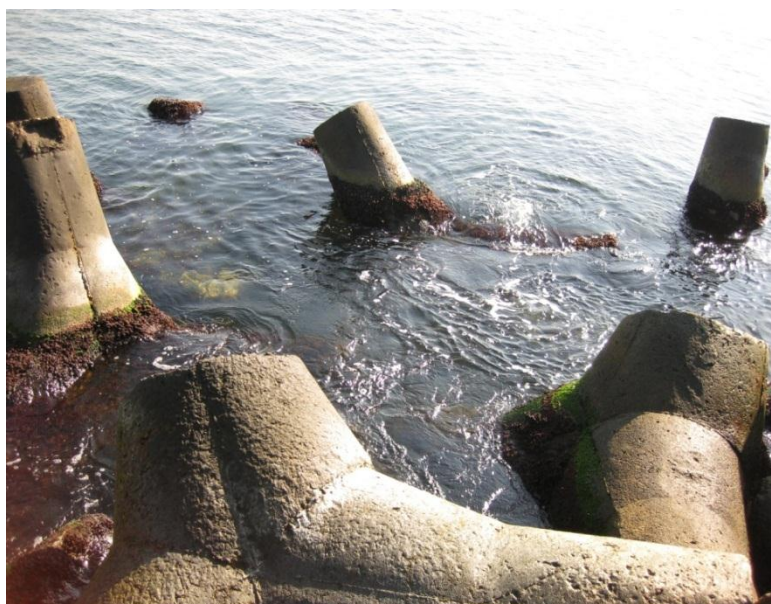
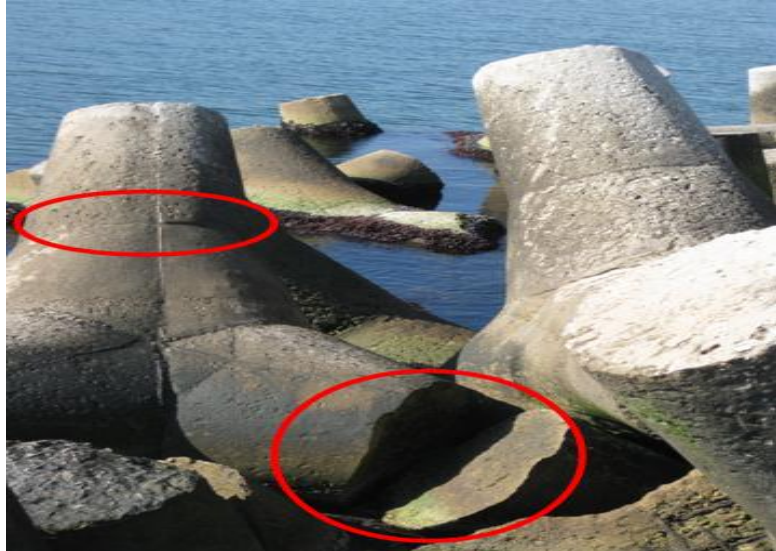
This picture was taken at the very tip of the breakwater. You can see two tetrapods with missing legs. Because of heavy wave attacks the tetrapods are rocking and sometimes even moving (local people say that). Because of

rocking, tetrapods hit each other and this can result in broken legs. Another explanation is poor construction which is obvious in some of the tetrapods (a crack in the middle). On the tip are not enough tetrapods.

The number of broken tetrapods is in the order of 10 to 15. They usually break in the middle of the leg, which is the place of stress concentration.

By the observation it became also clear that some of the tetrapods were not constructed / casted at the same time. Probably the casting was stopped halfway and continued the next day or even after the weekend which led to a bad cohesion between the different castings. These are the weak links in the design of the tetrapods. This also means that the wave breaking capacity of the tetrapods will reduce if some elements are broken. Which means more loads attacks the break water.

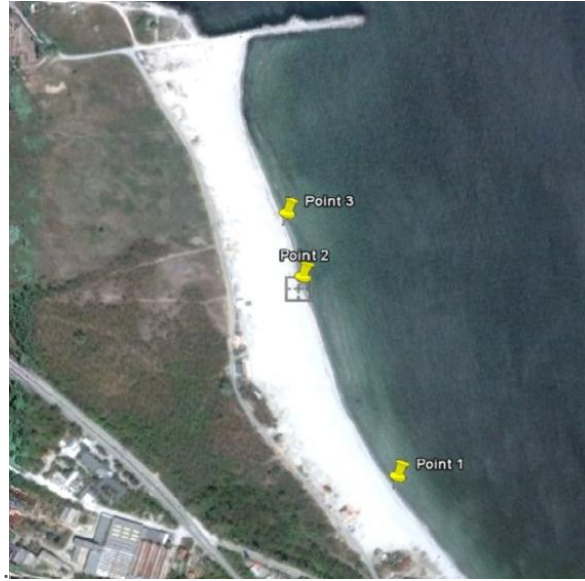
FIGURE 5-1 - SAMPLING LOCATIONS

From the first observation can be concluded that the beach is quite uniform in long-shore direction. Therefore three cross-sections have been chosen, to investigate the sub-soil. The first location is the furthest away from the northern breakwater. It is chosen, because this location is just outside the area where the future marina can be constructed. The second location is in the middle between the breakwater and the first location. The third location was planned to be close to the breakwater, but due to logistics and communication problems it moved southward and it was placed 100 m from the second location. The advantage is that two samples relatively close to each other can be compared. The three locations are shown on the map in Figure 5-1 with the GPS coordinates and longitude/latitude in Table 5-1.

UTM E (m)	UTM N (m)	Long(°)	Lat (°)
Point 1	0574291	4780709	27.913.589	43.175.494
Point 2	0574153	4781010	27.912.398	43.178.218
Point 3	0574129	4781106	27.912.126	43.179.087

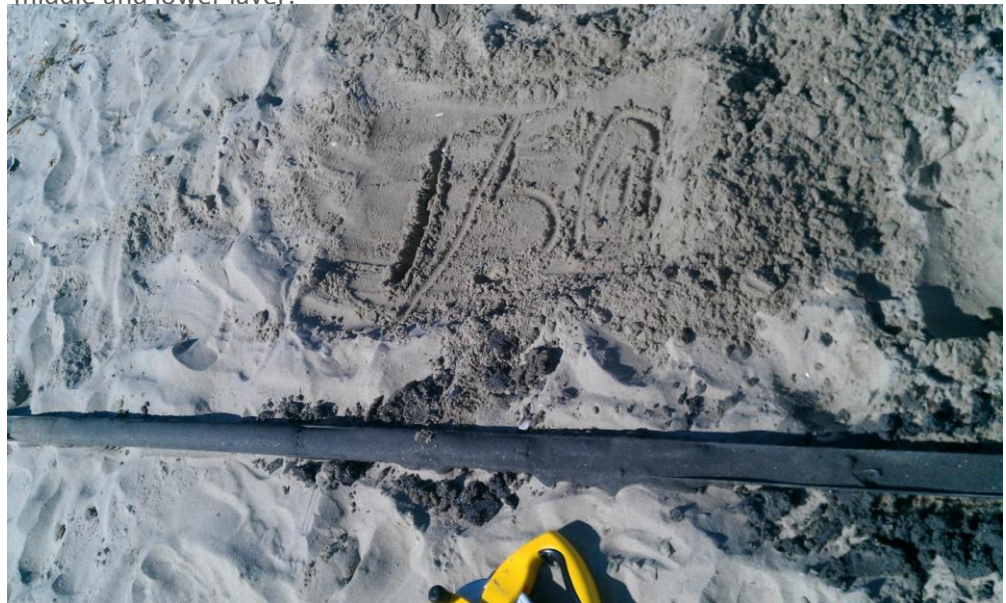
FIGURE 5-2: SAMPLE AT POINT 1 WL-50M

On the dry beach a small shovel is used to dig the sand until the waterline. Due to this primitive tool only sand from the top 50 cm of the bottom could be included in the sample. In the water a piston is used to make the sand samples. At the moment of sampling the sea was calm and there were only small waves. The samples in the water where taken approximately 1.5 meter deep. There was a clear visual observation of the colour difference in the sand from bottom to 1.5 meter lower. It can be seen that it is lighter at the sea bed than deeper into the bottom. An example of this can be found in **Error! Reference source not found.** To get a clear sample of the entire column at three sections of the column some sand has been taken to the laboratory. Some sand from the top, middle and lower laver.

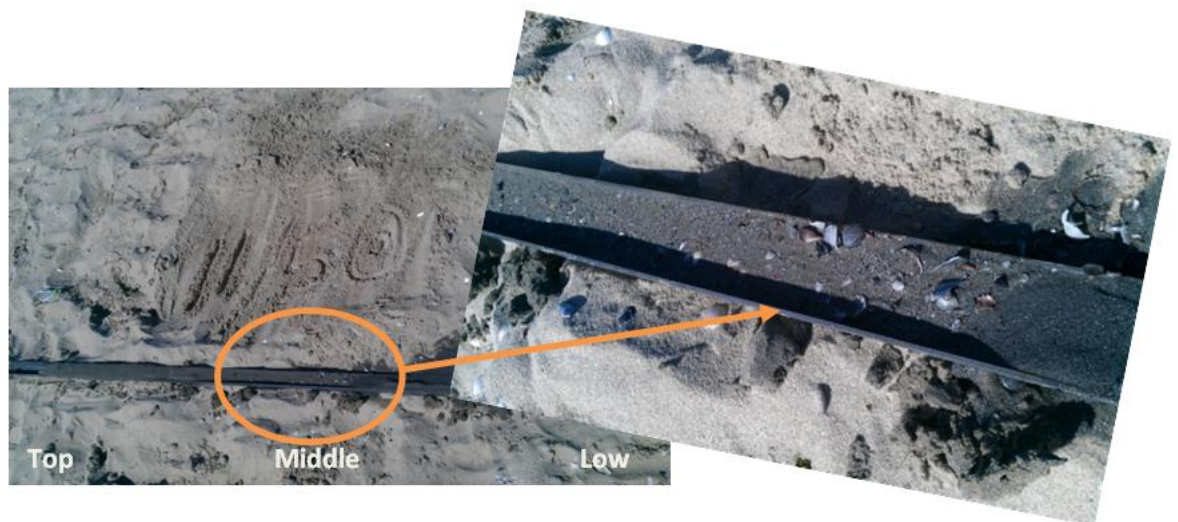
FIGURE 5-5 – SHELLS IN THE SAND COLUMN

The exact reason of the high concentration calcium at WL -30m from point 1 and WL -50m from point 2 is unknown. One possible theory is that seashells got stuck within an alternating bar which moves from the near shore in offshore direction. Sand covers the seashells within the sub-layers. During the penetration sampling offshore, sand was taken from three sections of the sampling pole. So from the top, the middle and lower part of the sand sample. One could see seashells covered by sand deeper within the penetration column.

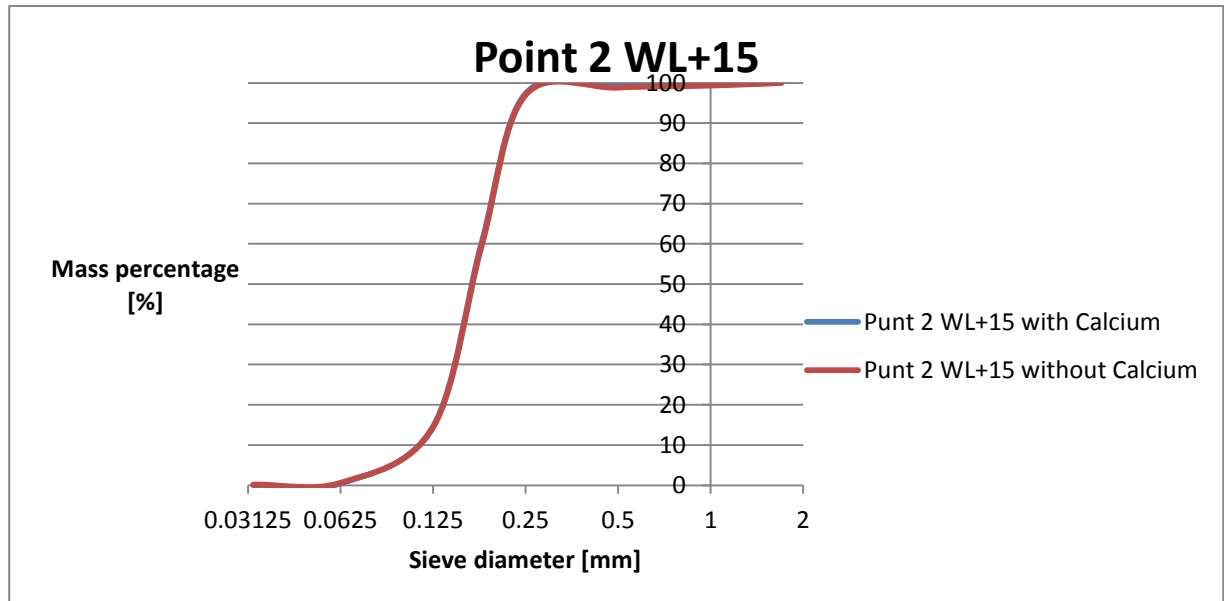
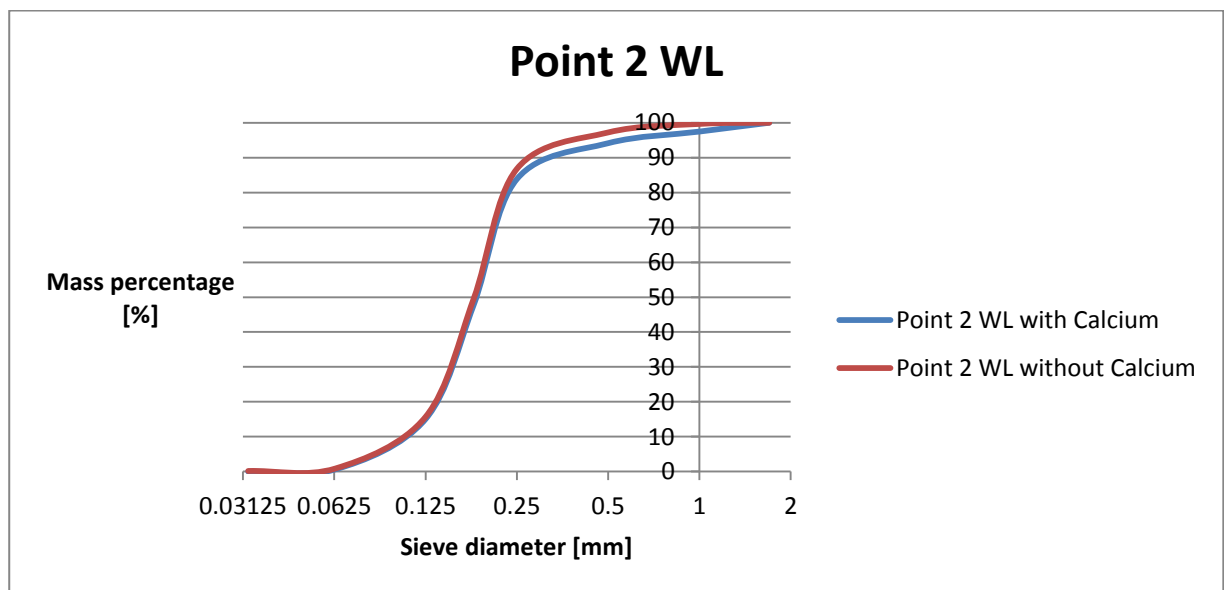
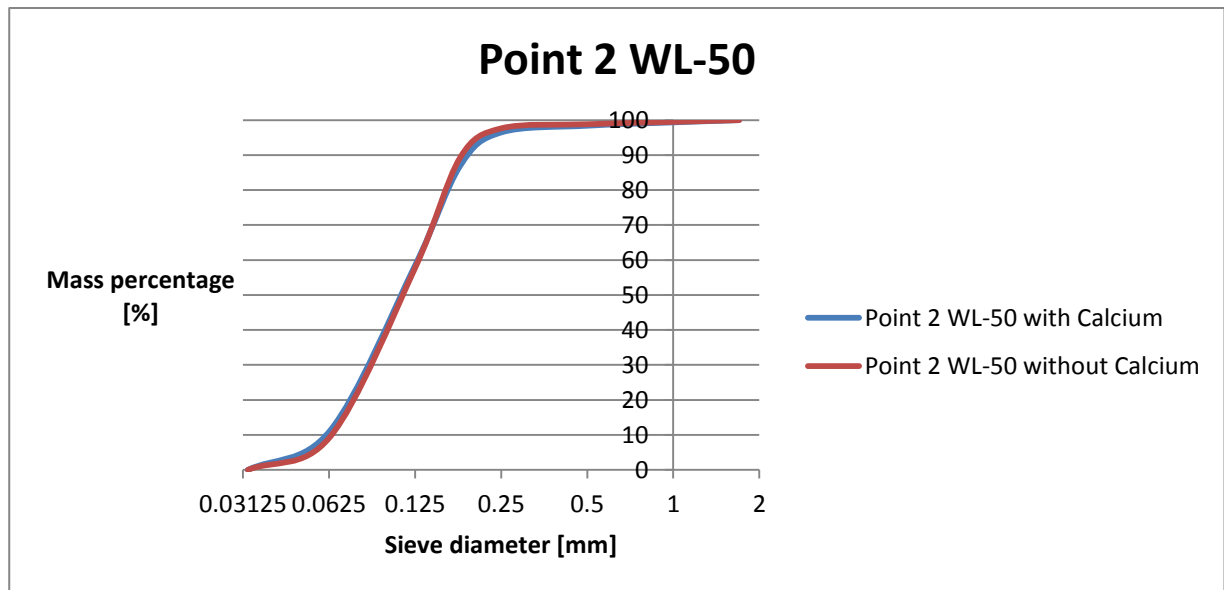
FIGURE 5-6 - SIEVE CURVES POINT 2 WL+15 WITH AND WITHOUT CALCIUM

FIGURE 5-7 - SIEVE CURVE POINT 2 WL WITH AND WITHOUT CALCIUM

FIGURE 5-8 - SIEVE CURVE POINT 2 WL-50 WITH AND WITHOUT CALCIUM

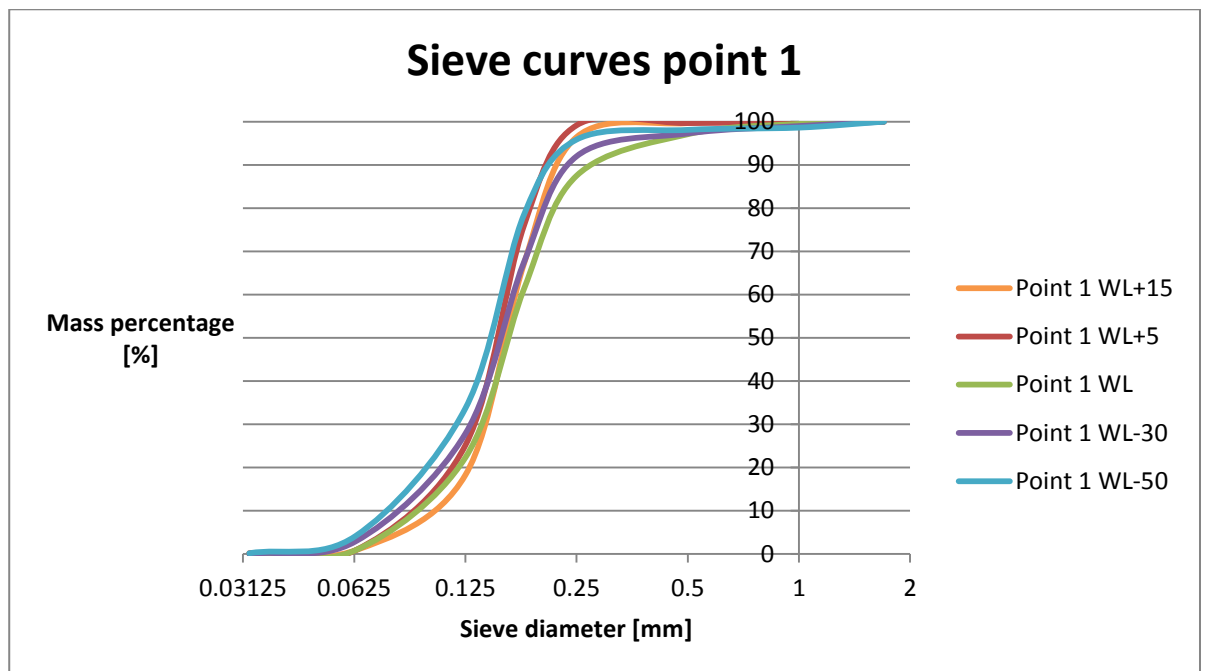
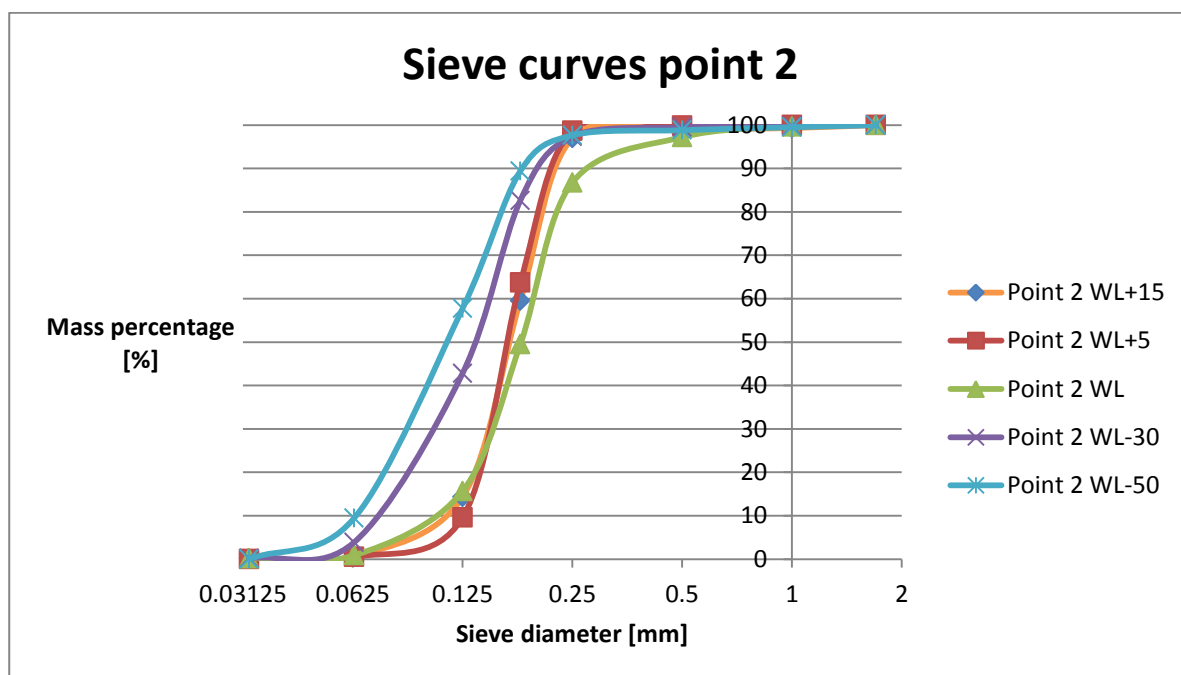
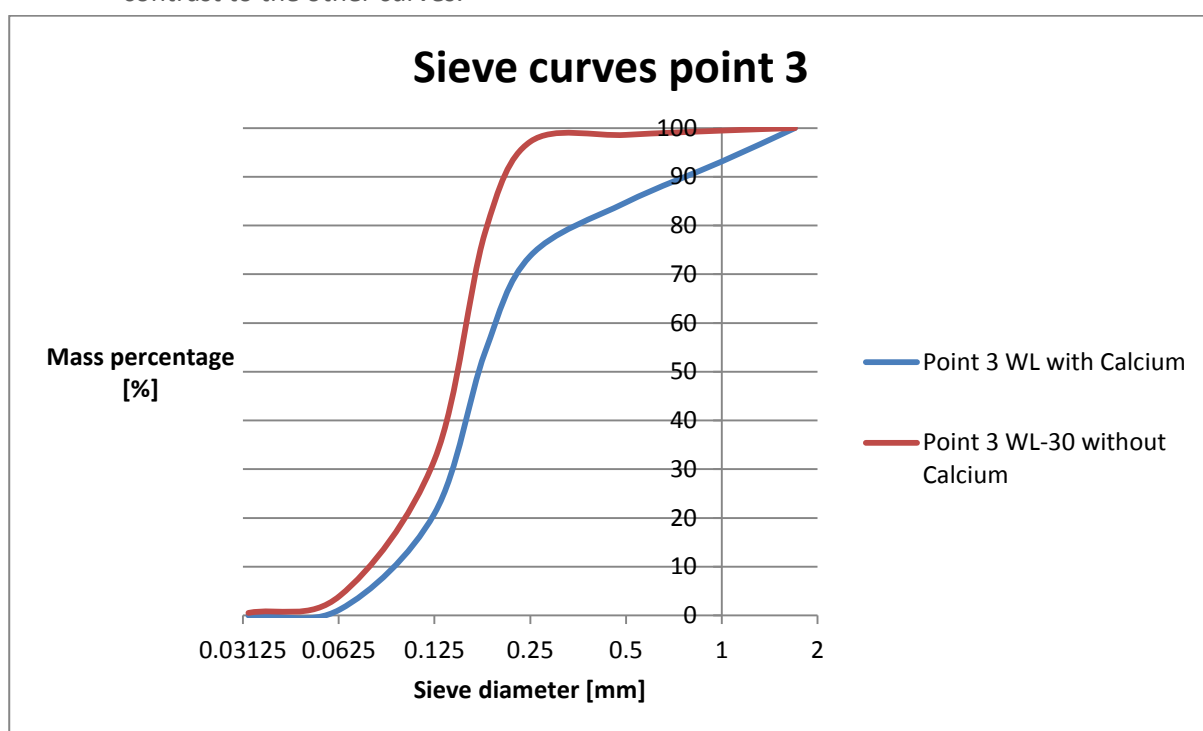
FIGURE 5-9 - SIEVE CURVES POINT 1

FIGURE 5-10 - SIEVE CURVES POINT 2

FIGURE 5-12 - SIEVE CURVES POINT 3

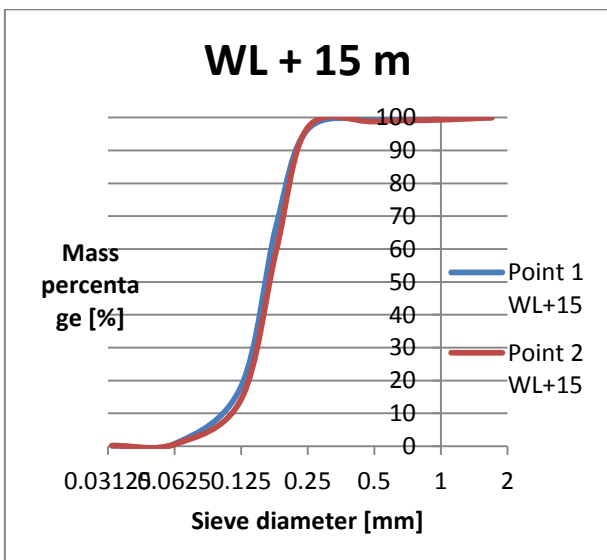
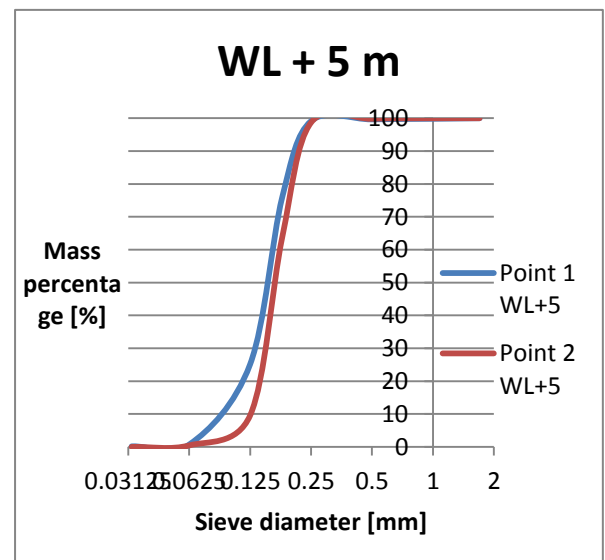
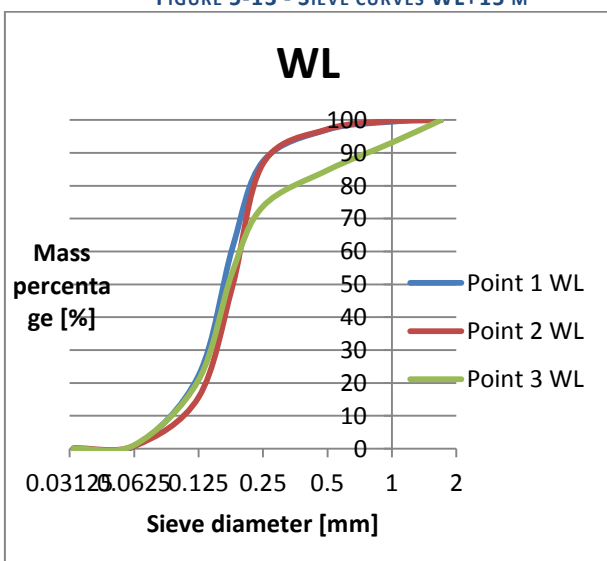
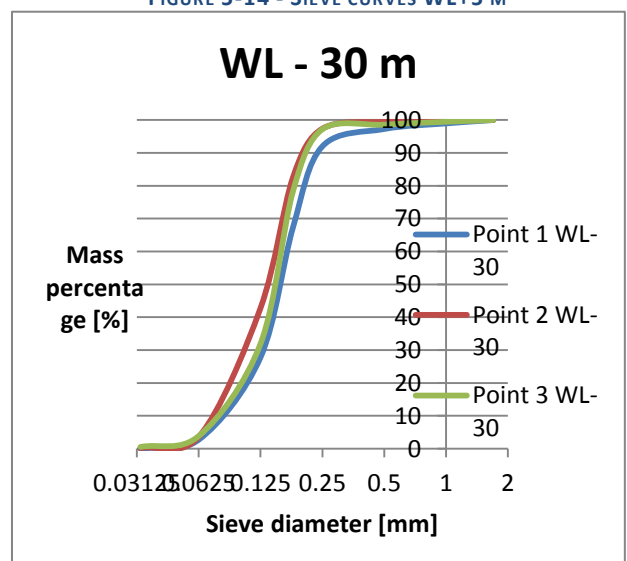
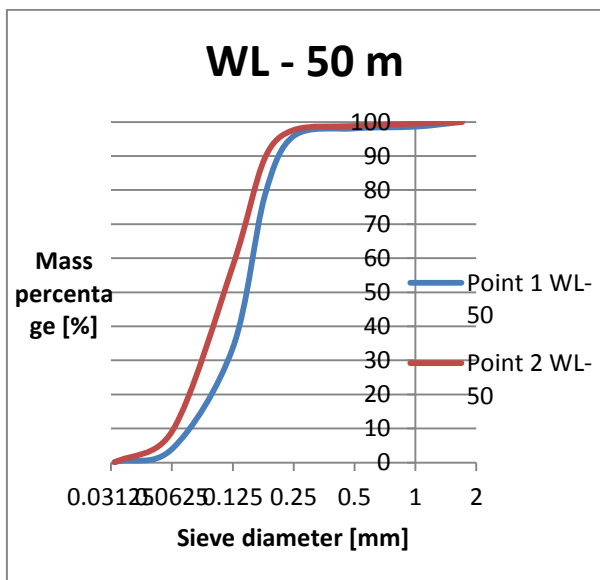
FIGURE 5-13 - SIEVE CURVES WL+15 M

FIGURE 5-14 - SIEVE CURVES WL+5 M

FIGURE 5-15 - SIEVE CURVES WL

FIGURE 5-16 - SIEVE CURVES WL-30 M

FIGURE 5-17 - SIEVE CURVES WL-50 M

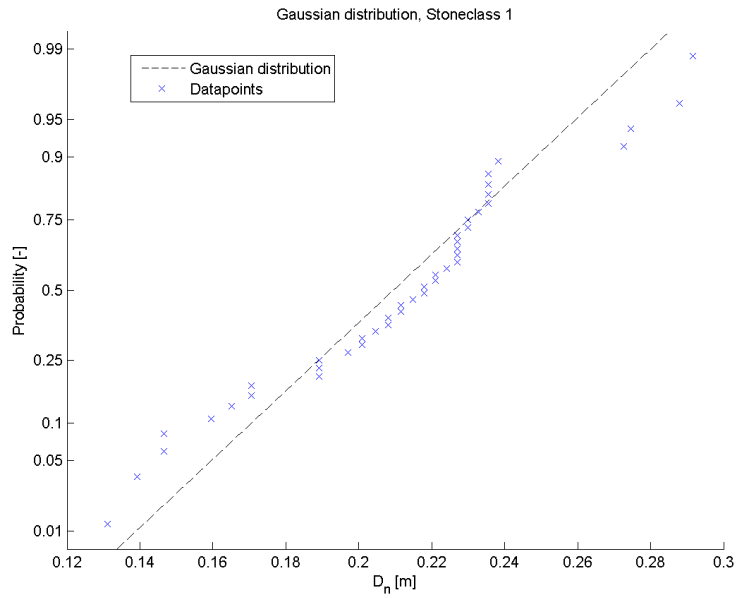
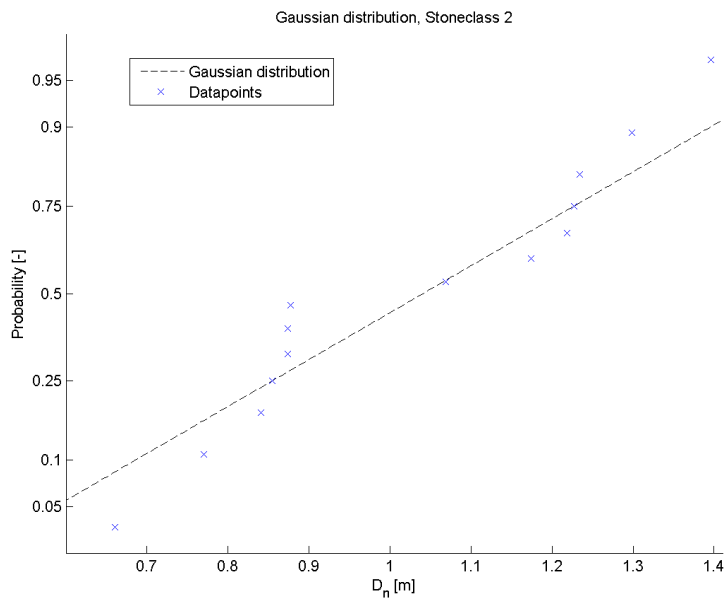
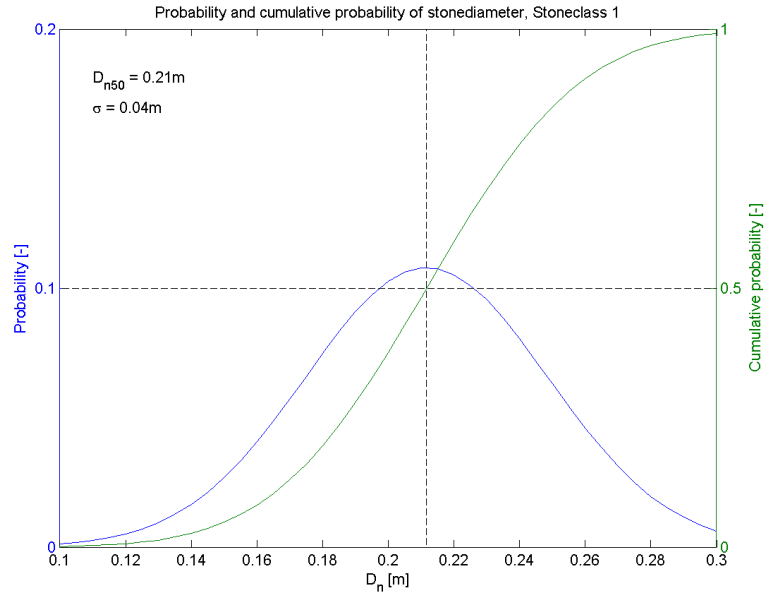
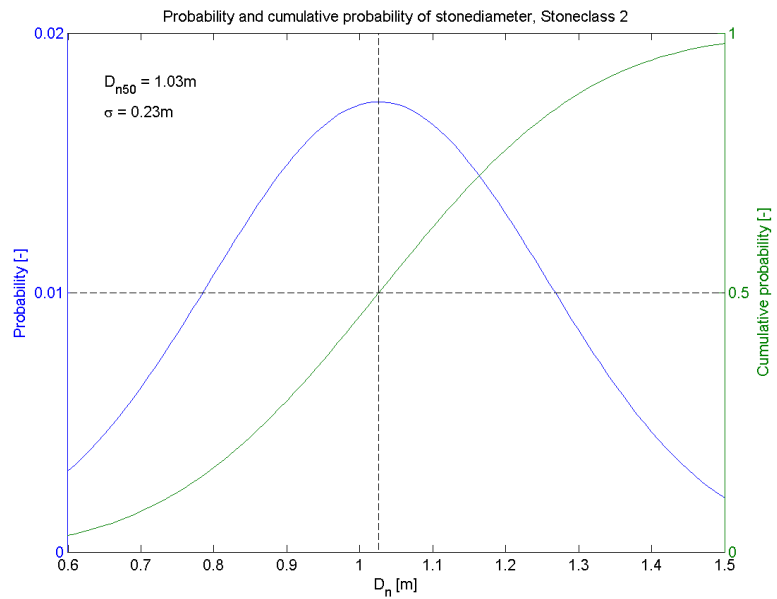
FIGURE 6-1 - THE DATA POINT OF STONE CLASS 1 ARE GAUSSIAN DISTRIBUTED

FIGURE 6-2 - THE DATA POINT OF STONE CLASS 2 ARE GAUSSIAN DISTRIBUTED

FIGURE 6-3 - THE PROBABILITY DENSITY FUNCTION AND CUMULATIVE PROBABILITY DENSITY FUNCTION OF STONE CLASS 1.

FIGURE 6-4 - THE PROBABILITY DENSITY FUNCTION AND CUMULATIVE PROBABILITY DENSITY FUNCTION OF STONE CLASS 2.

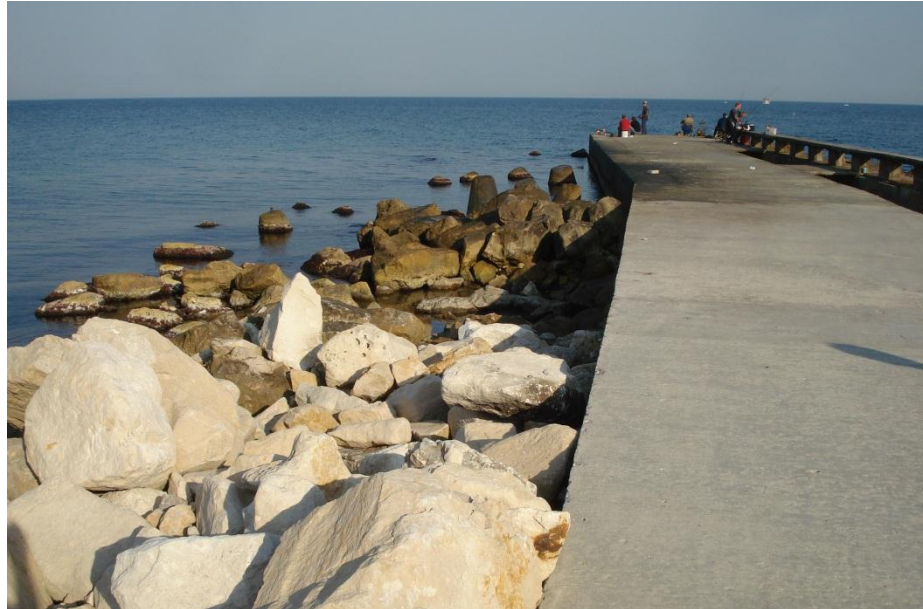
FIGURE 6-7 - CURRENT ST. KONSTANTIN GROIN

Hudson is essentially only applicable for permeable groins, which is the main reason why the Van der Meer-formula is used in the redesign. In this approximation N is set to 7500, which is representative for an average storm climate. A durable design of a groin will incorporate a damage factor of less than 2, which is equal to the threshold of damage. The damage level of the current St. Konstantin groin is probably much higher, because on some places the armour stones are broken or even removed, see Figure 6-7.

The amount of stones of stone class 2 easily available at the Marciana quarry is sufficiently large to repair or even rebuild the St. Konstantin breakwater. A first estimation of the amount of stones available is 4500 m³, while only a volume of armour stones of 750 m³ is necessary when constructing a new one-layer thick armour layer.
