Eemdijk full-scale field test programme: ground dike and sheet pile dike failure test

Programme d'essai terrain à taille réelle Eemdijk: essais de déformation et de rupture pour une digue standard en terre et une digue renforcée avec palplanches

ABSTRACT: Dikes in the Netherlands have traditionally been constructed with soil. Climate change and subsidence requires heightening and or reinforcing these existing dikes. Traditional reinforcements demand additional space, which in some cases conflicts with existing buildings. Applying sheet pile walls in dikes allows for strengthening while minimizing the increase in footprint. However, a validated design approach that complies with relevant regulations lacks. To enable the validation of a proposed design approach, a full-scale field test programme (Eemdijkproef) was performed near the town of Eemdijk, The Netherlands. It consisted of a step wise approach: 1) sheet pile pullover tests, 2) ground dike stability test, 3) sheet pile dike stability test. All tests were loaded until failure occurred. The two similar test dikes were constructed at full scale (5m high, 25m wide, 60m long). In one dike an 18m long sheet pile wall was installe

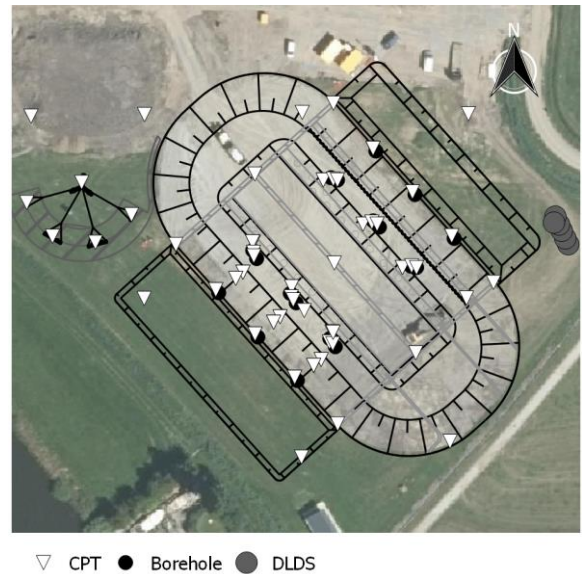
Figure 1 shows the FST site with the sheet pile dike at the NE-side and the ground dike at the SW-side. The POT is located at the W-side. Furthermore the soil investigation points are

presented with the Deltares Large Diameter Samples (DLDS) at the E-side.

Figure 1 Topview FST site with soil investigation points.

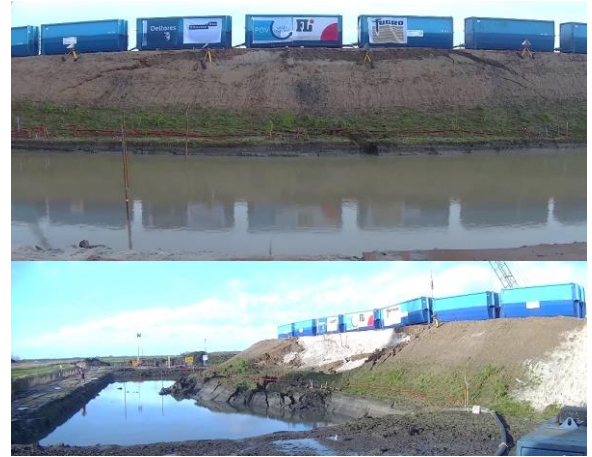
Failure became visually clear due to large cracks developing at the transition of slope and crest, accompanied with horizontal

displacements at the toe of the dike. The failure occurred over approximately the middle 30 m of the ground dike, see figure 9a. A large part of the total deformations (several meters) developed in the first hour after the first signs of failure, and steadily increase to its final position, see figure 9b.

Figure 9 Photo's of ground during failure (a) and after failure (b).

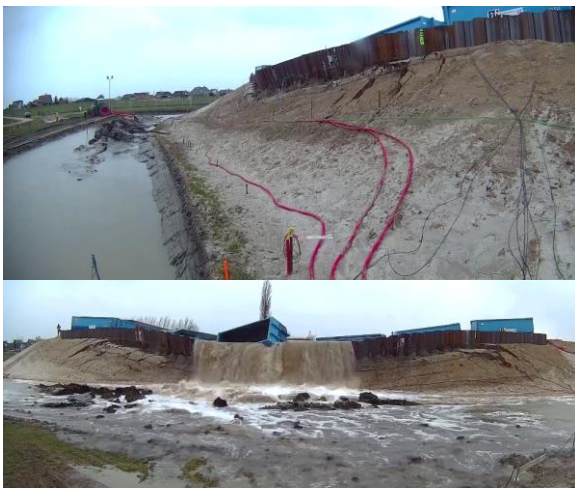
The deformations accelerated once the sheet pile failed due to local buckling. The slip surface exited in the bottom of the ditch, approximately 5m from the toe of the dike. The sliding ground mass was pushed upward even above the water level in the ditch, see figure 12a. Deformations stopped once the top of sheet pile was pushed over by 6m and down by 2m.

Figure 12 Photo's of sheet pile dike during failure, just before (a) and during (b) flooding.

Figure 11 presents the SAAF measurements at several times. At the early stages the slope provided enough support such that the cantilever wall deflected backwards at the top. Failure of the sheet pile starts after exceeding the maximum bending moment capacity which corresponds with a displacement of typically 0.5m at the top. After failure of the sheet pile, the large deflection finally caused flooding of the FST site (see figure 12b).
