CT 5318 FIELDWORK HYDRAULIC ENGINEERING

Preface

This report is made for the fifth years course CT5318 "Fieldwork Hydraulic Engineering" of the faculty of Civil Engineering at the Delft University of Technology. During the study civil engineering the students mainly follow theoretical courses and learn to describe and study all kind of physical phenomena with help of mathematical expressions and models. The fieldwork of Hydraulic Engineering is one of the opportunities to get a 'real life' impression of the studied phenomena's and theories.

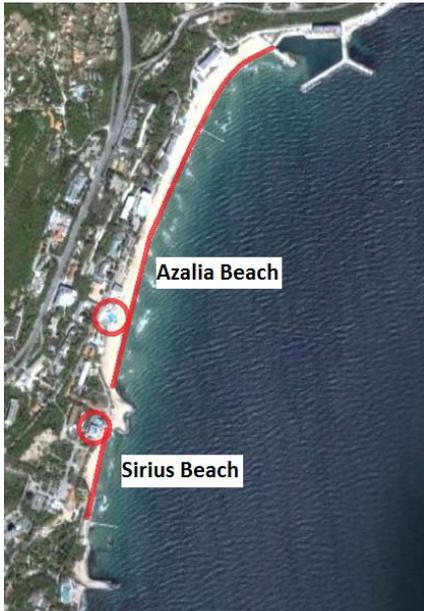
Figure 3: Overview of the location of the Sirius and Azalea beaches.

Between Sirius beach and Azalea beach there are two small groynes located which are meant to interfere in the longshore sediment transport and to trap sediment, to ensure a minimum beach width. An overview of the two beaches is presented in Figure 3.

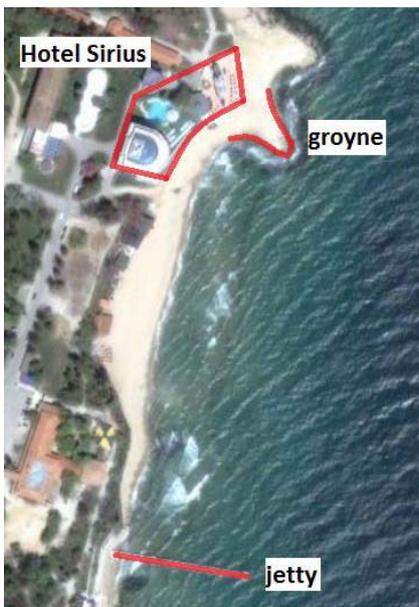
Figure 4: Overview of Sirius beach.

This beach is approximately 300 meters long and runs from a jetty in the South to a small groyne in front of Hotel Sirius in the North, see Figure 4. Guests of Hotel Sirius use the northern part of this beach, located directly in front of the hotel, which is very small and suffers from erosion.

With the earlier mentioned measurements, it can be seen that in the past few years a landward shift of the coastline occurred, resulting in a decrease of the beach width, which is already quite small. The width is approximately 20 metres and at the hotel no more than 5 metres.

The small groyne in the northern part of the beach is built to prevent erosion of the beach in front of the Sirius Hotel. The smaller rocks used in the construction of this groyne can be found spread over a small area. From this observation it can be concluded that the size of the rocks was probably not sufficient to withstand the force of storm waves.

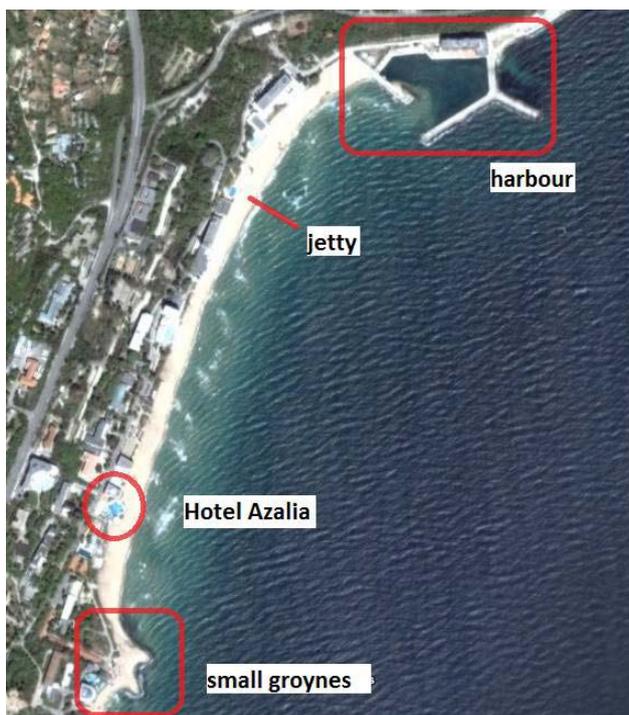
Figure 5: Overview of Azalea beach.

Azalea beach is located directly north of Sirius beach and is approximately 1200 meters long and 40 meters wide. The beach runs from the small groynes in front of the Sirius Hotel in the South to the breakwater of a small harbour in the North. A jetty is positioned at a certain point perpendicular to the coast; this can be seen in Figure 5.

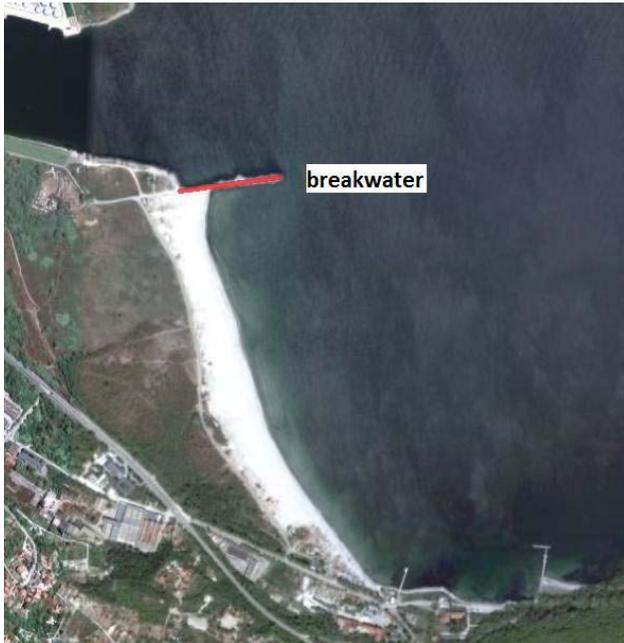
Figure 6: Overview of Asparuchovo beach.

This beach has a length of approximately 1 km and it is bounded by a breakwater at the northern end. This breakwater is built around 35 years ago with the goal to prevent sedimentation of the entrance channel leading to the port of Varna, at the end of the Varna Lake. The breakwater has been adapted and extended multiple times because it was damaged clearly. The southern end of the beach is not defined so clearly, but the beach rotates a little and it changes into a more rocky area. All this can be seen in Figure 6.

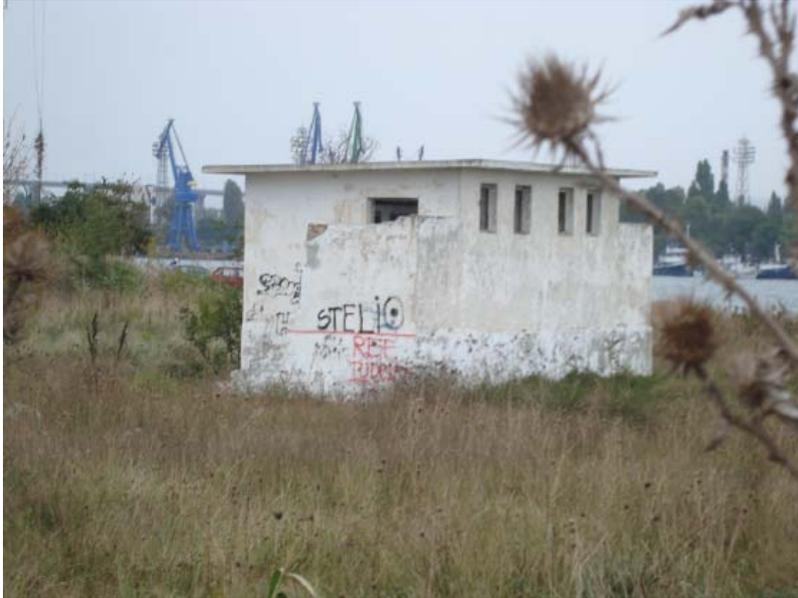
Figure 9: Overall reference point Asparuchovo beach.

In this project a white concrete building is chosen as reference point. The actual reference point on this building is marked with a red horizontal line. In Figure 9, this overall reference point is given.

GPS coordinates (UTM) of the overall reference point are: T 0573854 E / 4781339 N.

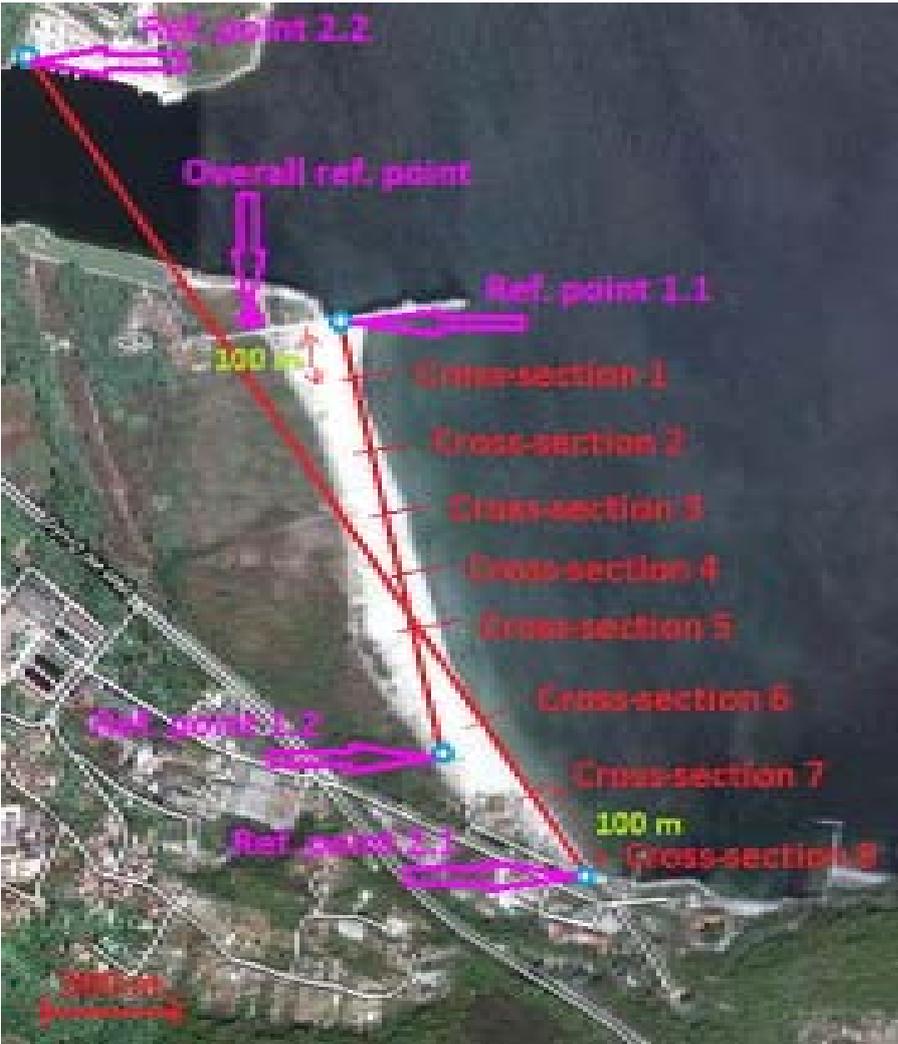
Figure 10: Overview reference points, baselines and cross-sections.

In this project two baselines have been defined, which are presented in Figure 10. Each baseline lies between two reference points.

An overview of the points of cross-section measurement of Asparuchovo beach has already been given in Figure 10.

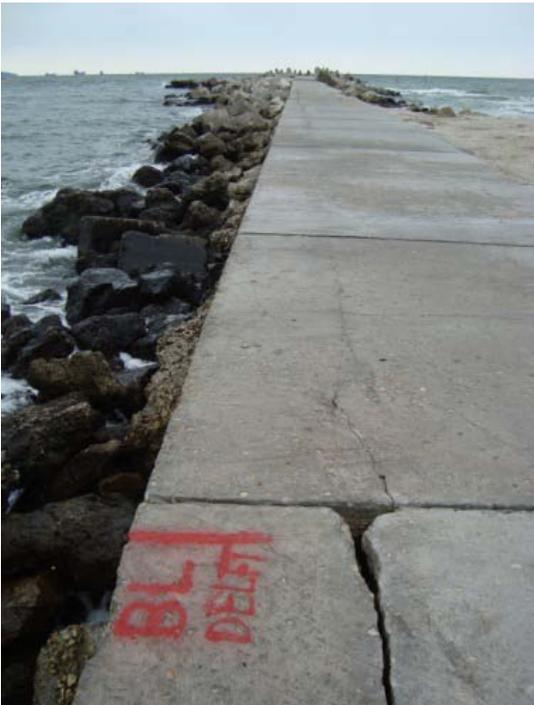
Figure 11: Reference point 1.1 (near breakwater, marked with 'BL Delft').

- Reference point 1.1 (near breakwater, denoted with 'BL Delft'): T 574027 E / 4781393 N. See Figure 11.
- Reference point 1.2 (yellow box on beach, the concrete plate on which the box is placed is marked with red paint with the text: '2010 CT5308'): T 574167 E / 4780749N. See Figure 12.

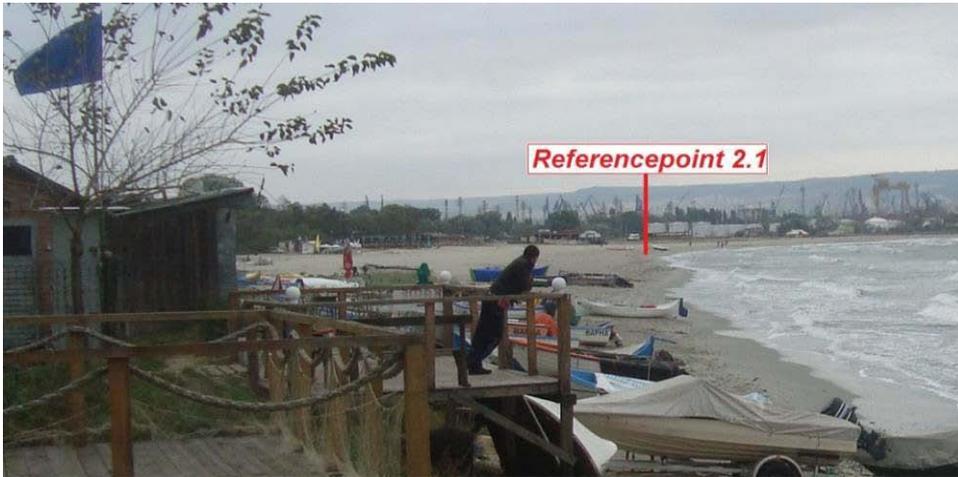
Figure 13: Reference point 2.1 (left of silos, photographed while standing on baseline).

- Reference point 2.1: the left vertical side of the silos. See Figure 13.
- Reference point 2.2 (southern end of beach, marked with 'TU'): T 574444 E / 4780475 N. See Figure 14.

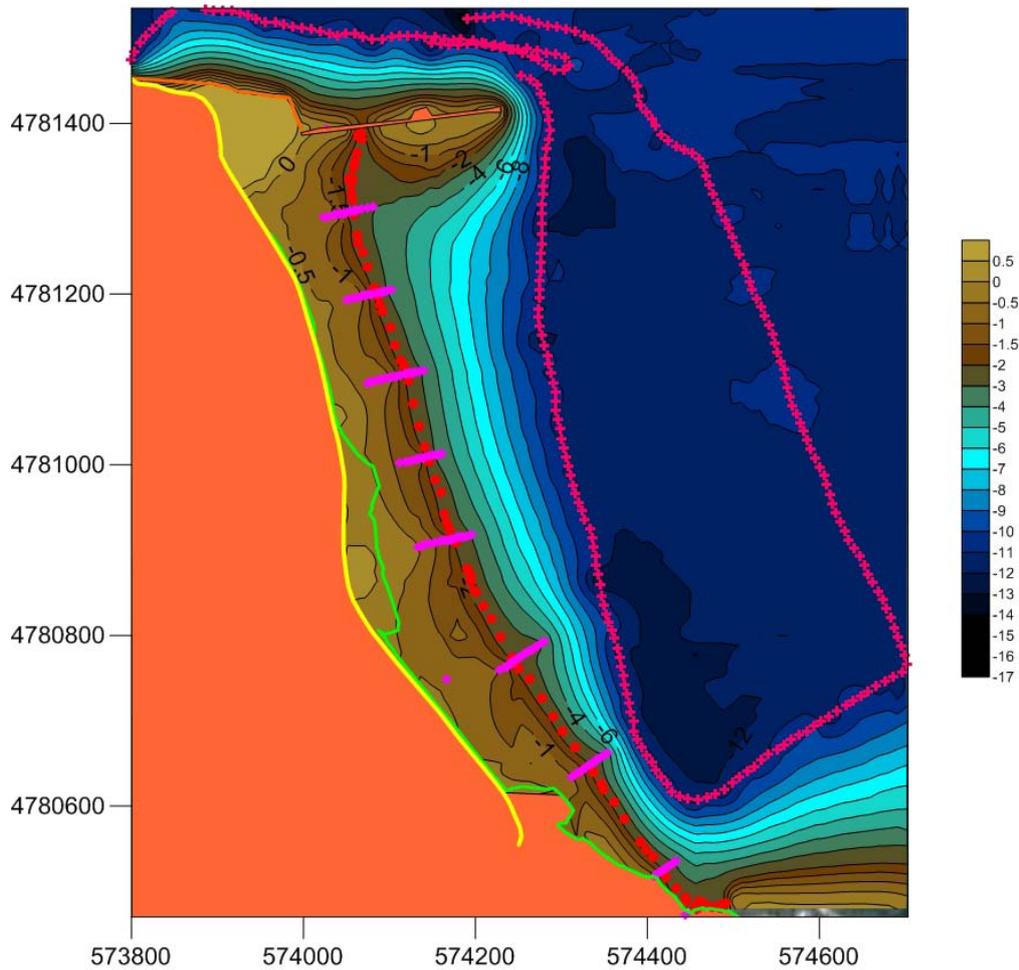
Figure 23: Map of contours (plotted with Surfer).

These cross-section measurements can also be plotted into a map of contours. This has been done with the help of the program Surfer. The results are given in Figure 23. The pink bars are the different cross-sections that have been measured. The red dotted line near the water is the waterline. The pink dotted line in the sea is the line on which echo soundings have been done. The green line is the line of vegetation, while the yellow line is the road behind the beach. The coordinates are UTM coordinates. It should be noted that the deeper blue parts in the graph are nonsense because no data is available for those regions.

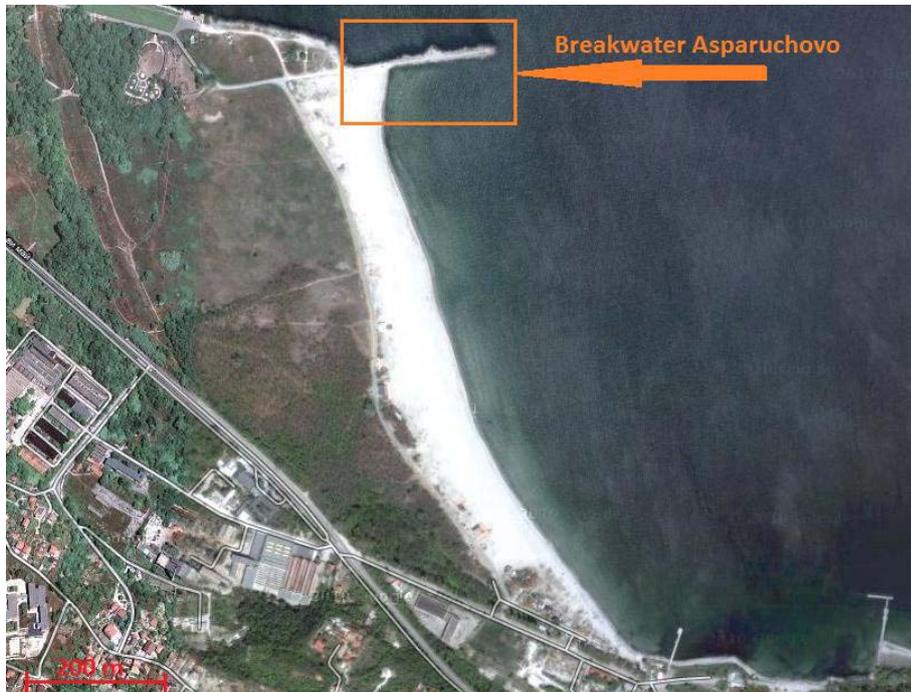
Figure 24: Breakwater Asparuchovo beach.

The breakwater of the beach of Asparuchovo is located at the northern end of the beach. North of the breakwater is the main entrance channel to the large harbour of West Varna. The mound type breakwater is built to prevent siltation of the channel and to protect the Asparuchovo beach from erosion. The breakwater is shown in Figure 24.

The breakwater is not in a good condition; probably the authorities do not accomplish structural conservation and repairing works. The lack of maintenance in combination with constructional mistakes and bad quality material led to this bad condition of the breakwater.

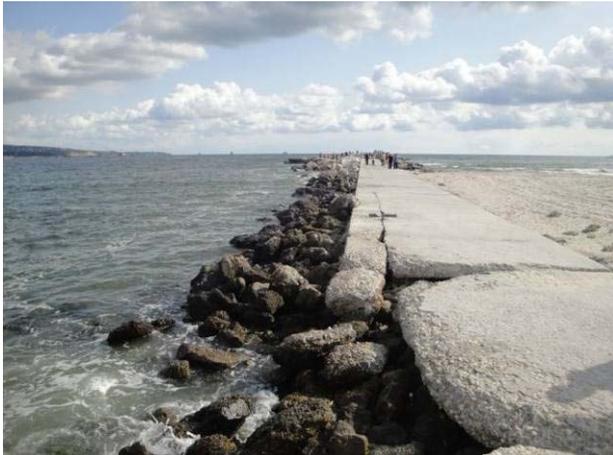
At the canal side (left) of the breakwater are 3 different types of armour present. Starting at the shore there are natural rocks and proceeding to the head of the breakwater there is a combination of natural rocks, different sizes of concrete blocks and tetrapods. This is shown in Figure 25 till 28. At the head of the breakwater only tetrapods are used as armour. At the beach side (right) of the breakwater the same types and combination of armour is used.

Figure 25: Natural rocks at the channel side of the breakwater.

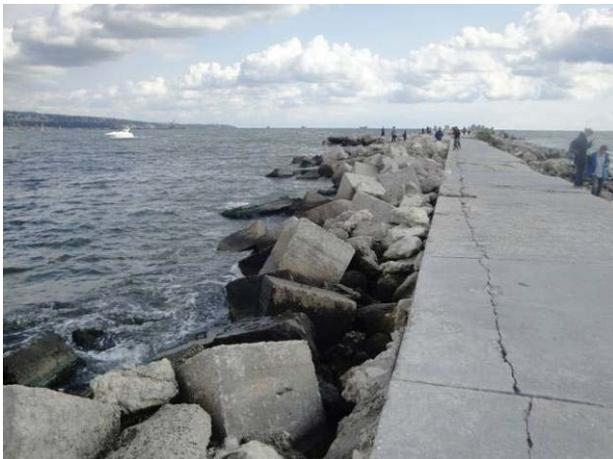
Figure 26: Mixture of concrete blocks and natural rocks.

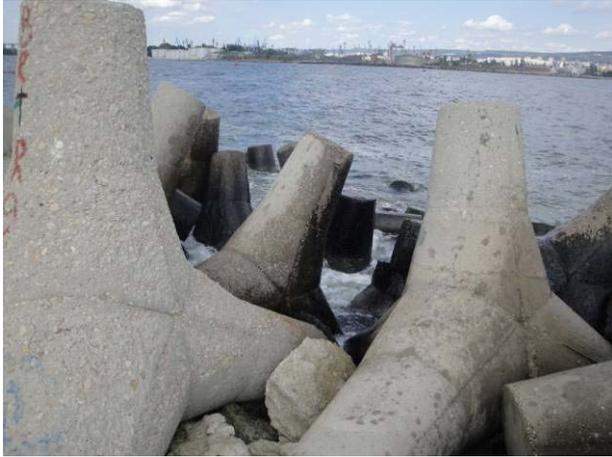
Figure 27: Mixture of tetrapods, natural rocks and concrete blocks.

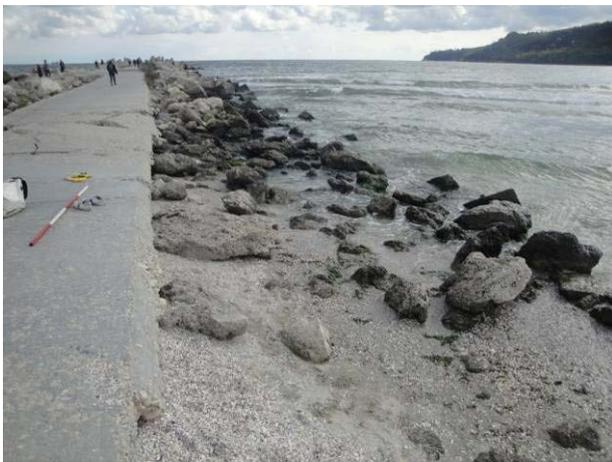
Figure 28: End of the beach, start of the revetment with natural rocks at the beach side (right).

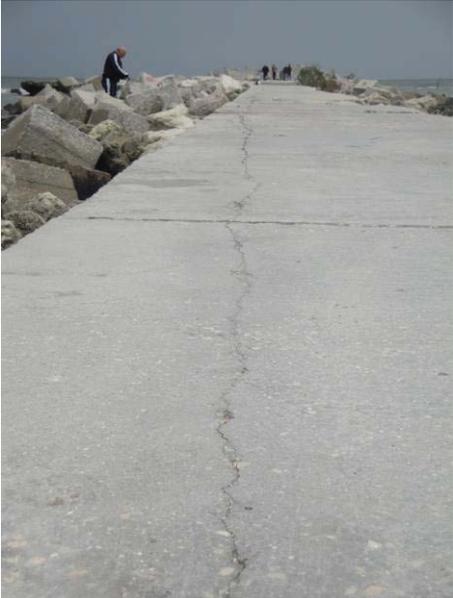
Figure 29: Overview of the crack following the length of the breakwater.

From the base of the breakwater till the head of the breakwater there runs a crack which can be seen in Figure 29, 30 and 31. Further investigation in this crack led to the outcome that exactly at the position of the crack, there is an iron pipe placed in the concrete surface plate.

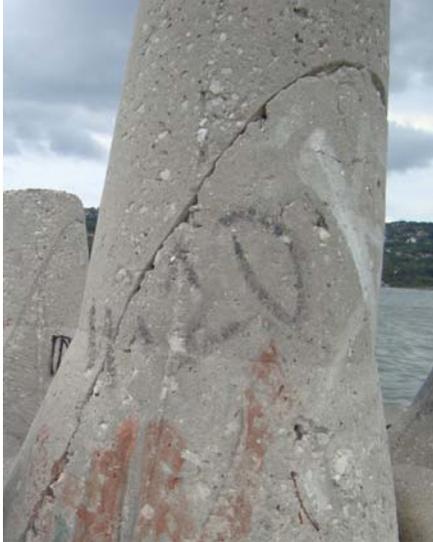
Figure 32: Result of poor construction, construction line clearly visible in tetrapod.

From the condition of the tetrapods and the broken pieces of the tetrapods, it is clear that these concrete units were not carefully constructed and placed at the structure. The lines which are clearly visible on the tetrapods originated from the casting procedure (see Figure 32); probably the casting was stopped halfway and continued the next day or even after the weekend which led to a bad cohesion between the different castings. These construction lines are weak links in the concrete volume of the tetrapods. Therefore more tetrapods are likely to break at the construction line.

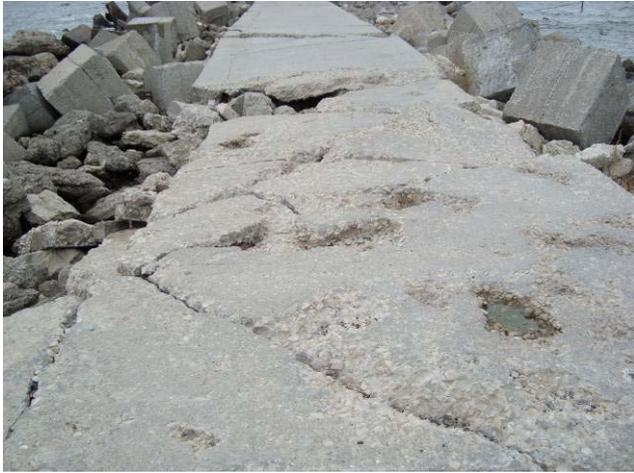
Figure 35: Totally destroyed surface plates.

The surface plates are all connected with each other and are placed above a layer of natural rocks. This will cause large stresses when a wave comes in and generates an upward pressure underneath the surface plate. Because of the rigid structure of the linked surface plates, and the corroding iron pipes, the plates are badly damaged. This is shown in the figures below. Further, the design of the structure could probably not successfully react to the settlements of the subsoil of the structure.

After the calculation of the design wave heights another explanation of the overall damage can be found. The design wave height for the concrete elements seems to be rather low; this could initiate movement of the elements which in combination with bad quality concrete could lead to damage. However this is an intuitive feeling, bathymetric conditions could in some cases result in a low design wave height. Further analysis of wave- and bathymetric data is advised for a thorough analysis of the damages.

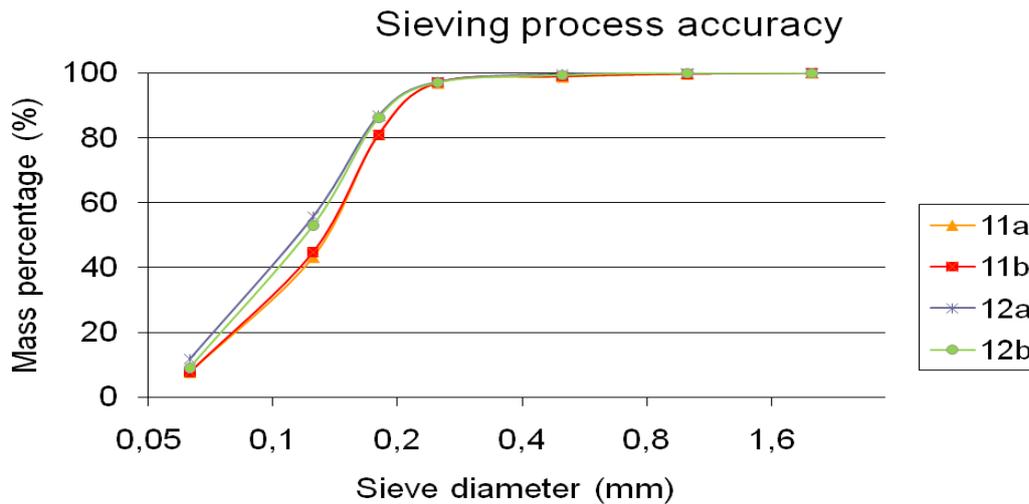
Figure 39: Sieving curves of two soil samples.

After all the shells were removed with hydrochloric acid the samples were dried again in the oven. The samples were crushed in order to loosen the particles and samples of approximately 100 g were taken. In order to take an unbiased sample of 100 g, a special separation device was used. Not using this sampling device could result in an over- or under- representation of the fine particles. Subsequently the sample was put in a sieving machine. Seven sieves were used in order to produce an accurate sieving curve; sieves with an opening width of 2 mm, 1 mm, 0.5 mm, 0.25 mm, 0.18 mm, 0.125 mm and 0.063 mm were used. In order to provide a more accurate view, it was also required to measure sediment with a diameter smaller than 0.063 mm, but these sieves were not available. The sediment was put in the top sieve; these sieves were put on top of a vibrating machine to help the sediment through the sieves. Then the weight per sieve had to be determined. With this information (the weight percentages per sieve,) the weight percentages and the cumulative could be calculated and the sieve curves were produced, see Figure 39 and Figure 40.

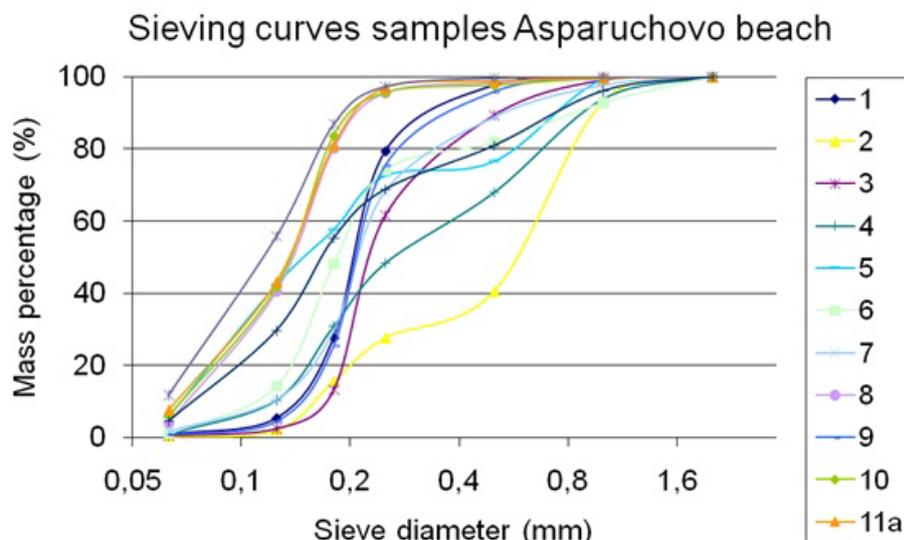
Figure 40: Sieving curves soil samples Asparuchovo beach.

The results following from the sieving process can be found in Table 6: Table 6 and Figure 40. These results show that on average the 0.5 mm < d < 0.125 mm fractions are best represented, that there is less of the 2 mm < d < 0.5 mm fractions and that there is almost no sediment with a diameter larger than 2 mm or smaller than 0.125 mm.

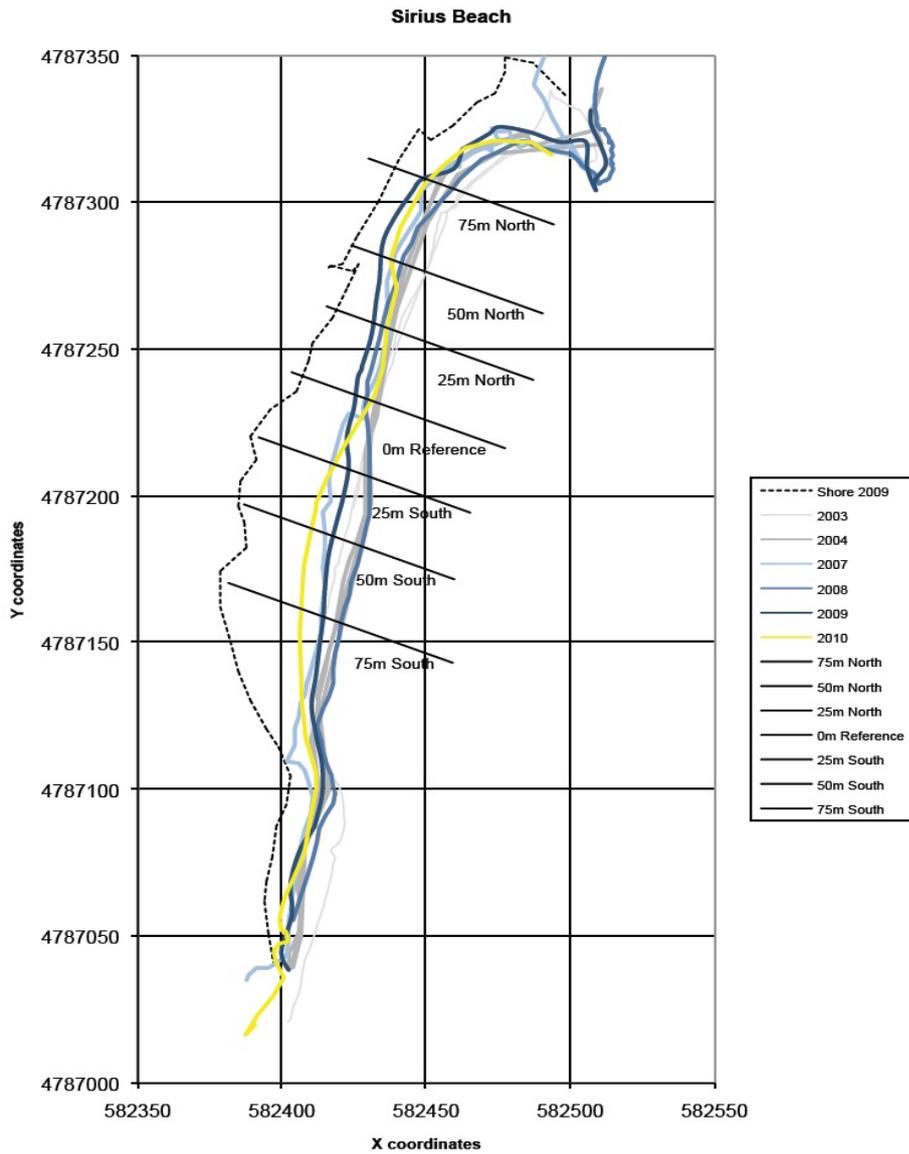
Figure 42: Development of the waterline from 2003 till 2010.

Like previous years the waterline has been measured at Sirius Beach with a GPS receiver. The results from this year and those from previous years are shown in Figure 42 below.

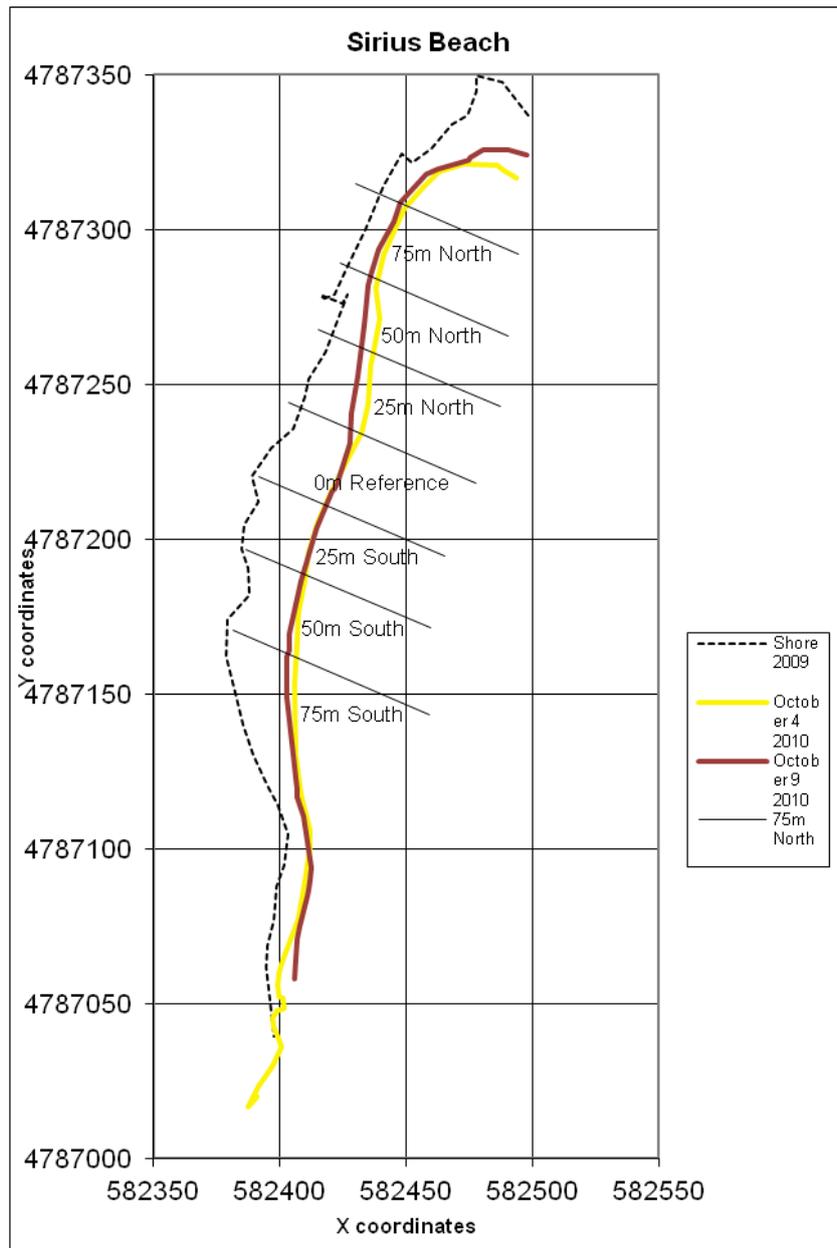
Figure 43: Waterline at Sirius Beach on October 4 and October 9 of 2010.

In just five days the waterline moved a lot, especially at the northern side of the beach. The waterline has been moved landwards. It could be possible that the beach is changing from a summer profile towards a winter profile. During the measurements the sea state was wild; wave heights up to two meters and more were observed. Due to these conditions the waterline has moved landwards. The photos taken at arrival and departure days show a different beach profile (see Figure 44).

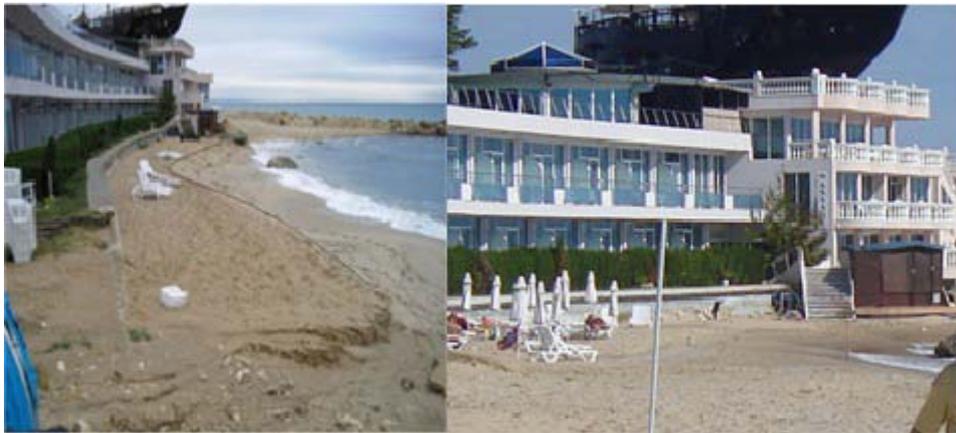
At the waterline the beach profile is steep, which indicates a summer profile being attacked by bigger waves. On the photos, shown in Figure 45, you can see a different kind of beach, at the left (2009) you can see a step where the beach drops down, indicated with a black line. On the other photo (2010) you can see that there is still no step, the beach is high compared to last year and has a steep slope at the waterline.

Figure 45: Beach profiles in front of Sirius Hotel in 2009 (left) and 2010 (right).

The idea that this year a summer profile is still visible, while last year a more of a winter profile was visible, is confirmed by wind data. In Table 7 and Table 8 the amount of days with wind over 13 knots from the first of August 2009 and 2010 can be seen. Also the wind direction is shown (always North-West or North) because the northerly winds and waves will create a more northerly facing beach. This year there were only two days of wind with a speed of more than 13 knots, compared to ten days last year.

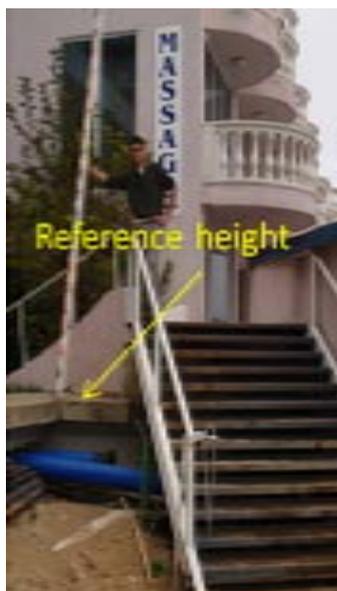
In previous years reference points and levels are defined. The overall reference point, chosen in 2003, is near the stairs to the swimming pool, as shown in Figure 46. The top of the concrete floor is determined as reference height. The reference height of this overall reference point is marked as being the zero height. The GPS coordinates (UTM) of the overall reference point are: T 582380 / 4787140.

Figure 46: Overall reference point with the reference height or zero height.

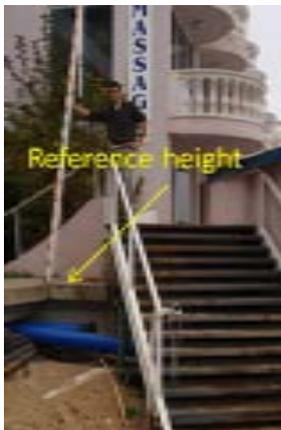
- Reference point 1 (same as overall reference point, see Figure 46):
GPS (UTM) coordinates: T 582380 / 4787140. See Figure 47.
- Reference point 2 (Stairs at southern end of Sirius Beach):
GPS (UTM) coordinates: T 582450 / 4787340. See Figure 48.

Figure 47: Reference point 1, stairs to swimming pool Sirius hotel. This is also the overall reference point mentioned before.

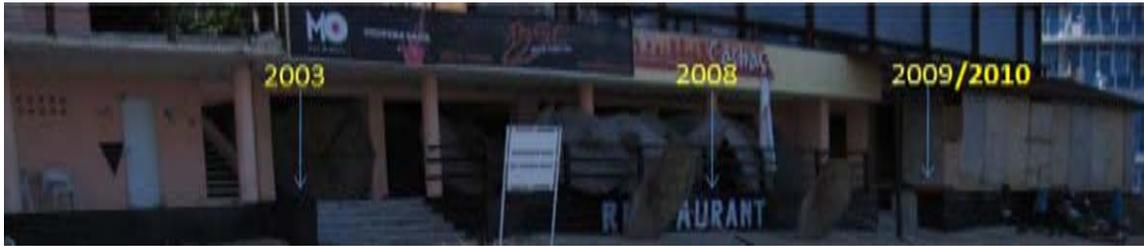
Figure 49: Zero reference points from previous years 2003, 2008, 2009 and this year 2010.

Since both reference points cannot be used to determine a perpendicular line, an extra reference point is introduced for cross-section 0. This zero reference point is not used for heights but only to determine the first cross-section. Figure 49 below shows the zero reference point for Sirius beach, indicated with an arrow. It is the same zero reference point that was used in the report of 2009, although in this report the text and the picture did not correspond [3]. Further, the zero reference points from 2003 and 2008 are indicated in this figure.

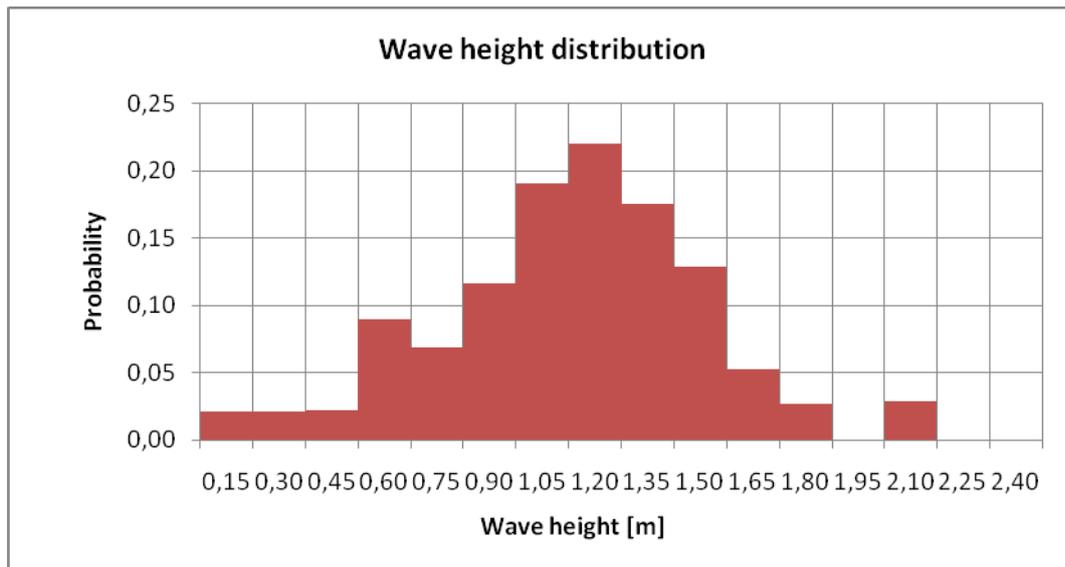
Figure 59: Wave height distribution of measured waves.

First in Figure 59 the distribution of the measured waves is shown. For this first dataset out of four, 48 individual waves were measured. From these data several expressions for the wave height were derived. In Appendix D the measured data are included, which are converted into wave heights in meters. From these data the theoretical Rayleigh distributions were calculated and compared to the measured data, scaled to compare to the Rayleigh distribution.

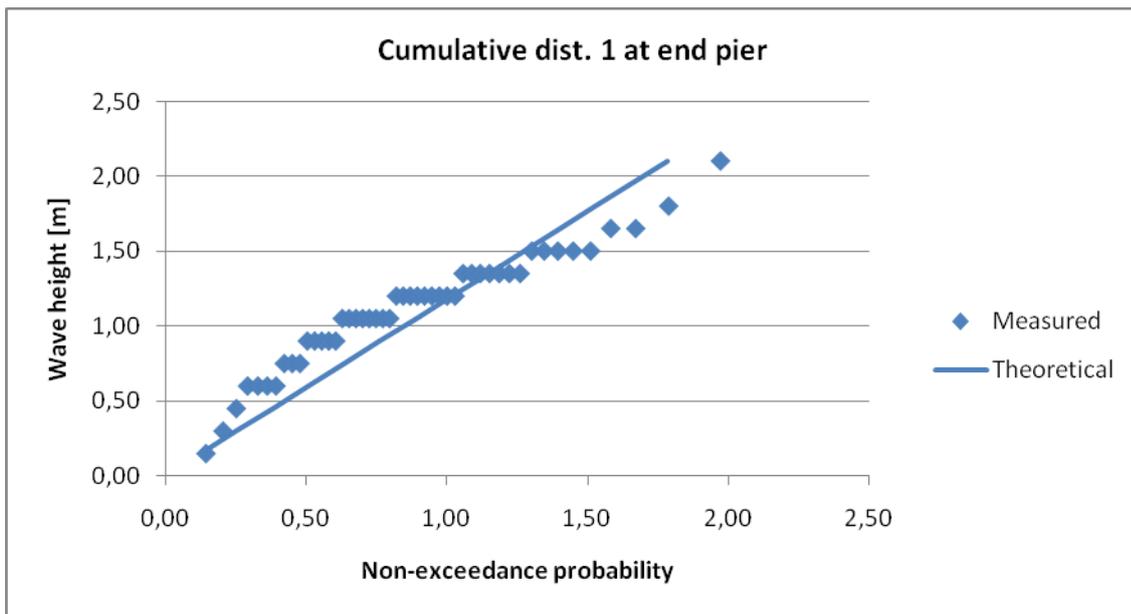
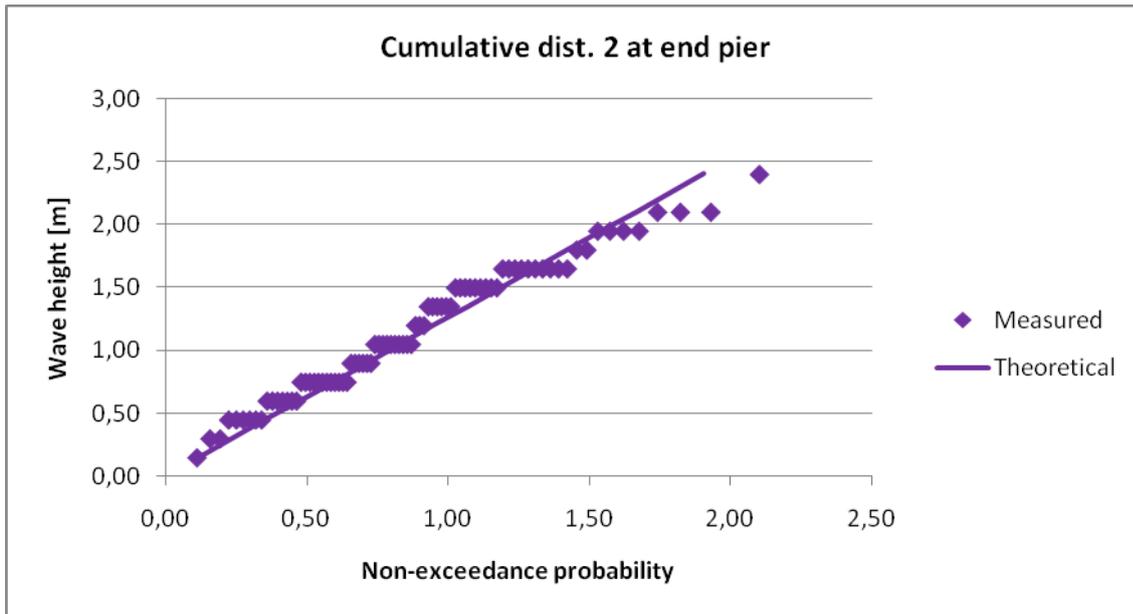
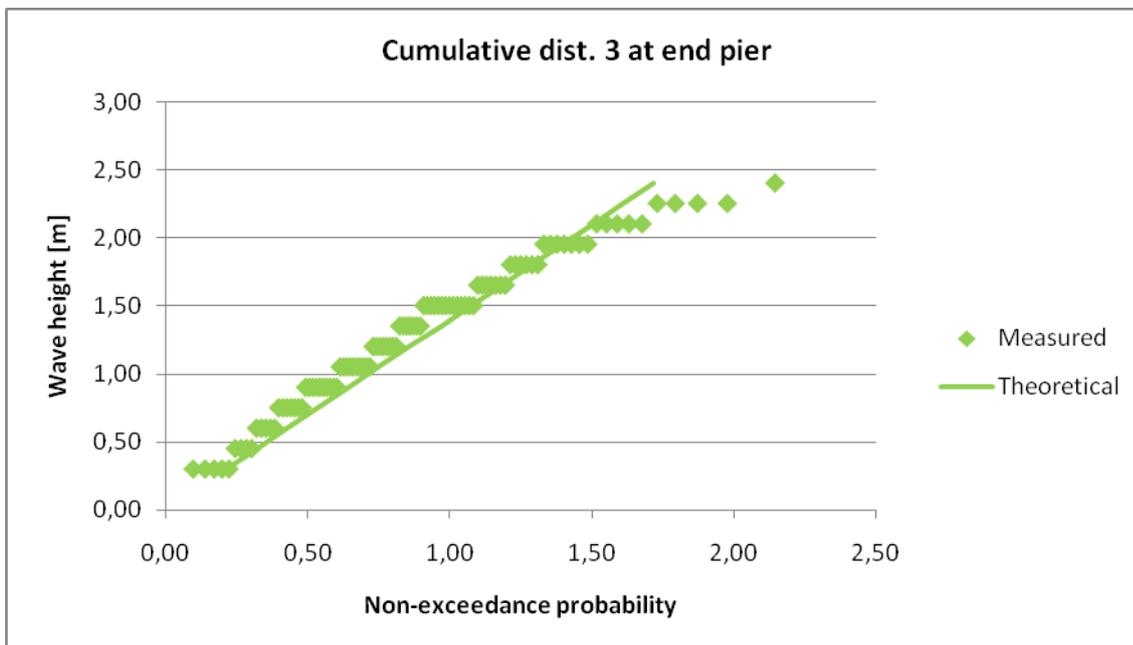
In Figure 61, 62 and 63 the measured wave height distribution is plotted together with the theoretical Rayleigh distribution. As one can see, there is a deviation from the theoretical Rayleigh distribution. This deviation can be explained, because at the location where the wave height was observed the waves were already breaking.

When Figure 61, 62 and 63 are compared to Figure 60, there is clearly a relation. At the higher wave heights, the deviation from the Rayleigh distribution is getting larger. This deviation in shallow water can be explained by the nonlinear phenomena in shallow water, with breaking of the waves as an example.

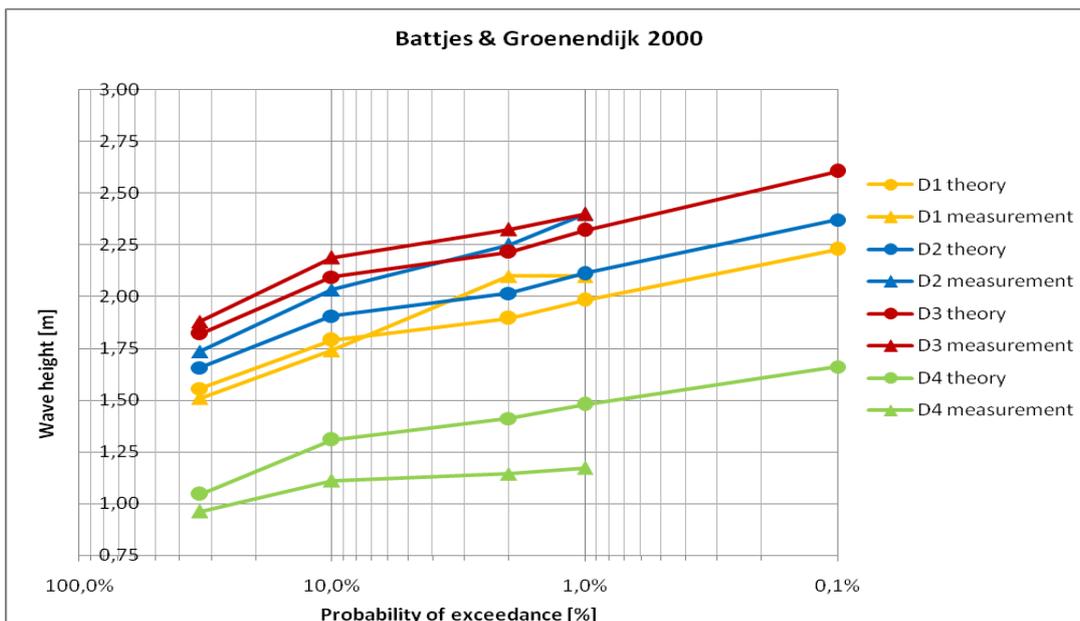
Figure 65: Measured wave heights compared to Battjes and Groenendijk 2000.

In Appendix E a table with calculated values is included, from where Figure 65 is the result. Here one can observe the four datasets that were acquired, in relation to the theory of Battjes and Groenendijk. As visible in Figure 65, dataset 3 fits in the best way to the theory. A reason for that could be that in dataset 3 a total of 100 individual waves were measured, compared to only 48 individual waves in dataset 1.

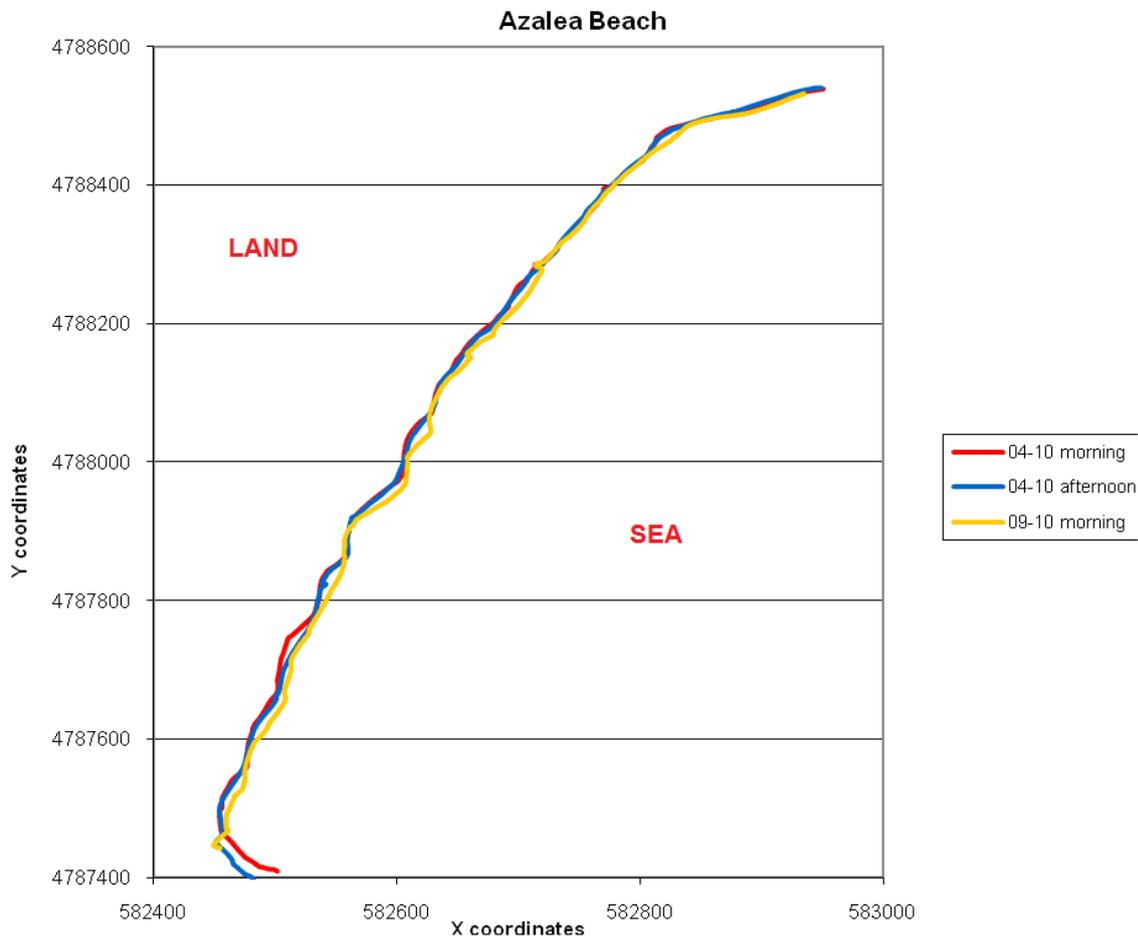
Figure 67: Waterline position at different days in 2010.

During the fieldwork, the waterline has been measured at two different days, see Figure 67.

The above mentioned factors all contributed to the shift of the waterline. The measuring errors are supposed to have given the largest contribution.

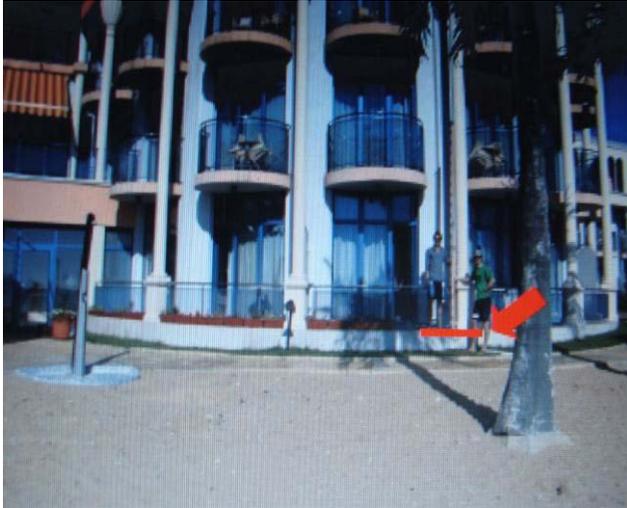
On this beach the chosen reference point is the upper side of a concrete under beam in front of Azalea hotel. This is the first round tower when coming from Sirius beach (and not the second!). The overall reference point is marked red in Figure 70.

Figure 70: Overall reference point (upper side of concrete beam).

In this project, the height of the theodolite compared to the overall reference point has been measured with the help of a levelling rod, placed on the concrete beam showed in Figure 70. The height of the theodolite compared to the overall reference point is $- 0.73$ m.

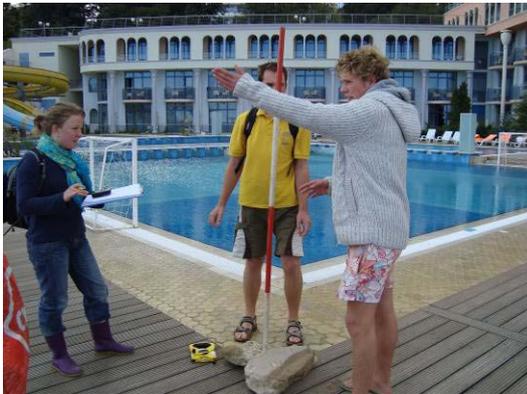
Figure 71: Overall reference point (upper side of concrete beam).

- Reference point 1 (outside swimming pool of the Azalea Hotel):
T 582476 E / 4787668 N. See Figure 71.
- Reference point 2 (at the concrete semi-circular platform of the outside bar of the Sunny Day hotel): T 582588 E / 4788005 N. See Figure 72.

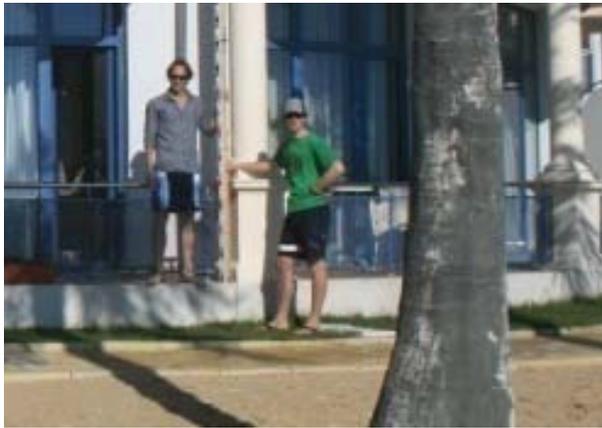
Figure 73: Zero reference point Azalea beach.

Since both reference points cannot be used to determine a perpendicular line, an extra reference point is introduced for cross-section 0. This zero reference point is not used for heights but only to determine the first cross-section. The same zero reference point as in the report of 2009 is used in this report of 2010. Figure 73 below gives the zero reference point for Azalea beach, which lies on the bottom of a concrete pile of the southern wing of the Azalea hotel.

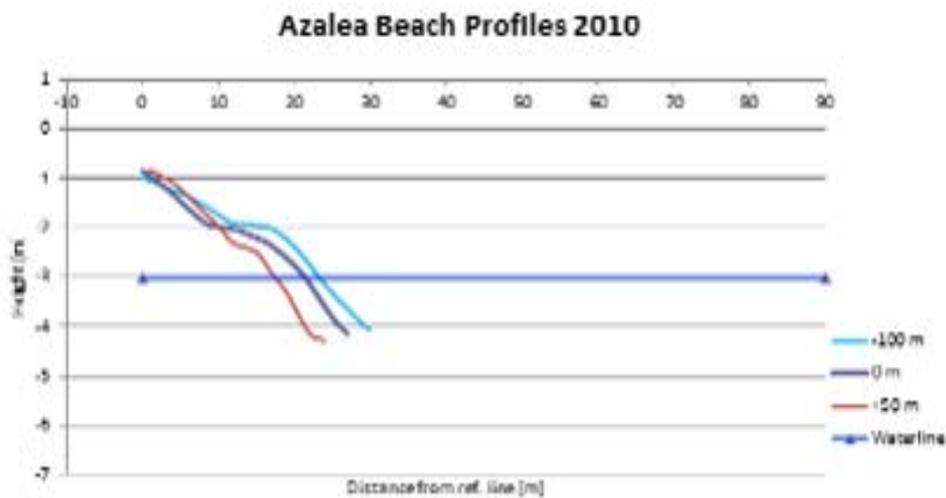
Figure 75: Beach profile Azalea 2010.

A summary of the measurements of the cross-sections can be given in a graph, see Figure 75.

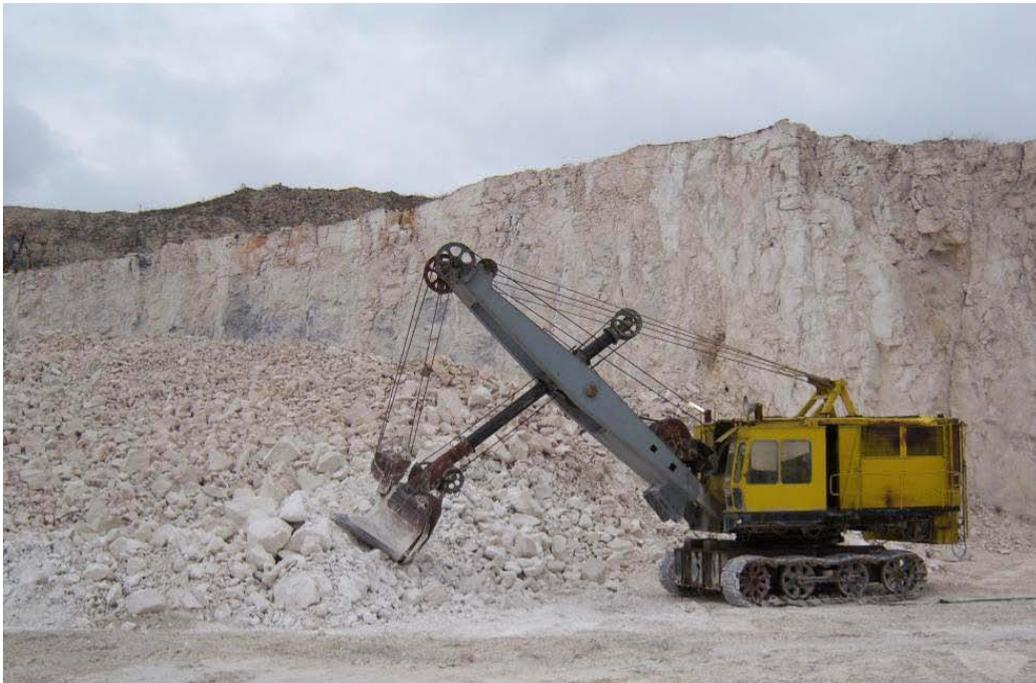
To investigate the available rock in the surroundings of Varna, two quarries near Varna were visited. At the Marciana quarry near Devnya some parameters of the rocks available for hydraulic engineering works were investigated. And at the Sini Vir quarry, south of Tsonevo, the quarry itself and the quarry processes as drilling holes near the edge to fill them with explosives and a stone crusher to crush the larger rocks were observed.

Figure 81: A grab wagon at the Devnya quarry
