CT 5318 FIELDWORK HYDRAULIC ENGINEERING

Preface

This report is made for the fifth years course CT5318 "Fieldwork Hydraulic Engineering" of the faculty of Civil Engineering at the Delft University of Technology. During the study civil engineering the students mainly follow theoretical courses and learn to describe and study all kind of physical phenomena with help of mathematical expressions and models. The fieldwork of Hydraulic Engineering is one of the opportunities to get a 'real life' impression of the studied phenomena's and theories.

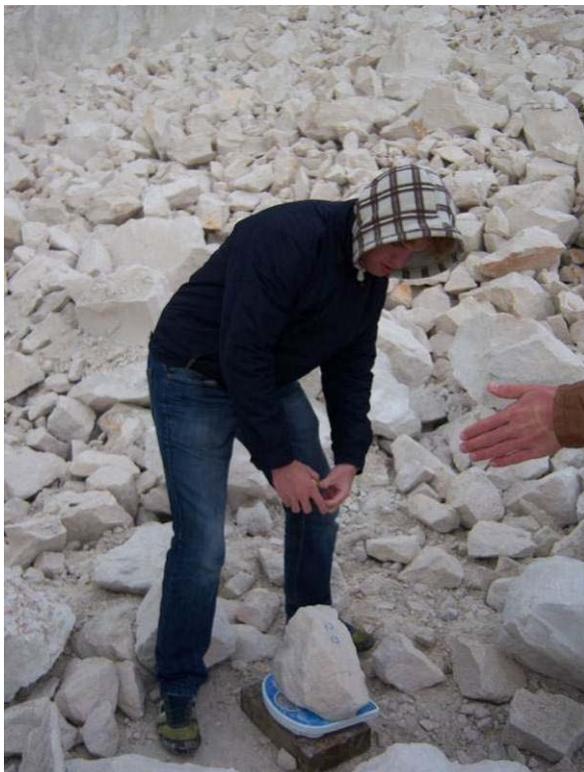
Figure 82: Measuring small rocks with the weighing scale.

The results of the measurements of the two groups are averaged such that there are two measured values. Group 1, which was second in line of measuring the small rocks, broke the weighing scale when they were still in the process of weighing all the rocks. This explains the blanks in Table 13 for the weight values of some of the rocks measured by group 1. There are some reasonable differences between the measurements of the two groups because of the unreliable weighing scale. Figure 82 shows the measuring process of the small rocks.

The specific density is determined on $\rho_s = 2360 \text{ kg/m}^3$. With this value and the measured weight of the smaller rocks at the Marciana quarry the volume of the several stones can be determined, like is done in Figure 82 below.

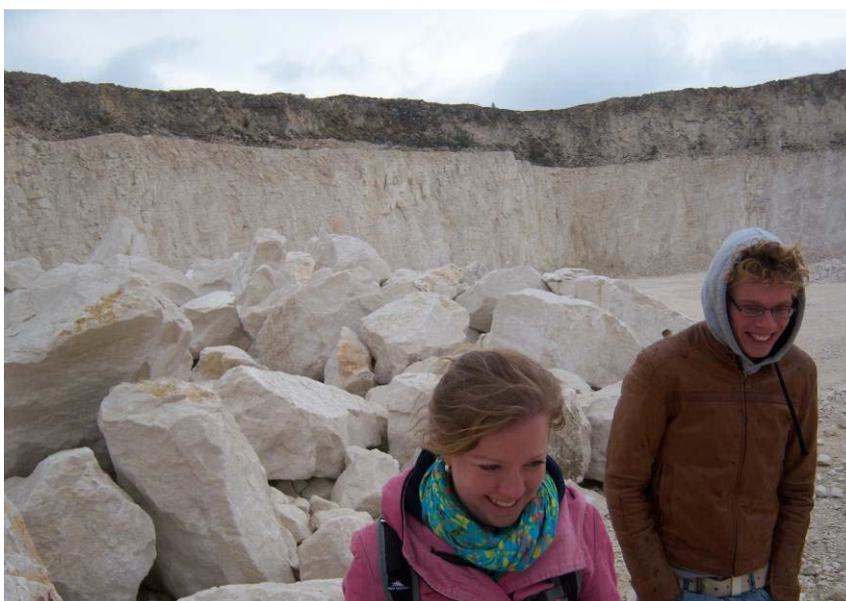
Figure 86: The large rocks at the Devnya quarry.

With the blockiness and the measured values of length, width and height of the smallest boxes the rocks could fit in, the volume was calculated. And the nominal diameter D_{n50} follows from the volume. Knowing the density of the type of rock, the mass was calculated as well. An overview of the characteristics of the five large rocks considered at the quarry can be found in Table 17.

Calculating the volume of rocks without being able to weigh the mass of a stone is less accurate, because an estimation of the blockiness has to be made. The estimation of the blockiness of the heavy rocks is based on the calculated blockiness of the small rocks and how blocky the small and the heavy rocks look on the pictures. From the pictures it can be concluded that the heavy rocks have a slightly bigger blockiness than the small rocks, i.e. about 15 % bigger. The blockiness of the heavy rocks can now be calculated: $B(\text{heavy rocks}) = 1.15 \cdot B_{\text{mean}}(\text{small rocks}) = 1.15 \cdot 0.37 = 0.43$.
