Fieldwork Hydraulic Engineering
Artificial Islands Asparuhovo, Bulgaria

CIE5318 Fieldwork Hydraulic Engineering
Varna, October 2012
Delft, December 2012

In October 2012 a group of sixteen Dutch students from Technical University of Delft and 4 four Bulgarian students from Varna Free University did fieldwork in Hydraulic Engineering in the surroundings of Varna, Bulgaria. Various activities were executed around St. Constantine and Asparuhovo Beach.

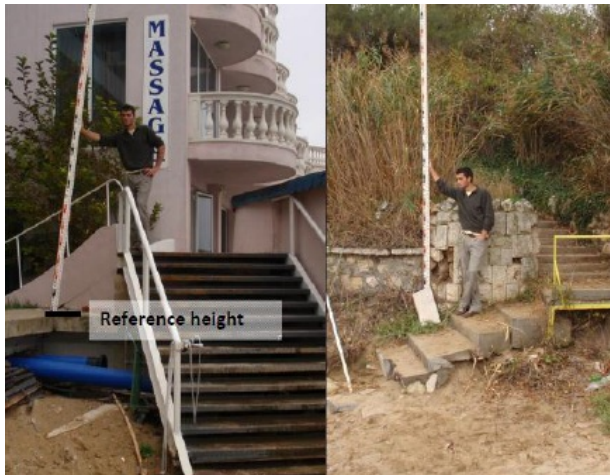
Figure 2-8 Reference points on Sirius Beach

The cross-sections can be determined by measuring vertical positions at specific points. Several years ago two reference points were chosen at the beach (see Figure 2-8). Reference point one is near the staircase to the swimming pool of the Sirius Beach hotel (35T, 582450 m east, 4787329 m north) and the other one at the south end of Sirius Beach (35T, 582380 m east, 4787136 m north).

By using these two points again, we can guarantee that our measurements are taken at the same distances as last year, which makes them comparable. The reference points are used to determine the baseline; a straight line between these two points. The reference point at the staircase was chosen as our zero point, because this was done last year as well. The years before several other zero points were used, but we decided to use last year's zero point again. From there on, 6 poles were placed with a mutual distance of 25m. From these six poles (all on the baseline) six cross shore profiles were measured, perpendicular to the baseline. In the figure below the reference points, baseline and cross-sections are visible.

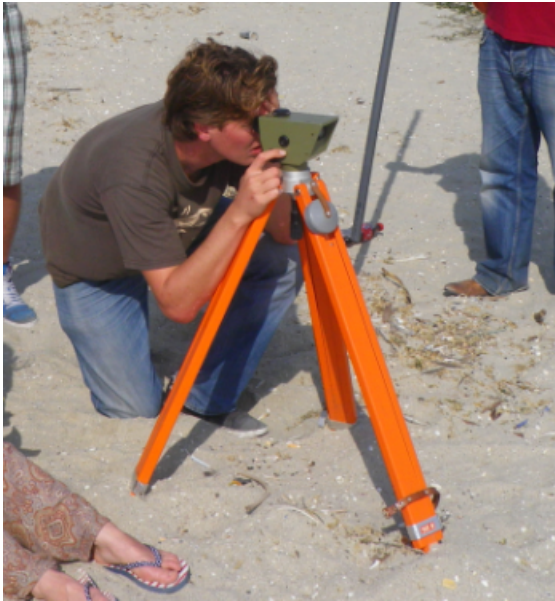
Figure 2-11 Use of the theodolite

The vertical positions are measured by the eye using a theodolite and a measuring pole. The reference point (ref point 1) at the staircase is a fixed point, and the height above mean sea level is known for that point (2.705 +MSL). The theodolite was positioned at a fixed point on the beach and the height was decided by looking at the reference point. From then on, the theodolite was used to

measure the vertical position by looking through the theodolite at a measuring pole. The measuring pole was placed at a point from where the distance to the baseline was known, and by looking the vertical position was then decided. In this way the horizontal (X,Y) and vertical position are known. This was done for many points along the cross sections, resulting in six cross shore beach profiles.

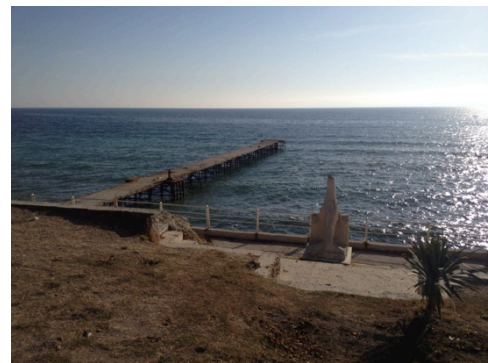
Figure 2-18 Jetty at St. Constantine and Helena

This year the wave data at Sirius Beach were obtained with use of a pressure meter instead of visual observation. The visual observation was impossible due to the damage of the jetty at St. Constantine and Helena (see Figure 2-18). On this jetty one group of students was able to insert a jalon in the sea while the other group of students did the observation from a breakwater at some distance on the right of the jetty with a theodolite in order to measure the

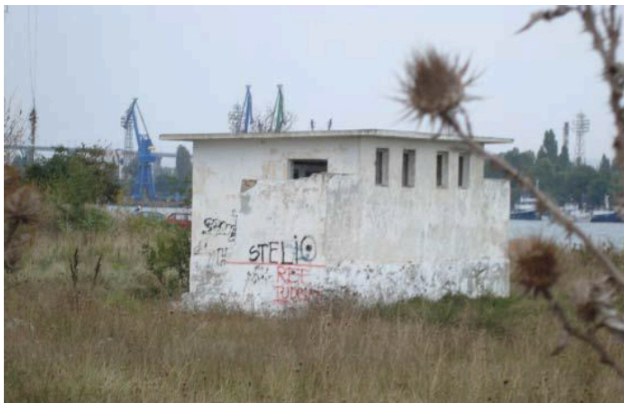
Figure 3-3 Reference point for height

There are three main reference points. These are reference point 0.1 (used as an reference point for the height) and reference point 1 & 2 (for the baseline). Reference point 0.1 is marked on a small building located inland (Figure 3-3). The location of the building is marked in the picture next to it.

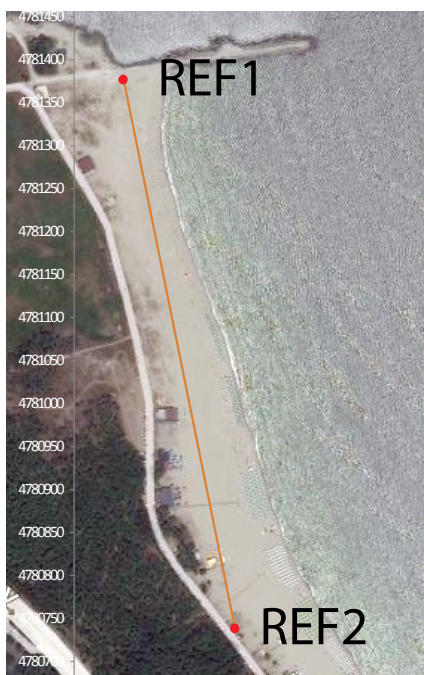
Figure 3-7 Baseline

Between reference point 1 and 2 the baseline is drawn. This baseline is the reference line for the cross-sections. Because reference point one is moved, the angle of the baseline is different. This will result in a slight incorrectness of the point and the angle taken for the cross-sections.

The “new” baseline is viewed in Figure 3-7.

The cross-sections are taken along the baseline at a specific distance from reference point 1. The three distances that are chosen are: 50m, 200m and 400m.

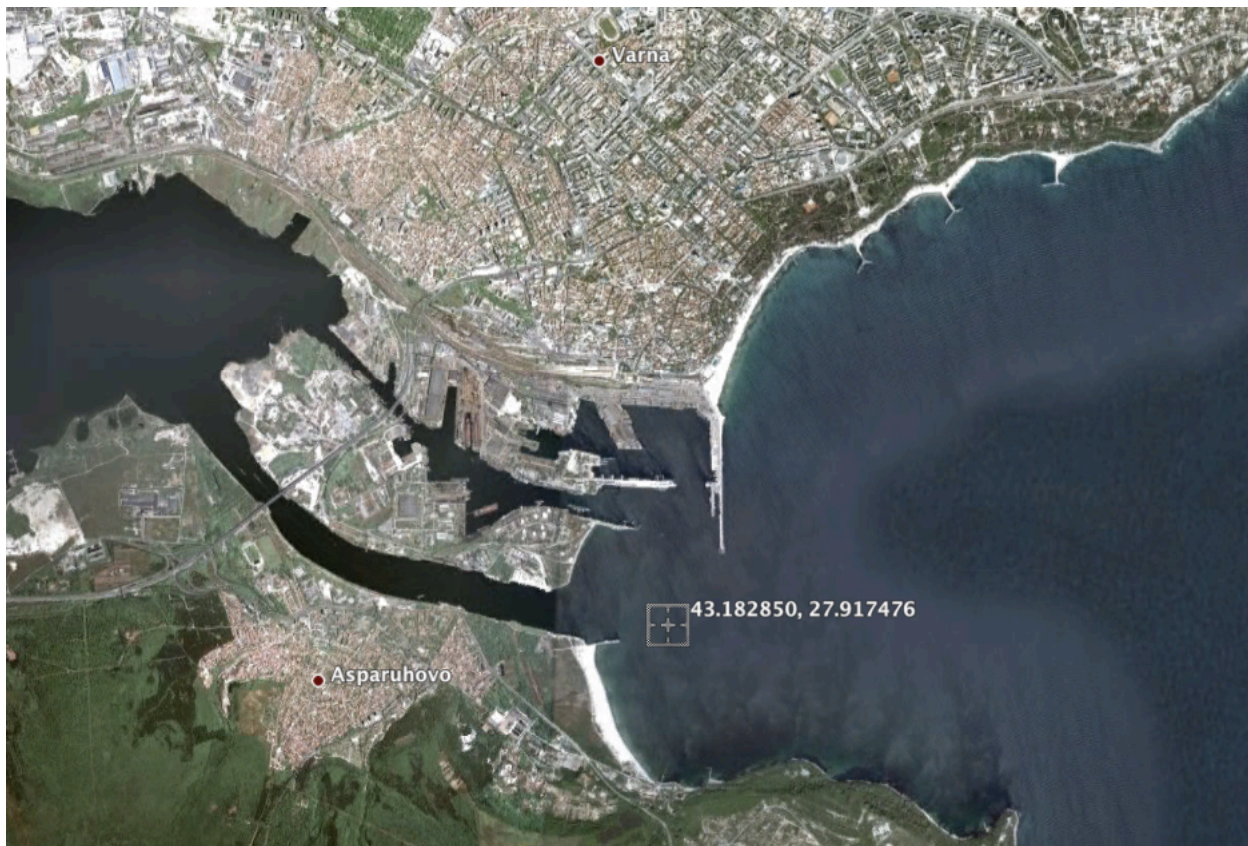
Figure 3-12 Location Wave Measurement Asparuhovo Beach (by Google Earth)

At Asparuhovo Beach there was one location chosen to measure waves with sufficient depth of approximately 8m (see Figure 3-12).

At this place (decimal UTM coordinates 43.182850E, 27.917476N) the pressure is measured four times. The duration of one measurement is twenty minutes and after one hour the instrument started to measure for the next time. In Table 3-1 the obtained wave characteristics are given for four windows. The short-term period is not representative for a wave climate. This must be at least one year. More detailed information about the analysis of this data can be found in Appendix A – Wave measurements.

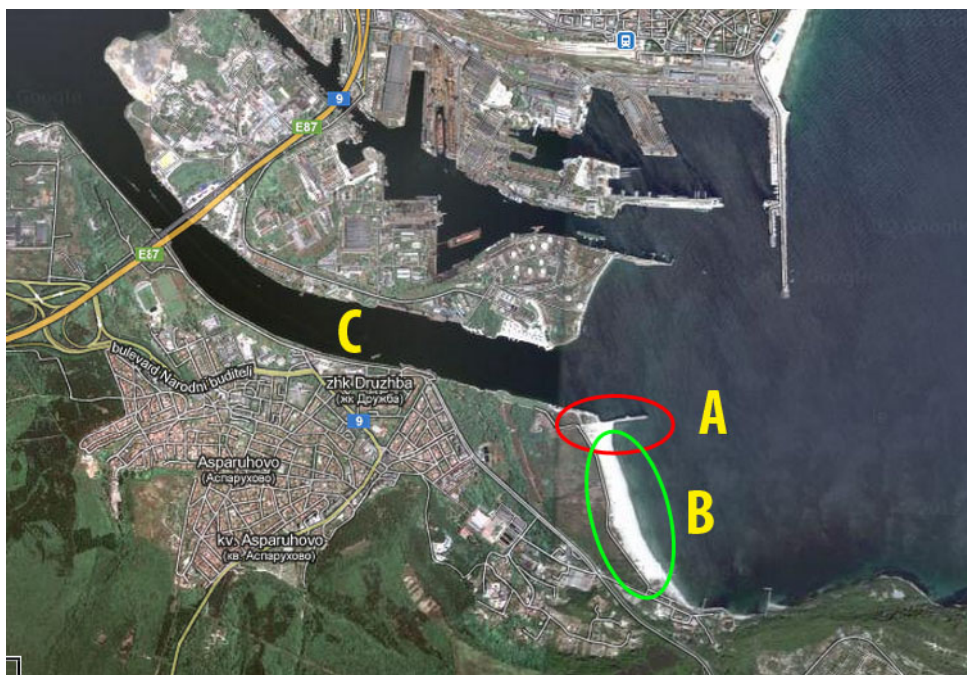
Figure 3-15 Overview

The breakwater at Asparuhovo Beach is situated at the north side of the beach. The breakwater has two main functions: maintain the channel entrance for the port of Varna and maintain the beach at Asparuhovo. The overview of the breakwater is shown in Figure 3-15. In this picture A is the breakwater, B is Asparuhovo Beach and C is the main channel. The channel north of the breakwater is main connection with the port of Varna and the black sea. The breakwater prevents siltation of this very important channel. The secondary task is the prevention of erosion of the beach during storms.

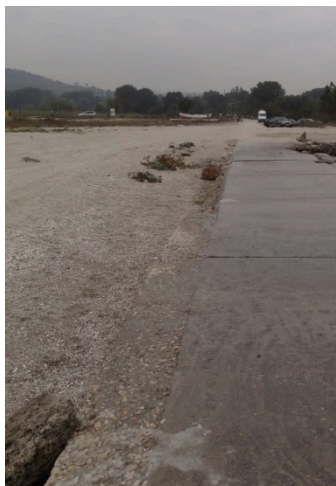
Figure 3-17 Beach protection

This is the first part of the south side of the breakwater. This part is protected by mainly the beach itself, as shown in Figure 3-17. This layer of protection can be quite weak because of the shelter that it is in. This part is about 60m long. There are a few natural stones with a d_{n50} of around 30cm. These are rocks that has moved their by the sea.

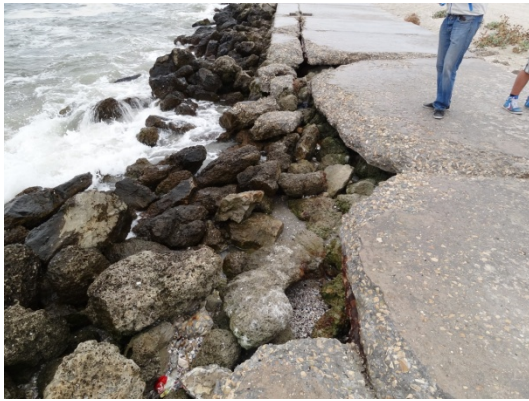
Figure 3-18 Section 2

The second section is much heavier defended than the first section. Because at the first section there are almost no waves and section 2 is more open for waves. The protection is still smaller than at the end of the break water because the biggest waves will break at the end of the break water. This part of the breakwater is mainly defended by natural stones with a d_{n50} of about 40cm, as shown in Figure 3-18. The gaps between these rocks are mainly filled with sand. This sand comes from the sand that

the waves take with them when it hits the breakwater. The dimensions on the north side are about 120m and on the south side 60m.

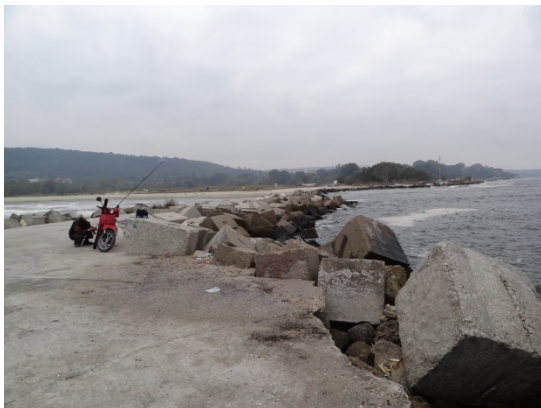
Figure 3-19 Randomly placed cubes

This section is protected by concrete cubes. At the beginning the cube size is $1\text{m} \times 1\text{m} \times 1\text{m}$, assuming that the concrete has a density of 24000 kg/m^3 the total mass of these cubes is 2.4 tons per element and at the end where the waves can be bigger the cubes have the dimension of $1.19\text{m} \times 1.23\text{m} \times 1.42\text{m}$, this gives a total mass of 5.0 tons per element. These cubes are randomly placed at both sides of the breakwater, see Figure 3-19. At the north side (channel side) there are also placed some old reinforced rubble to protect the breakwater, as shown in Figure 3-20. In this section there is also a widening of the breakwater. The exact reason for this widening is not clear; the only guess that can be made is that this was created for truck passing during construction. In the Netherlands you would not find such widening. This section has a length of 120m.

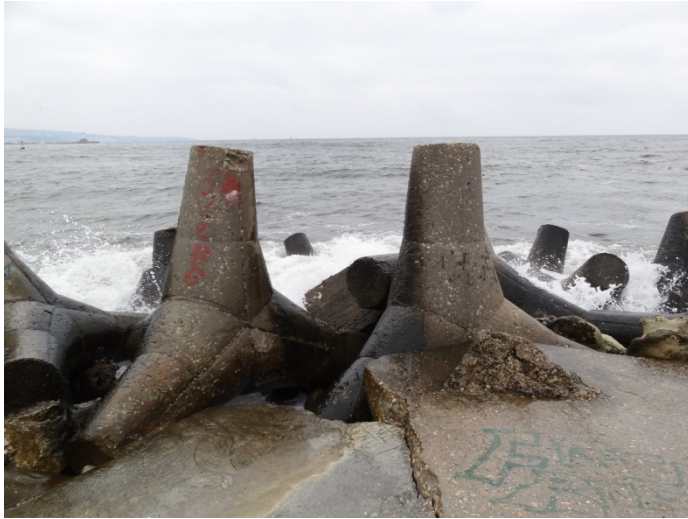
Figure 3-21 Tetrapods

At the end of the breakwater is section 4. This section is the most protected part of the breakwater. This part is protected by mostly tetrapods and also some cubes. The cubes are randomly placed between the tetrapods, but they are also clearly moved by a storm at some places. The tetrapods have an overall height of 2.79m. There are several layers, especially at the end of the break water there are 2 layers, as shown in Figure 3-21.

The damage coefficient of the tetrapod will be much lower, because this is for a double layer. There are two layers of tetrapods but these are not well placed, this could explain a bit of the different. Besides this a lot of the tetrapods are already broken after a maximum of one year at the groin. This will decrease the design height even more. The strange part is there H value for the tetrapods are much lower. Or there is a mistake made or they have dropped new tetrapods at the break water.

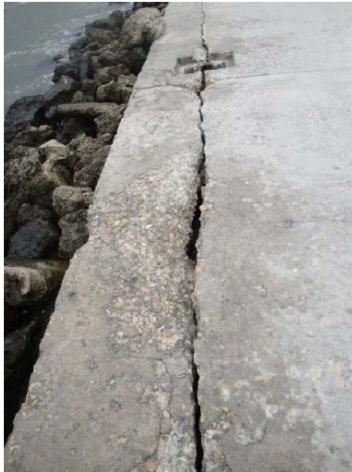
Figure 3-22 Crack 2010

It starts with a crack from the beginning to the end of the breakwater due to an iron pipe that goes through the breakwater. In the three pictures below, from left to right: 2010, 2011 and 2012, it is clear that the crack get bigger each year.

If the government of Bulgaria want to maintain this breakwater it is clear that they have to maintain it better. In the picture of this year in comparison with the last 2 years you can see that the quality of the breakwater is descending very quickly. If they want to fix it they have to create a better protection around the breakwater with high quality tetrapods. They also have to fix the surface plates and most of all fix the foundation beneath it.

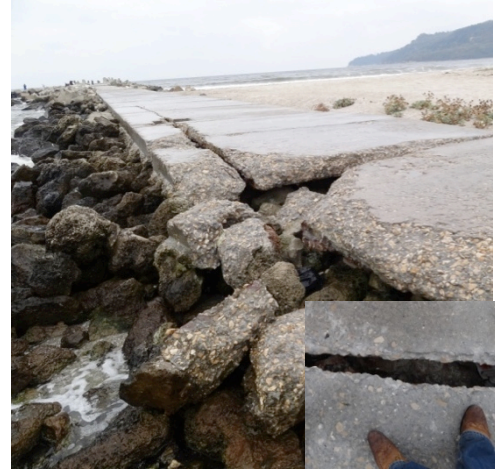
Figure 3-23 Crack 2012

From this chapter it is clear, even already mentioned, that the breakwater is in a very miserable state. This is mainly because of the poor construction of the breakwater. One of the biggest failures of the breakwater is the steel pipe that goes through the service plates. Because of this pipe the whole breakwater has already a fracture. The state of all the concrete is actually poor. Everywhere you could see that the concrete was failing, even the, mostly very strong, tetrapods were broken. The lack of maintenance causes the breakwater to fail even more.

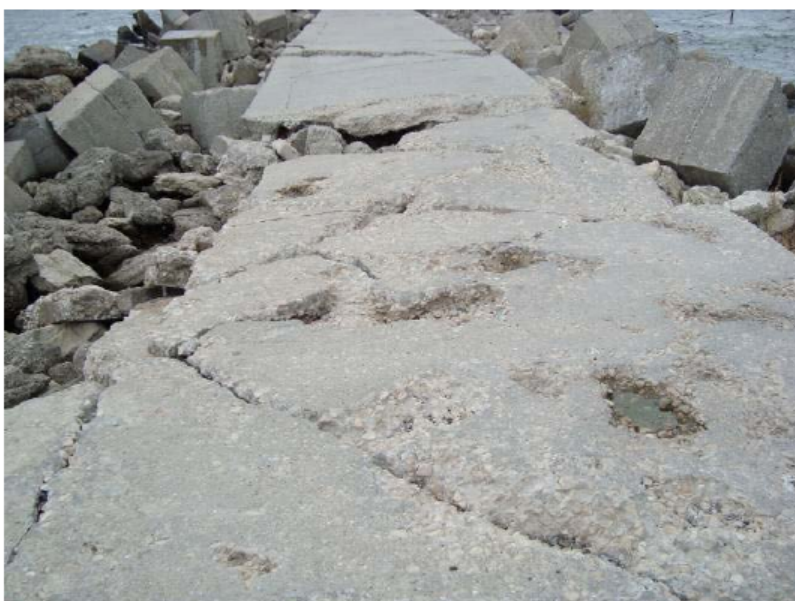
Figure 3-25 Surface plates 2010

The surface plates are the most weak points at this breakwater. There are also parts that are totally destroyed. Each year it gets in a worse state as shown in the picture below. These surface plates are all connected with each other. The surface plates have a foundation of natural rocks. This combination of inner connection and foundation creates big upward stresses when waves come in. This in combination with settlements that does not uniform drop and the natural rocks underneath the surface plates that are washed away due to storms causes the fail of the surface plates.

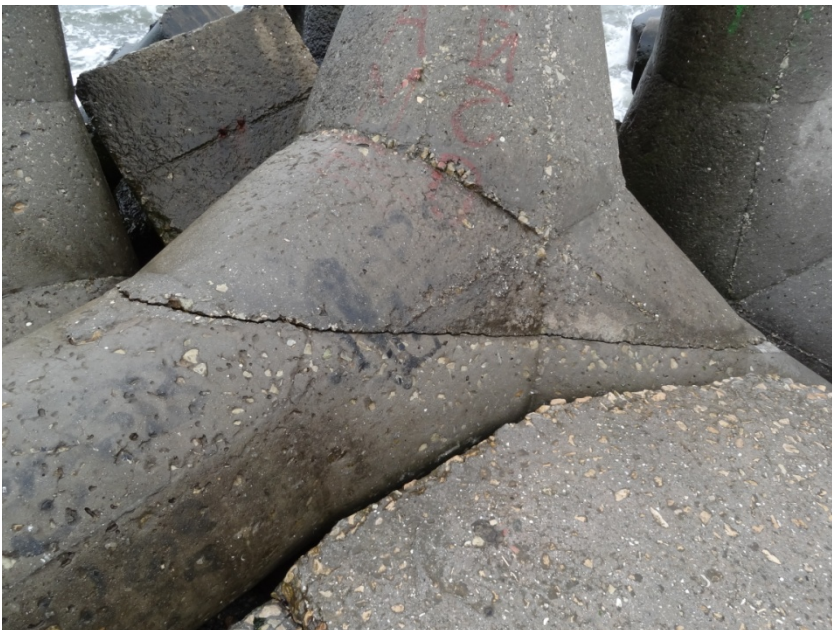
Figure 3-27 Broken tetrapod

The tetrapods that are used are also from bad quality. In the picture below there is a tetrapod with a breaking line. This breaking line is in all probability a construction fault. The constructor of this tetrapod probably take a break when it was filling it with concrete, maybe he even waited for the weekend to past. That way the tetrapod did not become one solid block but instead it consist more the less out of two parts. There are also some tetrapods with broken legs; this is because the tetrapods move due to the storms. The teachers with us told that he have seen them move.

Between the North Side of the Asparuhovo Beach and the entrance channel of the port of Varna a breakwater is situated. This breakwater is analyzed and the technical state of the breakwater is compared to the findings of the last two years. By comparing the pictures of the last two years with the most recent pictures the breakwater is in poor condition and is descending very quickly. The main reason for this condition is the poor quality of concrete used and the poor construction. With the experience of this breakwater the recommendations for future breakwaters are to create a better foundation for the breakwater, to use sufficient coverage for the reinforcement steel and to use better quality tetrapods to surround the breakwater.

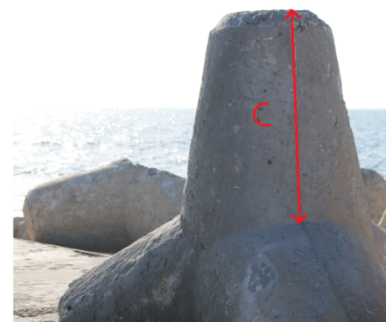
Figure 5-3 Leg length of tetrapod

The damage coefficient of the tetrapod will be much lower, because this is for a double layer. On the groin of St. Constantine you can hardly call it a single layer because the tetrapods are randomly placed and have no interlocking function. This results in a lower design height.

Besides this a lot of the tetrapods are already broken after a maximum of one year at the groin. This will decrease the design height even more.

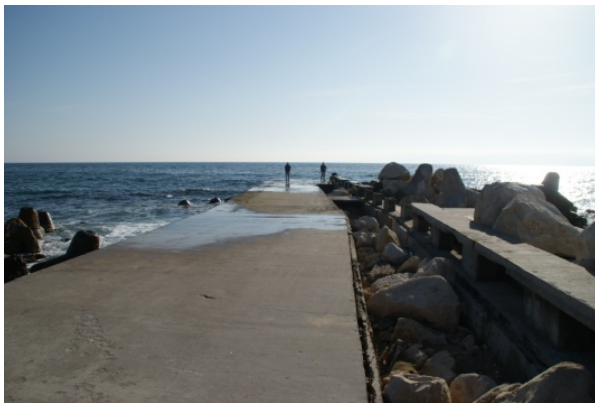
Figure 5-4 Last year's baseline was at the right hand side

Compared to last year a lot happened at the groin. There were tetrapods placed and a lot of stones moved and/or were broken. The baselines of the previous years were not visible anymore, because rock was all over it as you can see on figure 5.4.

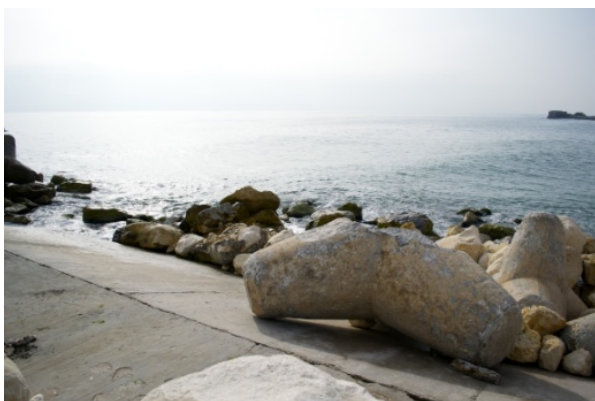
Figure 5-5 Broken tetrapod

The stones were moved during storms from the south. Also on the north side stones were moved. Besides that the tetrapods are not heavy enough, the quality of the concrete is also not very good. A lot of them are broken as you can see in figure 5.5.

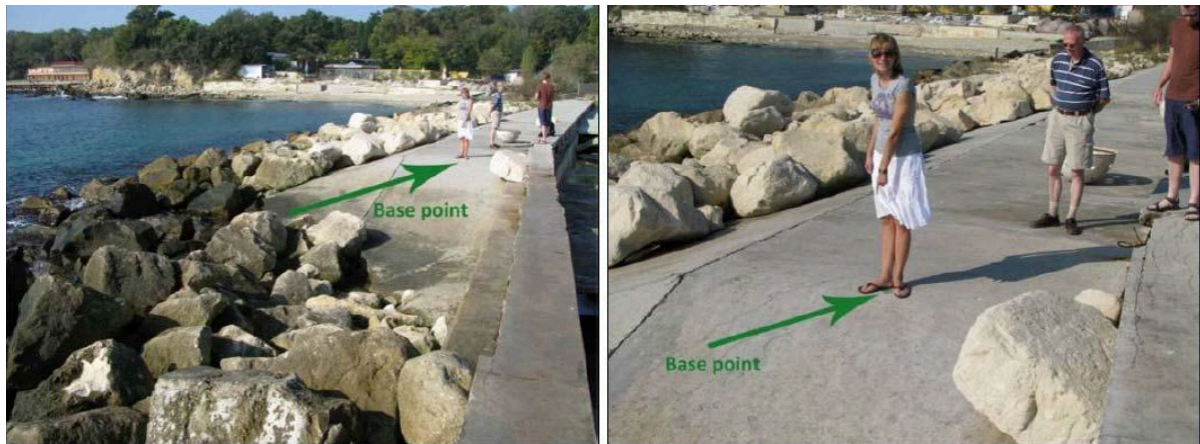
Figure 5-6 Base point 2011

In 2002 the groin near St. Constantinee is measured for the first time. Last year (2011) they marked a base point at the groin, just before the bent in the groin see figure below. Comparing this photograph with this year's photo, one can clearly see the difference of the concrete bar in the previous year. This is now completely gone. This year we were not able to take the same base point due to the damaged bar, so we had to move a little bit to get measurements. All measurements have still reference to the green point for correct comparison.

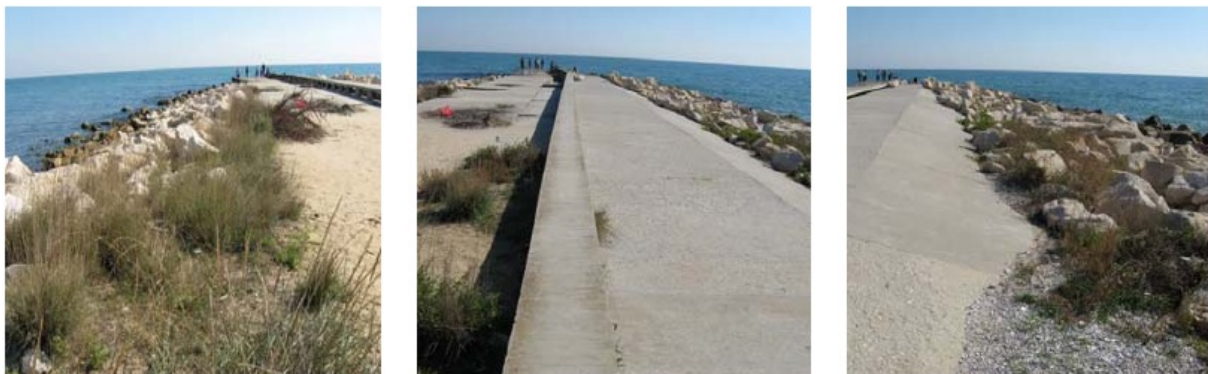
Figure 5-20 Groin in 2009

It could be that the last years more severe storms hit the groin. On pictures from the year 2009 the groin looks good and even vegetation is growing on it. It is also visible that the concrete slab is still in one piece.

Compared with last year and the years before the groin has changed a lot. Because of constant moving of the rocks and breakage of the concrete slab tetrapods were placed to prevent this. The tetrapods were not placed right. They had no interlocking functions and the quality is poor. This results in moving and breaking of the tetrapods and therefore it is no sustainable solution. More tetrapods should be placed, close to each other, to prevent the rocks from moving and wash out from smaller stones. Also the concrete should be of a better quality.

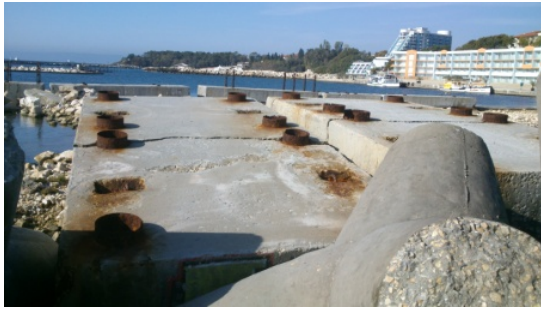
Figure 5-21 Eroded elements

There is a harbour close to the hotel Sirius. Probably this harbour was built for the loads of tourists that come to this place in the summer. It is clear that the harbour is unfinished. A lot of the material is piled up in front of harbour and from the caisson you can conclude that they are not connected the way they should be. The quality of the concrete elements is bad as well. A part of the elements are not reinforced and by those who are reinforced, the reinforcement is eroded.

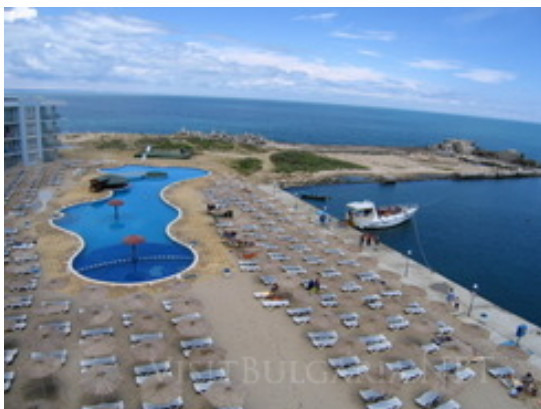
Figure 5-24 Hotel in front of the harbour

In front of the harbour a hotel was build. As was told in the introduction the main function of this hotel is as a land protection structure, because it was not allowed to built hotels to close to the shoreline anymore. On the figure below you can see the real function of the hotel. The harbour was intended to be used in the summer by tourists boats. Because the harbour was never finished it is now used by fisherman and there is hardly any boat.

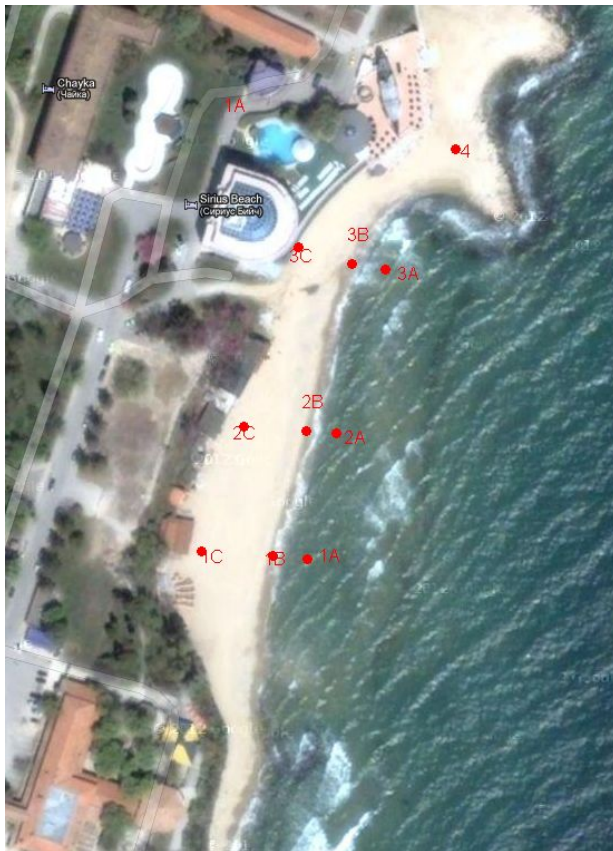
Figure 6-1 Sampling Locations

This year's aim for the sieve analysis was to determine the changes in grain size distribution and D_{50} of Sirius Beach. Therefore, the samples were taken at the same locations as in 2008 and 2009. These locations are shown in Figure 6-1.

The samples were taken at 4 points. In every cross-section, three samples were made. One sample 4 m offshore (numbered as A), a sample on the waterline (B) and the last sample 10 m landwards from the waterline (C). From the fourth point it was only possible to take one sample.

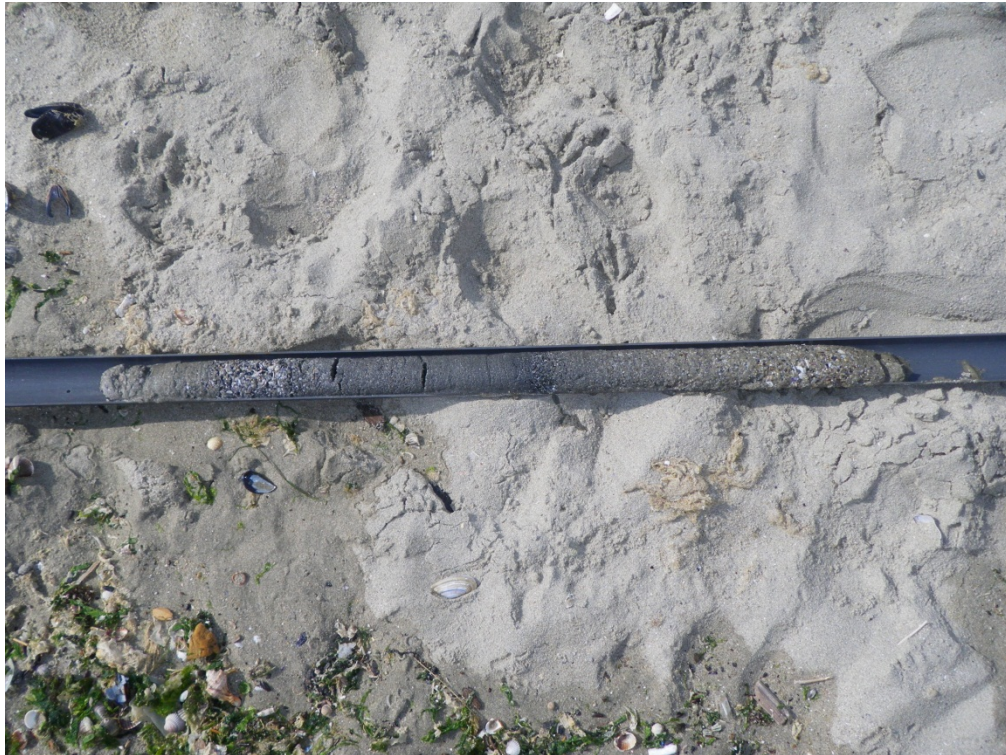
Figure 6-2 Piston

To obtain samples of the different locations, a piston was used (Figure 6-2). With this instrument it is possible to get a sand sample of approximately 0,5 m into the ground. The samples were taken and kept in numbered bags, in which they were to be transported to The Netherlands.

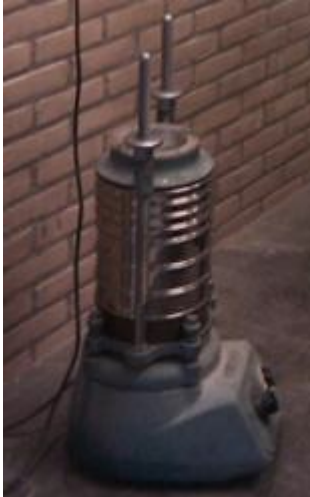
Figure 6-3 Sieving machine

Subsequently, the samples were sieved. For this, a sieving machine was used (Figure 6-3). On this machine, sieve trays with different mesh-sizes diameters were used. Based on experience of laboratory specialists, the samples were drilled in the sieving machine for 15 minutes.

The weighing balance in the laboratory has an accuracy of 0.1 gr.

To make sure the distributions are accurate, the whole sample was sieved. The samples were approximately 400 grams.

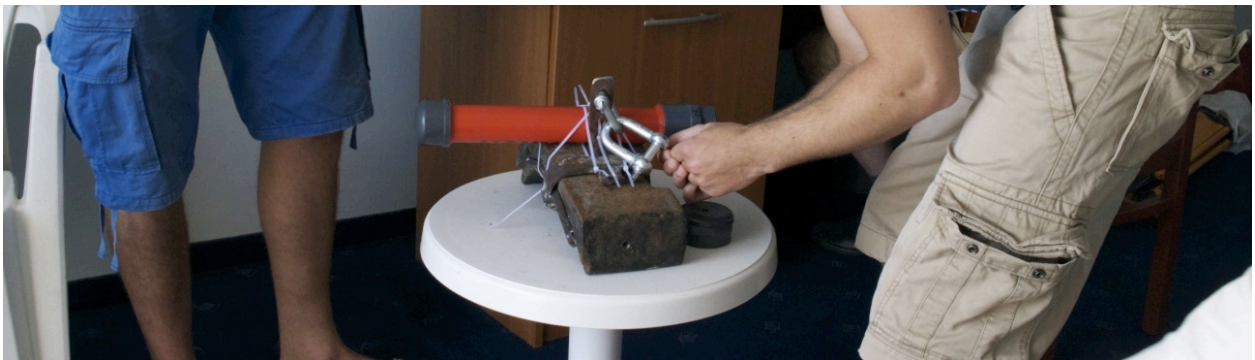
Figure A - 1 Wave pressure meter

A wave pressure meter is used to obtain wave data in general. The meter consists of different parts. In a plastic cylinder there are four batteries, electronics and a pressure sensor. The means used to get the meter into the water are an anchor, a rope, tireps and a buoy. The anchor was wrapped round the wave pressure meter with tireps. Consequently, the rope was used to connect the pressure meter to the buoy. In Figure A - 1 below the water pressure meter construction used is shown.

When this was done the anchor with the pressure meter on top was placed onto the sea bottom. The pressure meter was assumed to be 0.1m above the bottom. This information is required to calculate potential water depths.

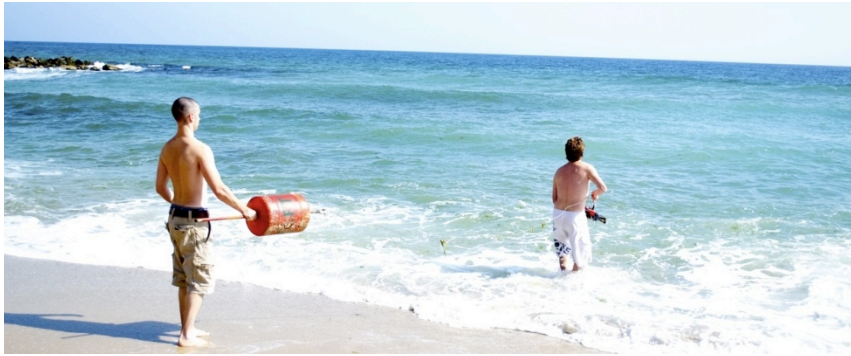
Figure A - 2 Placing the wave pressure meter at Sirius Beach

In the following picture the pressure meter is positioned (Figure A - 2). The meter measures: air pressure; hydrostatic pressure and pressure differences due to waves. It measures four times a second and saves the obtained data in portable memory locked in the electronics. With use of an analogue amplifier the signal from the sensor can be amplified. A simple computer program can be used to do this.
