# Eemdiijk full-scale field test programme: sheet pile pullover tests

## TProgramme d'essai terrain à taille réelle Eemdiijk : essais de déformation et de rupture de murs palplanches

**ABSTRACT:** Dikes in the Netherlands have traditionally been constructed with soil. Climate change and subsidence requires heightening and or reinforcing of these existing ground dikes. Traditional reinforcements demand additional space, which in some cases conflicts with existing buildings. Applying sheet pile walls in dikes allows for strengthening while minimizing the increase in footprint. However, a validated design approach that complies with relevant regulations lacks. To enable the validation of a proposed design approach, a full-scale field test programme (Eemdiijkproef) was performed near the town of Eemdiijk, The Netherlands. It consisted of a step wise approach: 1) sheet pile pullover tests, 2) ground dike stability test, 3) sheet pile dike stability test. All tests were loaded until failure occurred. The full-scale pullover tests (POT) consisted of 4 sheet pile configurations. The length of the sheet piles varies between 13 and 16m and the width of the panel varies between 1.8 and 4.2m

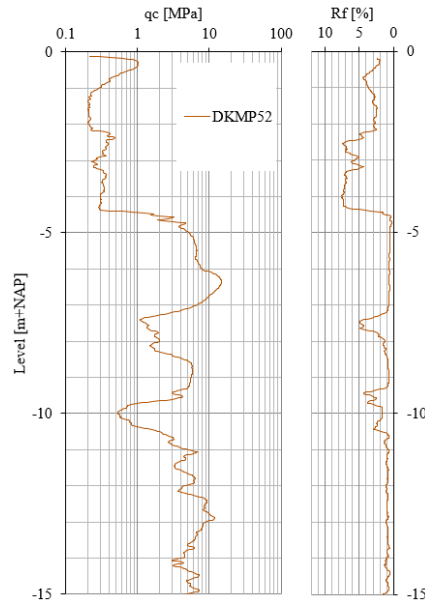
The ground conditions at the test site are homogeneous, consisting of peat and clay layers on top of a sand layer. In Figure 1 a representative CPT is presented and Table 1 presents the stratification. The “Eemdijkproef” comprised an extensive field and laboratory testing programme. A more detailed description of the geotechnical conditions is presented in (Lengkeek, 2019b). During

Figure 1. Representative CPT at POT site

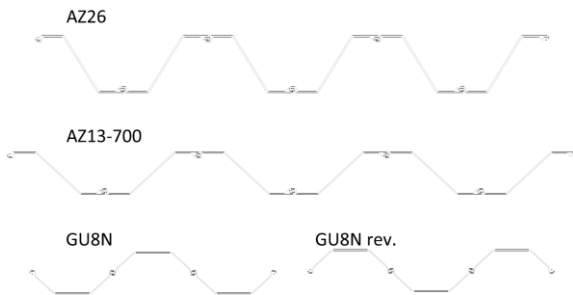
Four sheet pile configurations are tested in the POT (see figure 2):

- GU8N triple is a class 3 profile according to the (EN 1993-5, 2007) and the same type as used in the FST sheet pile dike. To assess the influence of the loading direction, this profile is also tested in the reversed direction (GU8N-rev).

- AZ26 profile is tested to validate the plastic bending capacity since this profile is a class 2

profile according to the (EN 1993-5, 2007) and therefore is expected to reach the full plastic bending capacity with additional plastic rotation capacity.

- AZ13-700 is a class 3 profile according to the (EN 1993-5, 2007) and is tested for comparison with the AZ26 profile. It is expected to reach the expected elastic bending capacity (plastic resistance in term of Eurocode) but not the full plastic bending capacity.

Figure 2. Sheet pile profiles

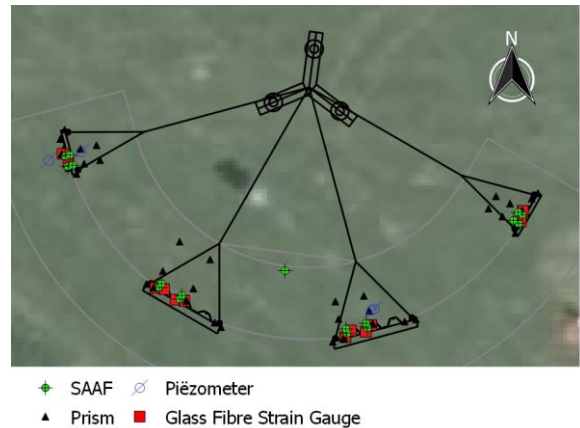
The test setup is presented in figure 3. Four sheet pile configurations are placed in a circular formation around a reaction frame. This reaction frame consists of 3 tubular piles interconnected with a steel Y-frame. To prevent any soil interaction between the sheet piles and the reaction frame the sheet piles are installed at a 15m distance of the tubular piles.

Figure 3. Top view POT site with monitoring instrumentation

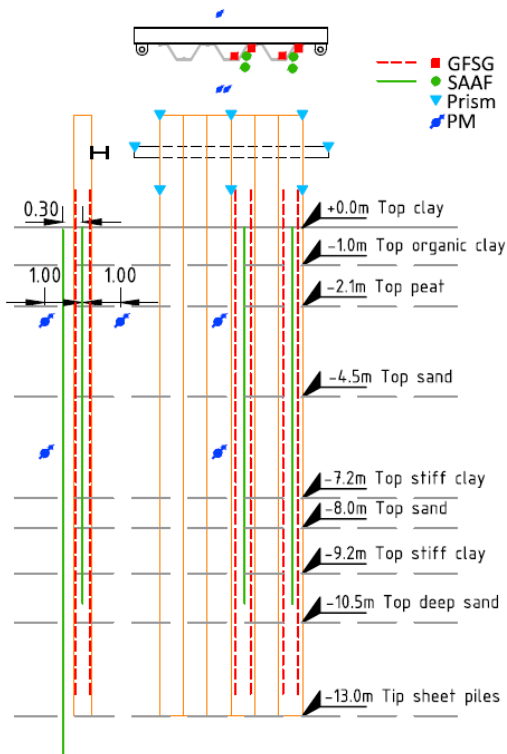
To monitor the horizontal displacements of the sheet pile, prisms are placed at three levels on the sheet pile and are monitored with total stations. Two SAAF's (Shape Accel Array Field) are

installed on the sheet pile wall and two SAAF's in the ground at 0.3m in front of the wall center-line to monitor the deflection and horizontal displacements over depth. The total pulling force applied by the hydraulic jack is measured by a force gauge and the stroke of the hydraulic jack is measured by an optical sensor. On the sheet pile wall glass fiber strain gauges (GFSG) are installed.

Figure 5. Top, front and side view of instrumented AZ26 sheet pile panel.

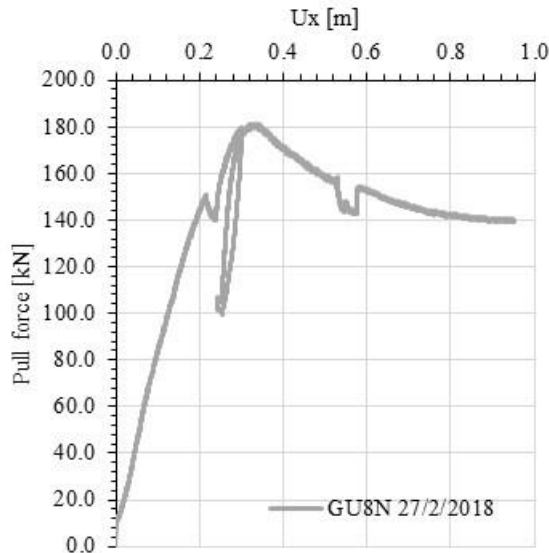
The maximum pulling force reached during this test is 180kN. The fixation level where rotation starts is about -2.0m NAP. Upon reaching 30cm of displacement the SAAF's on the sheet pile wall are removed to prevent any damage due to local buckling of the sheet pile. For this the pull-force is temporary lowered to 100kN. A similar procedure is also followed for the other tests. The obtained force-displacement diagram for the GU8N is shown in figure 6. In figure 7 the horizontal displacements measured by the SAAF and prisms are plotted just before removal of the SAAF. In this figure the SAAF's in front of the wall are also shown with an offset of 1m, in reality they are placed at 0.3m distance of the center-line of the sheet pile wall.

Figure 6. Force-displacement diagram GU8N.  
GU8N 2018-02-27 12:47:00

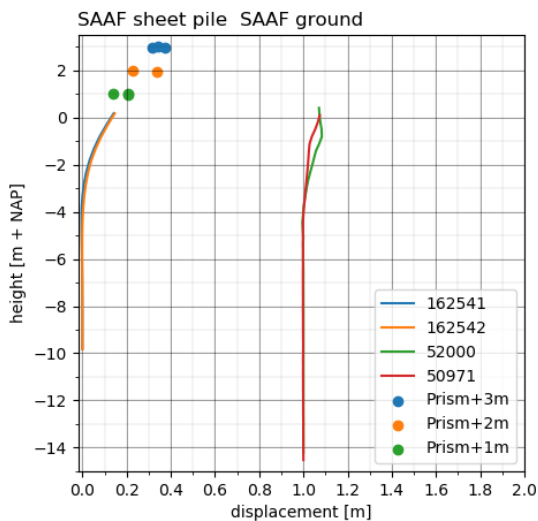
Figure 7. Horizontal displacements over depth of the SAAF and prisms at the GU8N sheet pile.

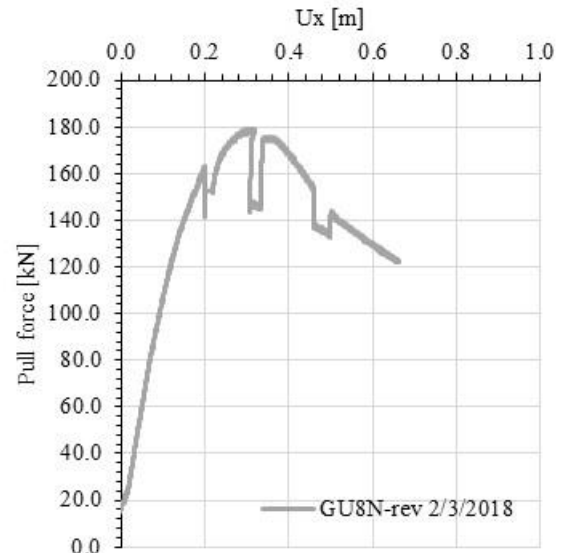
Figure 8 shows the maximum pull-force is almost 180kN, which is approximately the same as the GU8N triple-U profile. The reduction in pull-force after reaching the peak is however significantly larger compared with the GU8N triple-U profile. Figure 9 shows the deformations of the GU8N-rev triple-U profile and the layout is similar to figure 7

Figure 8. Force-displacement diagram GU8N-rev  
GU8Nrev 2018-03-02 13:53:00

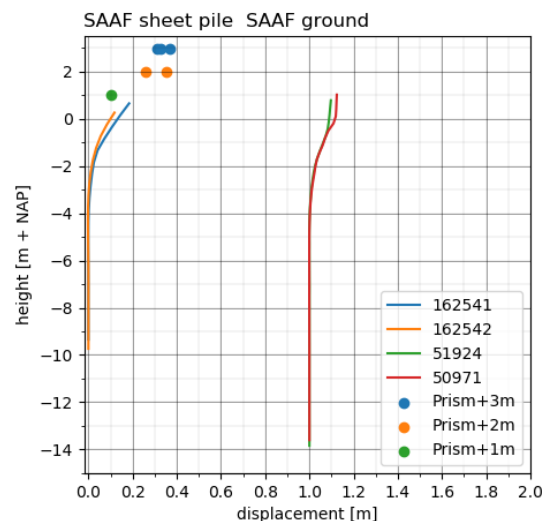
Figure 9. Horizontal displacements over depth of the SAAF and prisms at the GU8N-rev sheet pile.

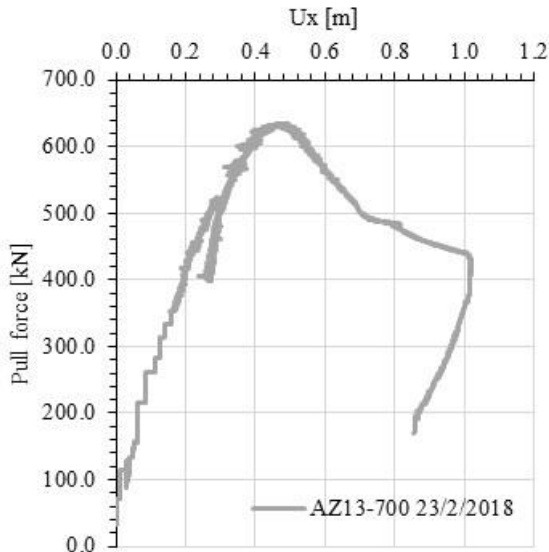
triple-U, the maximum pulling force is also higher at 634kN (figure 10). The AZ13-700 three double-Z profile is stiffer than the GU8N profile. This is also reflected in horizontal displacements (figure 11). The fixation level where rotation starts is about -4.0m NAP due to the higher stiffness.

Figure 10. Force-displacement diagram AZ13-700  
AZ13-700 2018-02-23 14:04:00

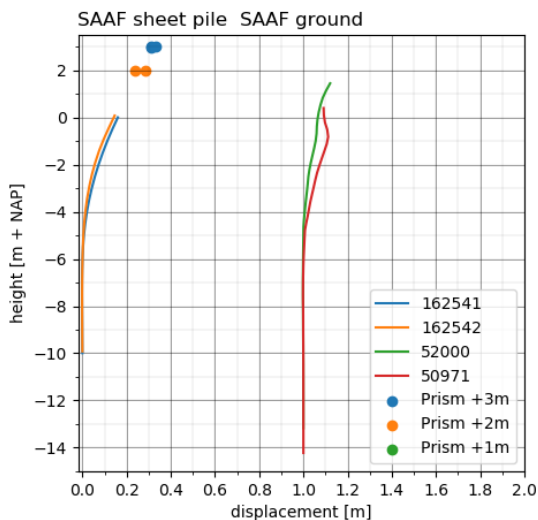
Figure 11. Horizontal displacements over depth of the SAAF and prisms at the AZ13-700 sheet pile

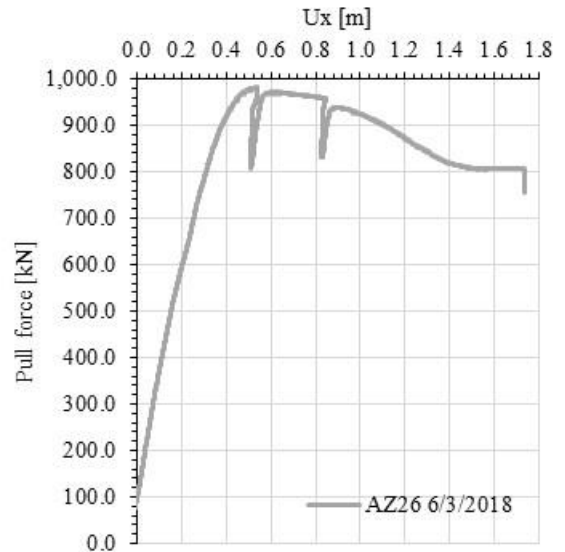
Figure 12. Force-displacement diagram AZ26  
AZ26 2018-03-06 12:34:00

The AZ26 three double-Z is the strongest profile that has been tested as part of the pullover test program, a maximum pull-force of 982kN is reached. The fixation level where rotation starts

is about -6.0m NAP due to the high stiffness. The results in figure 12 also show that after reaching the maximum pull-force this profile allows for large additional displacements with little reduction of the pulling force relative to the other tested profiles. This setup of three double heavier profiles represents also the typical configuration

The AZ26 profile has a relatively small reduction of pulling force compared to the other profiles. This corresponds to the classification according to (EN 1993-5, 2007) since this profile is a section class 2 profile in which some degree of plastic rotation capacity is expected.

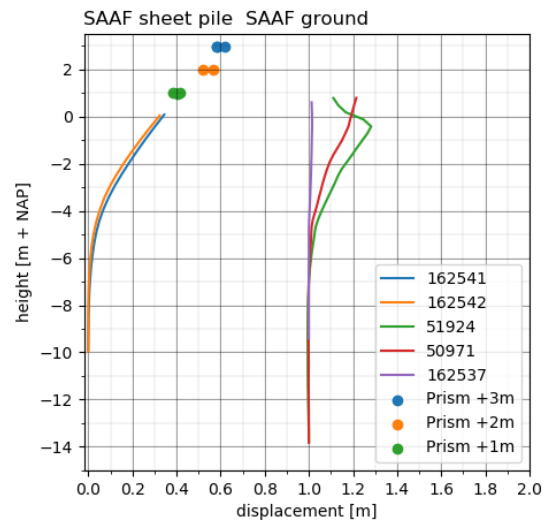
Figure 13. Horizontal displacements over depth of the SAAF and prisms at the AZ26 sheet pile.

Figure 13 shows the deformations of the AZ26 three double-Z-profile. The larger horizontal displacements relate to the deeper point of rotation, compared to the other profiles. In addition, one SAAF is placed at 5m distance of the sheet pile wall to measure the displacements of the soil on a larger distance.

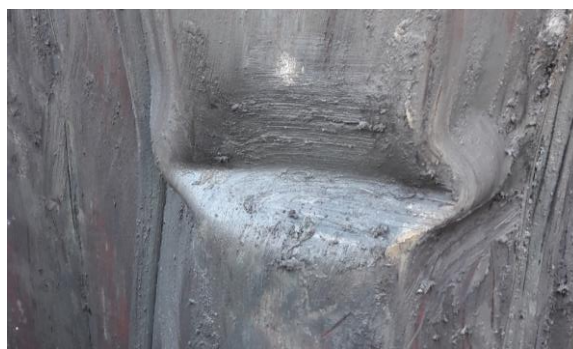
After performing the pullover tests the sheet piles have been excavated to investigate the failure mechanism. Figure 14 shows as example the buckled compression flange of the GU8N-rev triple-U.

Figure 14. Excavated GU8N-rev with local buckling

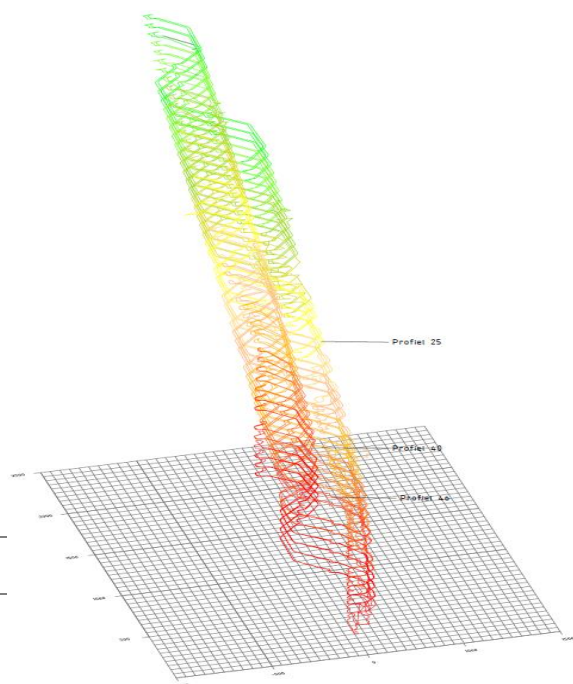
Figure 15. 3D scan of deformed GU8N-rev

In addition to the visual inspection of the excavated sheet piles 3D scans have been made to record the deformed shape of the entire profile, see Figure 15. Based on the 3D-scans it is observed that the buckling and plasticity is limited to approximately 0.5m height. The shape of the rest of the profile did not change significantly.
